The New Era for Printing

| Technical Service Bulletin | |
| File number : 2022005 | Date: 13/04/2022 |

## How to upgrade the firmware when E02 is displayed

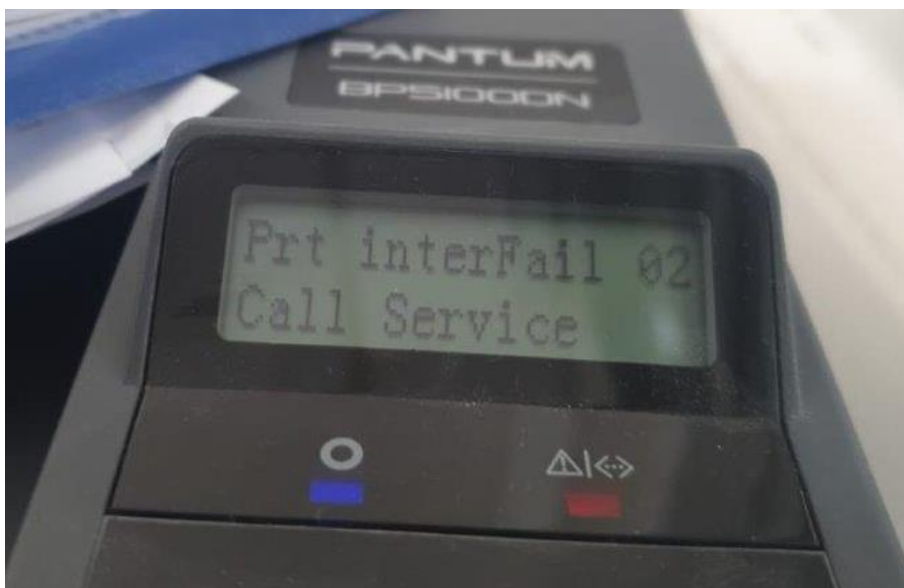
E02 is displayed as shown below:

Firmware issue.

1. Prepare the whole machine to be upgraded, and put the firmware package into the specified path (the path can be selected by yourself, which is convenient for uploading firmware)
2. Connect the printer to your computer via USB and turn on the printer.
3. Click "[Pantum\\_4020SFP\\_FWUpgradeTool \(3.A.1.6\)](#)" to enter the interface below:
