| Technical Service Bulletin | |
| File number : 2021017 | Date: 07/12/2021 |

## How to solve AirPrint cannot be used on IOS14

**Applicable Model:** P3016D,P3306DN,P3305DN,P3305DW series

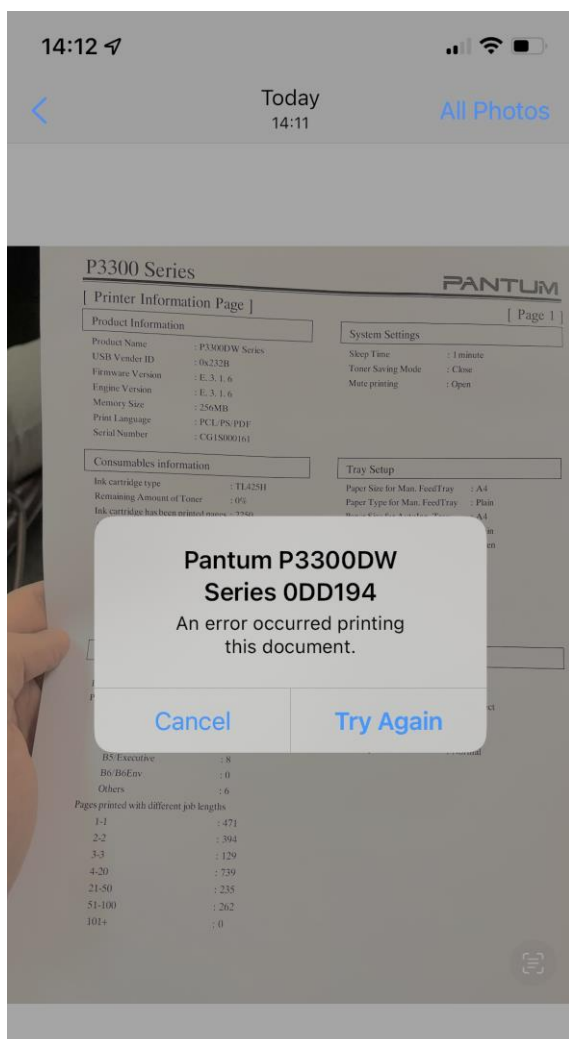
AirPrint cannot be used on IOS14 as shown below:

Firmware issue.

Upgrade the firmware :
