# SERVICE BULLETIN

**PRODUCT:** Xerox Versant 2100 Press (10)

**T8333-11-05**

**SUBJECT:** Break-in Procedure for Fuser belt Assembly  
(PN 001R00620)

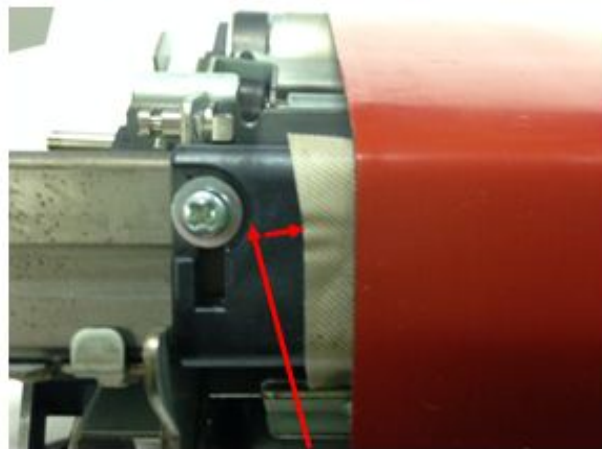
Case where slip sheet has been moved or pinched towards the center and away from the screw radius. This is NG case

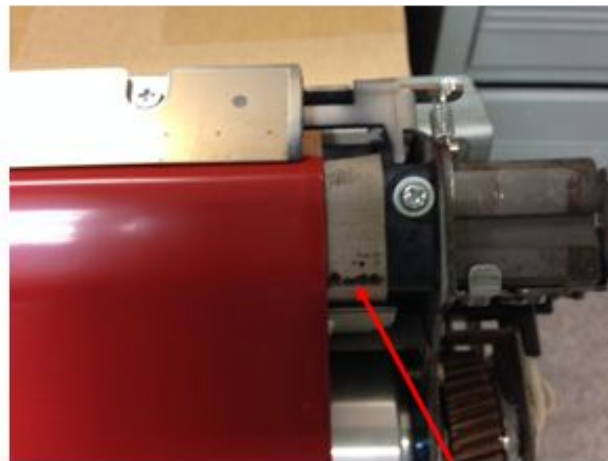
Case where slip sheet has become dirty from low oil condition and causes high torque. This is NG case.

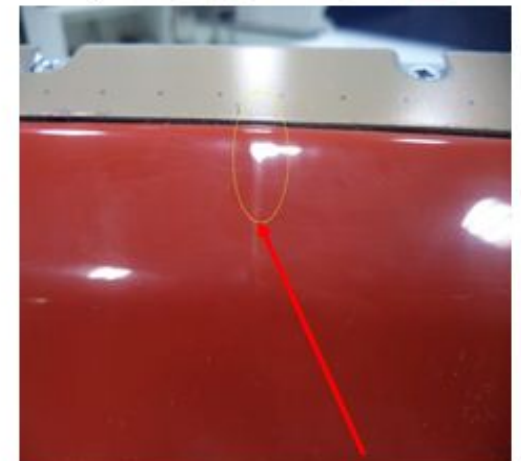
Case where slip sheet has been moved or pinched towards the center and had wrinkled in the center of the nip area causing creased prints. This is NG
