| Technical Service Bulletin | |
|---|---|
| File number : 2021018 | Date: 08/12/2021 |

## How to solve internal error 01 or 02 after databoard or LSU is replaced

**Applicable Model:** P2200-2500,M6200-6500,M6600 series

# PANTUM

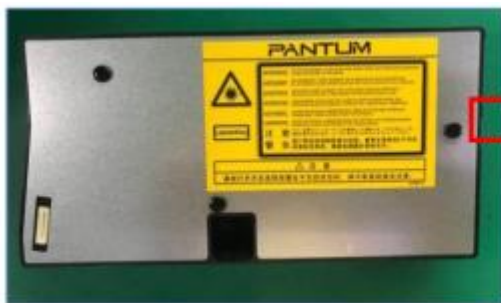
Old version

LSU version change description:

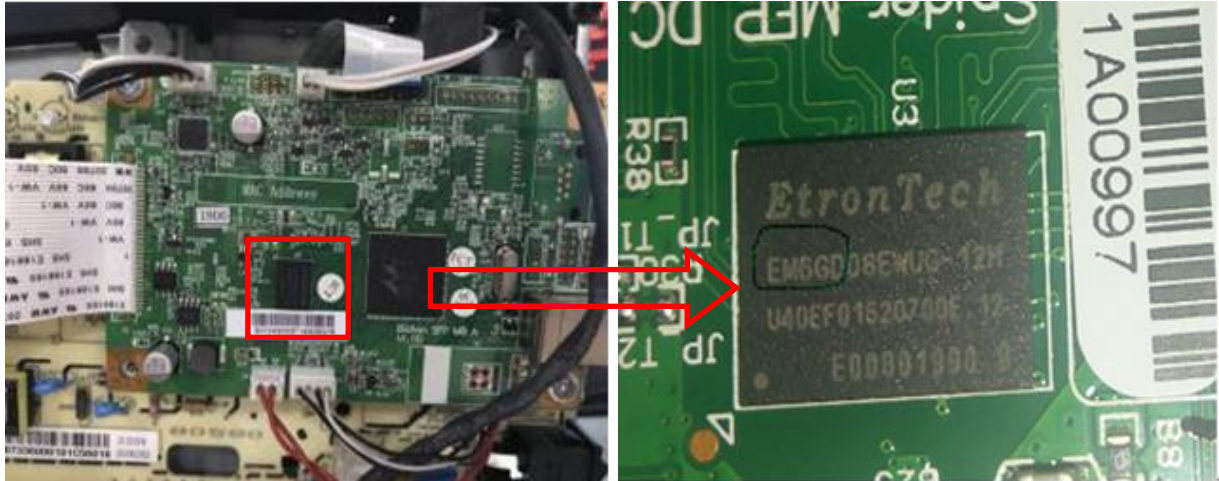
The printed content of the U3 chip shows that it is EM6GD at the beginning, then the memory is 256M ;

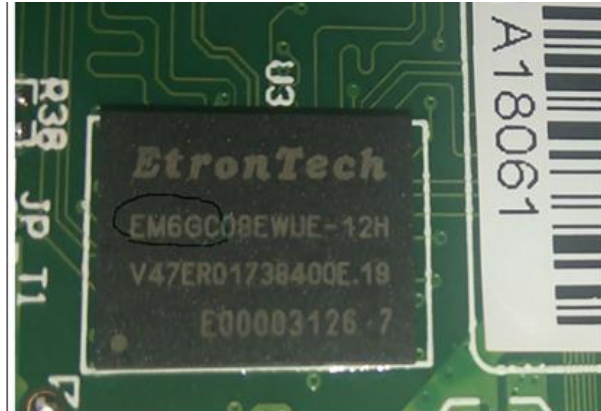
The printed content of the U3 chip shows that it is EM6GC at the beginning, then the memory is 126M;

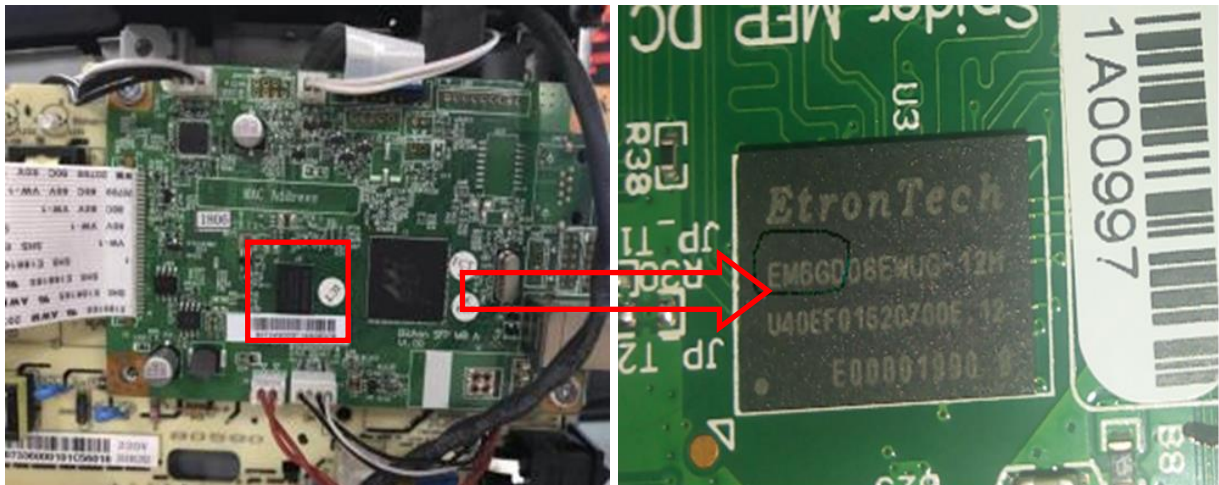
The printed content of the U3 chip shows that it is EM6GD at the beginning, then the memory is 256M ;

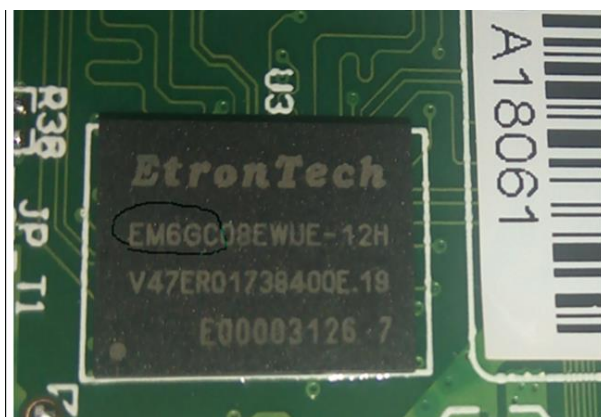
The printed content of the U3 chip shows that it is EM6GC at the beginning, then the memory is 126M;
