| Technical Service Bulletin | |
| File number : 2022003 | Date: 25/03/2022 |

## How to solve duplex printing abnormal sound

**Applicable Model:** P3010-3060,P3300, M6700-M6800,M7100-7200,M7300 series

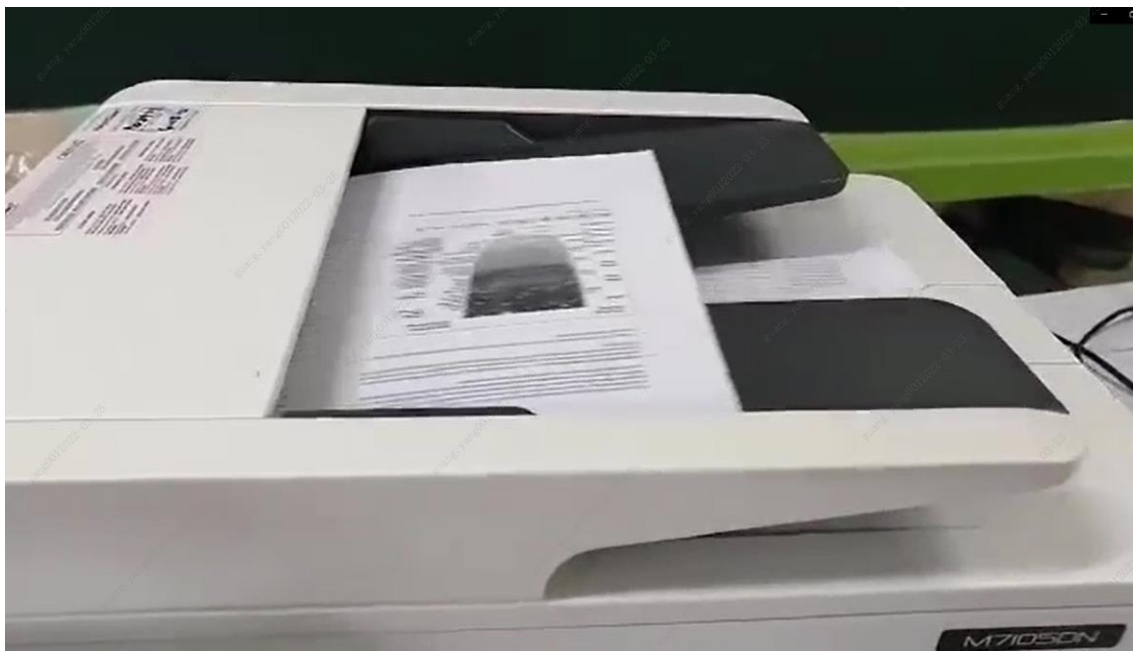
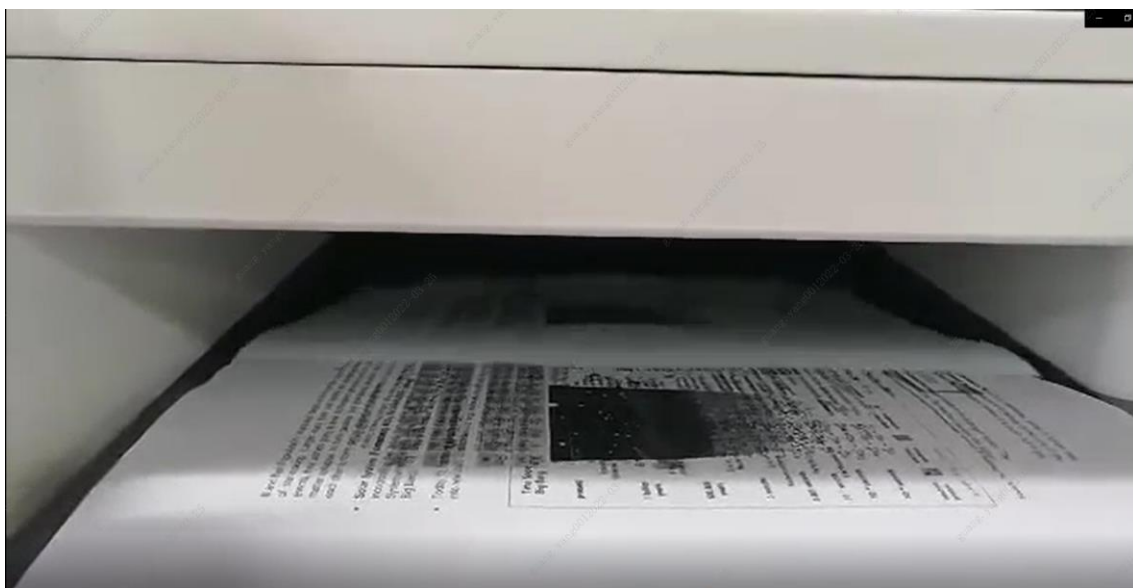
When duplex printing there is abnormal sound.

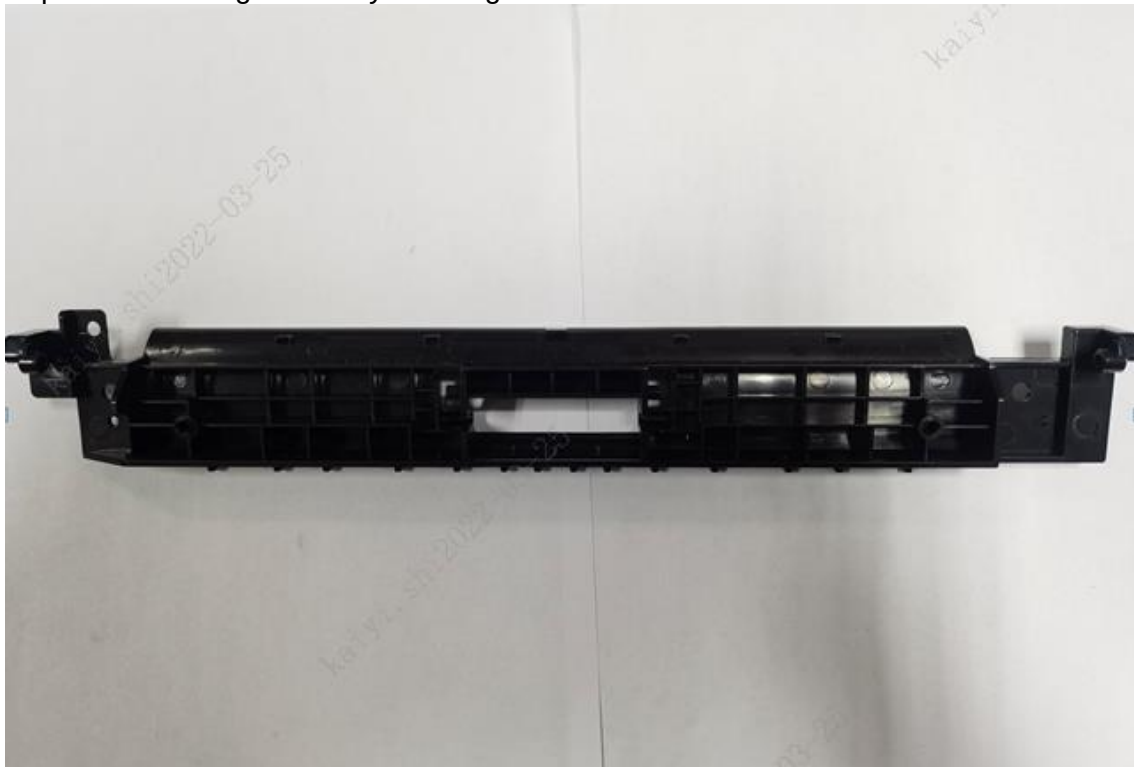
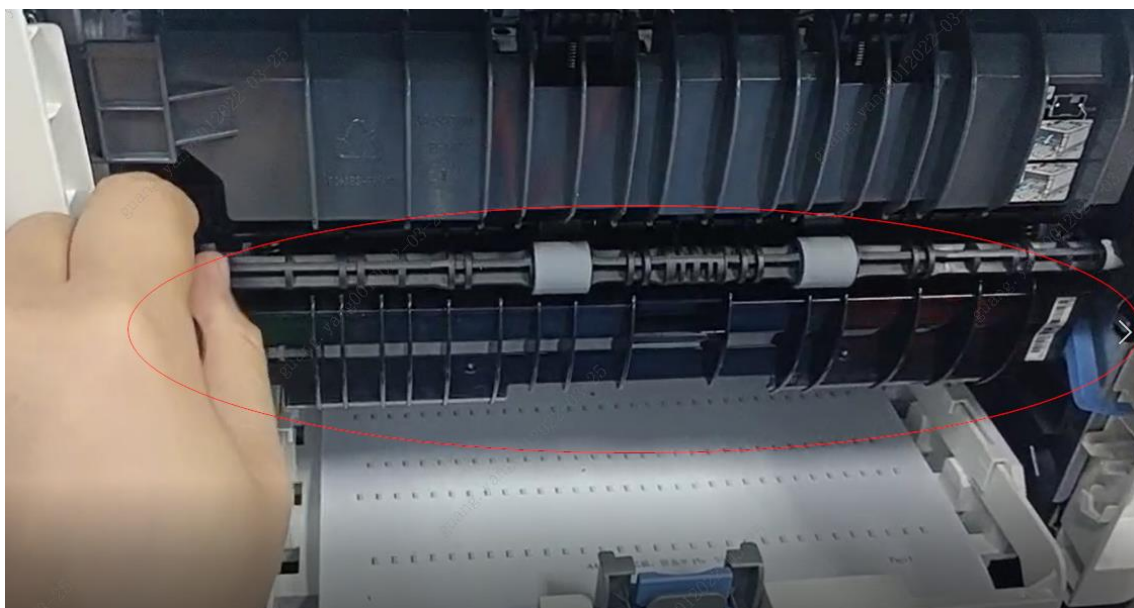
Paper feed leading assembly is too tight.
