The New Era for Printing

| Technical Service Bulletin | |
| File number : 2021015 | Date: 12/11/2021 |

| <b>How to solve printer display "Middle Jam"</b><br>5103 Platform |

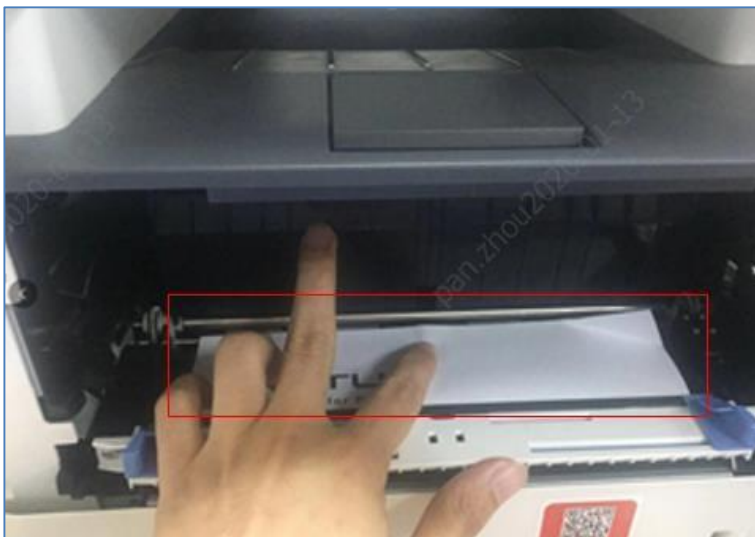
(2) Paper stuck between the moving guide component and the redress roll (not yet into the redress roll), as shown below:

- (1) Transfer sensor connecting rod dislocation or damage, transfer sensor failure.
- (2) Transportation spring loose out or transportation paper feed guide slightly deformed

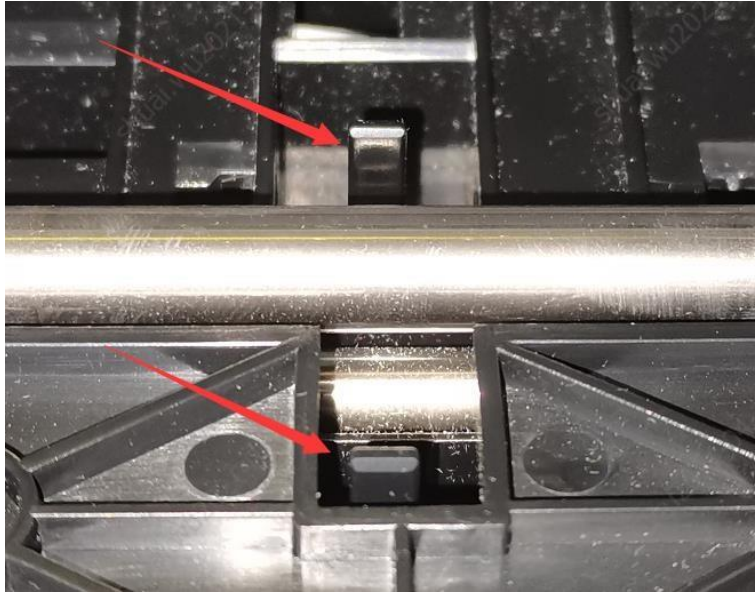
(Take out the toner cartridge and see)

- (1) Adjust the connecting rod of the transfer sensor to return to the normal position and move freely, as shown below:
