# HP Color LaserJet Managed MFP E77822-E77830 series – Control Panel Message Document (CPMD)

This document provides error-code troubleshooting information

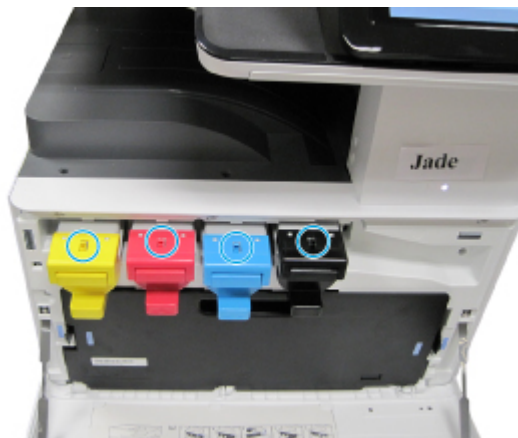
1. Open the front cover. Check if the toner cartridge or drum unit is installed.
2. Remove and reinstall the toner cartridge or drum unit.
3. Check if the toner cartridge or drum unit is installed correctly.
  - a. If the cartridge comes out automatically, check the toner cartridge latching hook.

- b. If the toner cartridge hook is damaged, replace the toner cartridge.

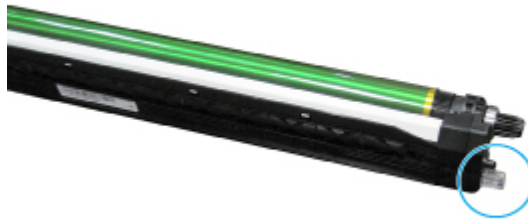
- b. If the CRUM connector is pushed into the drum unit, try to pull the jack out it and then ensure it is seated correctly.
4. If the drum unit is replaced, reset the kit count.
    - a. Open the following menus:
      - Support Tools
      - Service

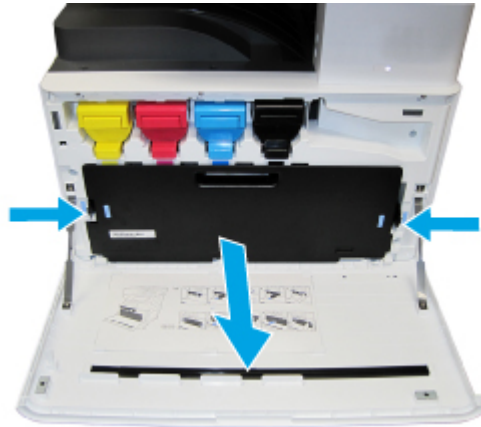
1. Open the front cover.
2. Check if the toner collection unit is installed correctly.
3. Remove the toner collection unit.

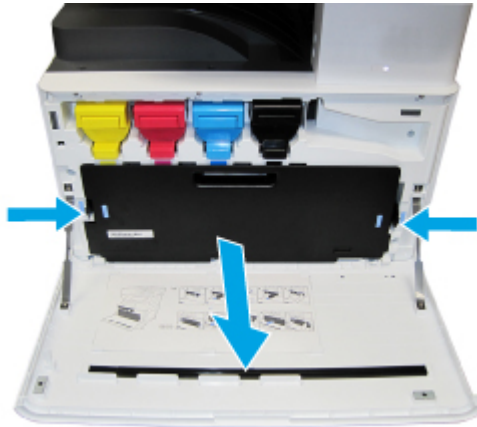
1. Open the front cover.
2. Check if the toner collection unit is installed correctly.
3. Remove the toner collection unit.

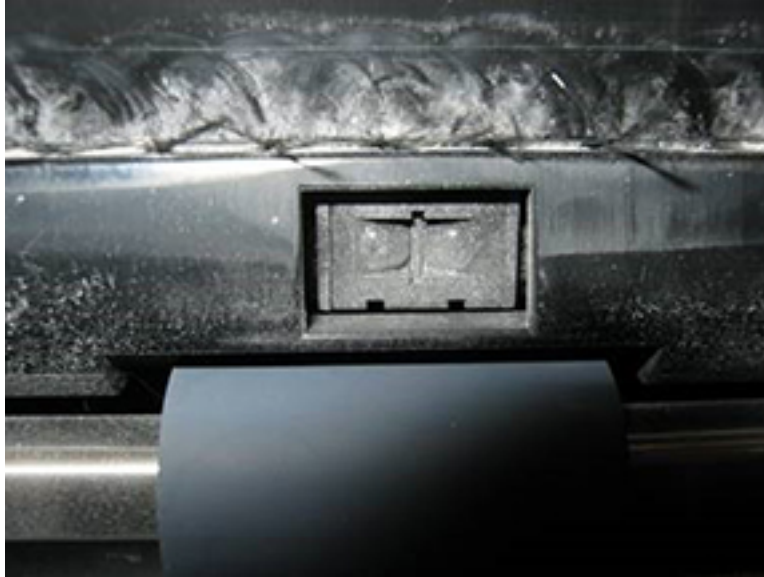
**Figure 3** Example of dust contaminated sensor

**NOTE:** If the feed sensor was dirty or contaminated, the 2 other sensors might be also and should be cleaned.

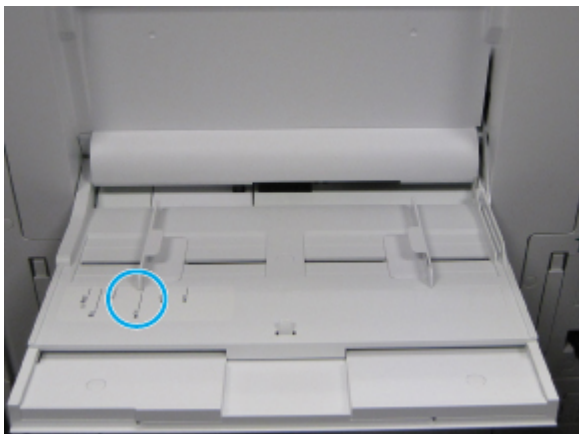
3. Ensure that the tray width guides are set to the correct paper size being installed into the tray. The arrow on the guide should line up exactly with the line connected to the paper size designation. Ensure that the tray is not filled above the fill mark on the tray.

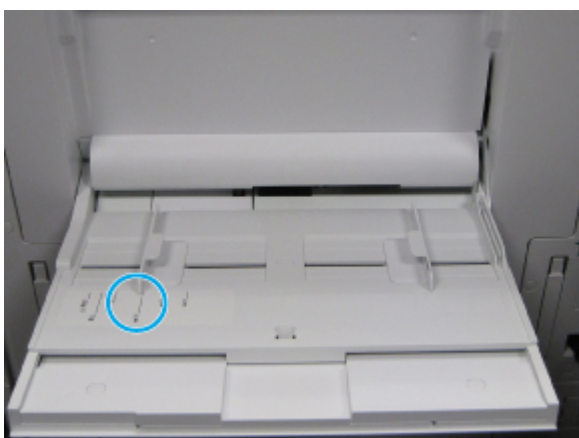
1. Remove any jammed paper from tray 1.
2. Ensure that the tray width guides are set to the correct paper size being installed into the tray. The arrow on the guide should line up exactly with the line connected to the paper size designation. Ensure that the tray is not filled above the fill mark on the tray.

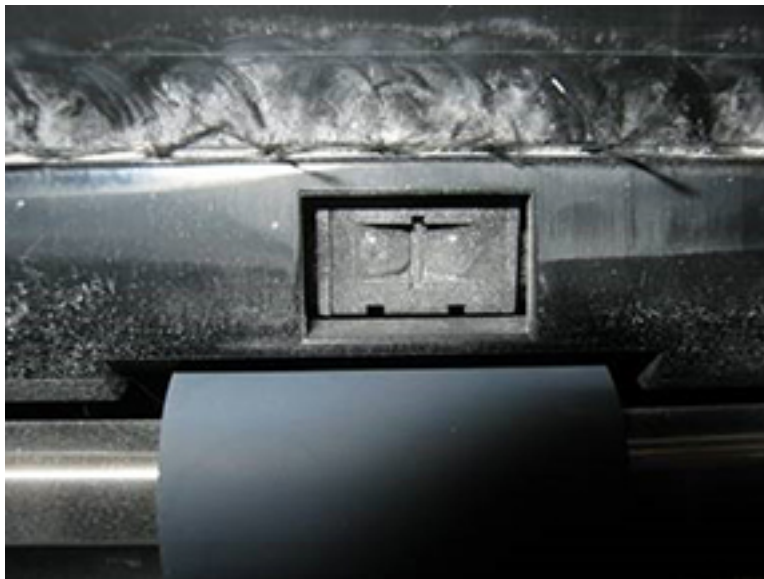
**Figure 5** Example of dust contaminated sensor

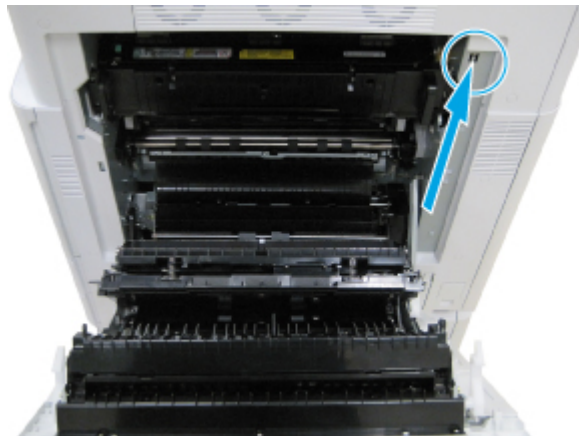
**NOTE:** To run this test, the right door sensor might need to be tripped.

- b. If the motor or the clutch does not function, check if both wiring harnesses are connected correctly.
- c. If the connection is good, replace the electric clutch or the MP registration drive as needed.

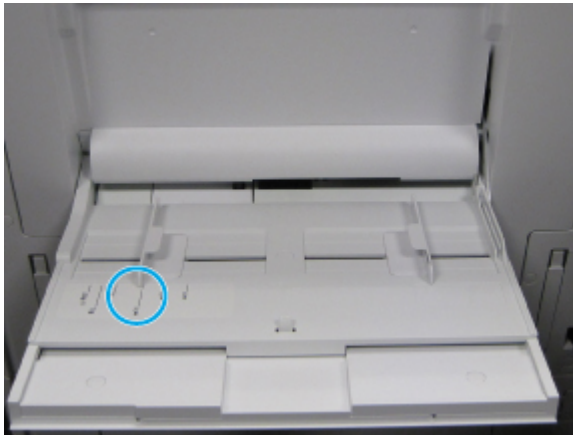
1. Open the right door. Remove any jammed paper from the area.
2. Remove any jammed paper from the tray 1.
3. Ensure that the tray width guides are set to the correct paper size being installed into the tray. The arrow on the guide should line up exactly with the line connected to the paper size designation. Ensure that the tray is not filled above the fill mark on the tray.

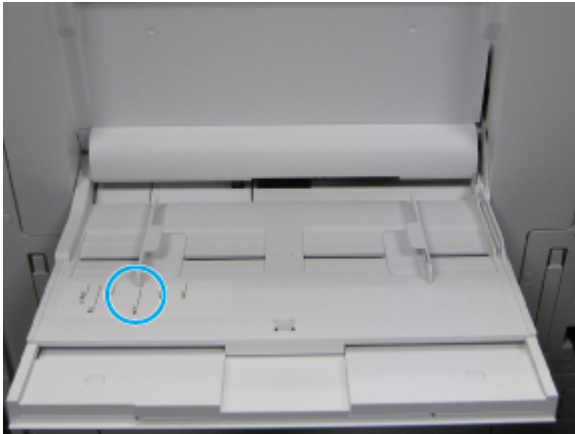
1. Remove any jammed paper from tray 1.
2. Ensure that the tray width guides are set to the correct paper size being installed into the tray. The arrow on the guide should line up exactly with the line connected to the paper size designation. Ensure that the tray is not filled above the fill mark on the tray.

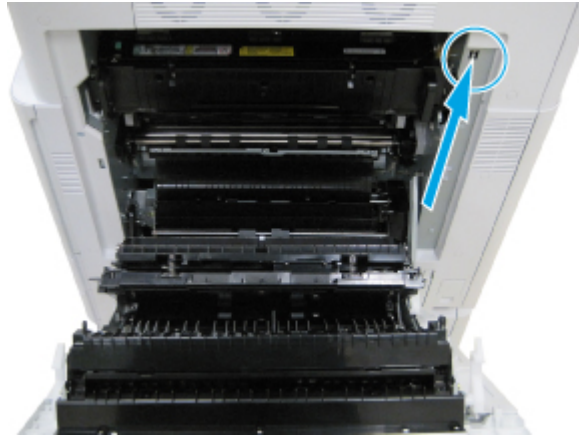
**NOTE:** To run this test, the right door sensor might need to be tripped.

- b. If the motor or the clutch does not function, check if both wiring harnesses are connected correctly.
- c. If the connection is good, replace the electric clutch or the MP registration drive as needed.

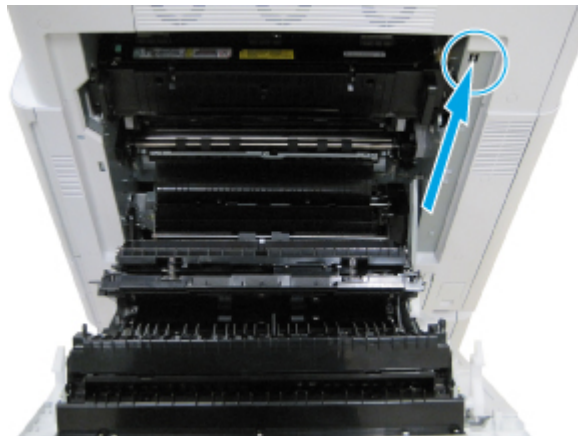
**NOTE:** To run this test, the right door sensor might need to be tripped.

- b. If the motor or the clutch does not function, check if both wiring harnesses are connected correctly.
- c. If the connection is good, replace the electric clutch or the MP registration drive as needed.

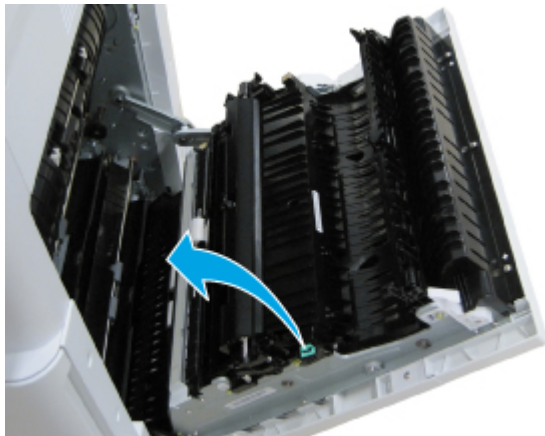
**Figure 18** Open the duplex path

1. Open the right door. Remove any jammed paper found.
2. Open the duplex path and remove any paper found.

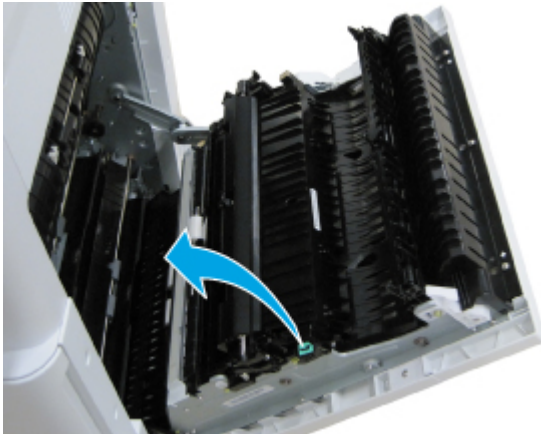
**Figure 20** Open the duplex path

2. Open the duplex path and remove any paper found.

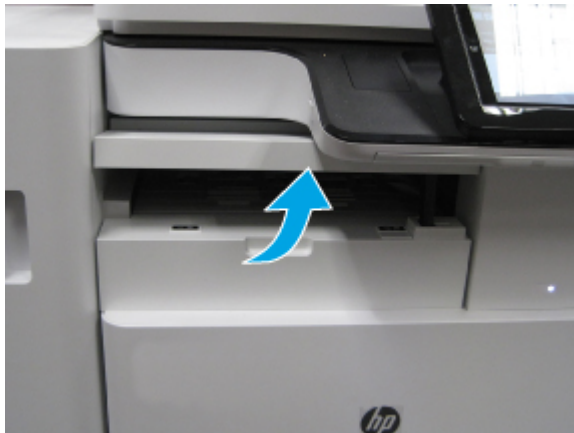
1. Open the IPTU access cover, remove the paper from the main body exit or the IPTU entrance, and then close the door.

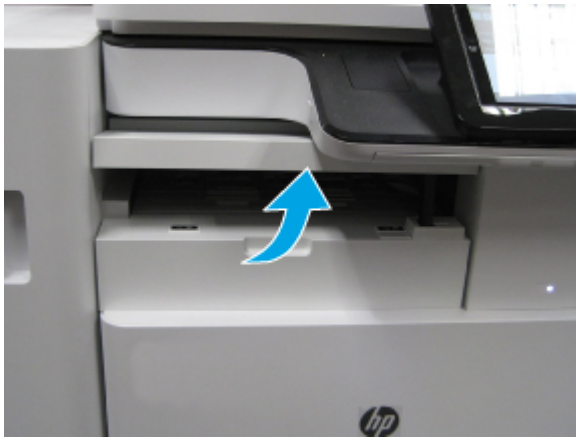
1. Open the IPTU access cover, remove the paper from the main body exit or the IPTU entrance, and then close the door.

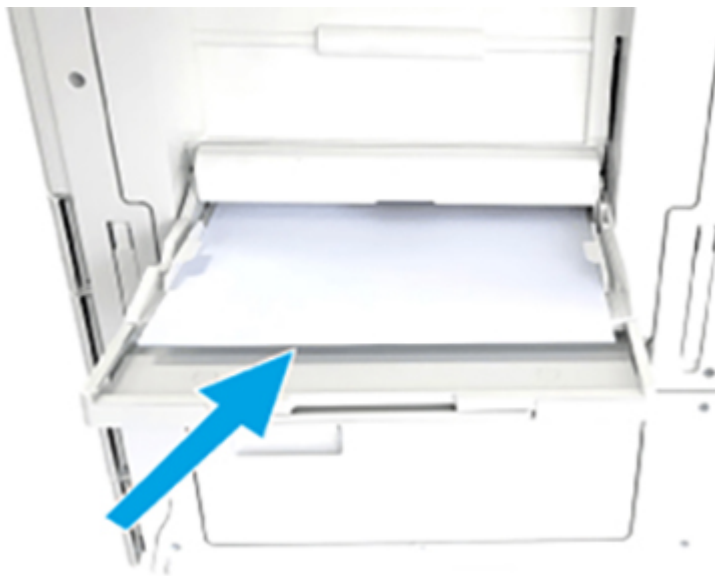
2. Turn the printer off, and then on.
3. If the paper being used is not A4 or letter, test with A4 or letter fed long edge first as indicated below. If a new error occurs, follow that error guide.

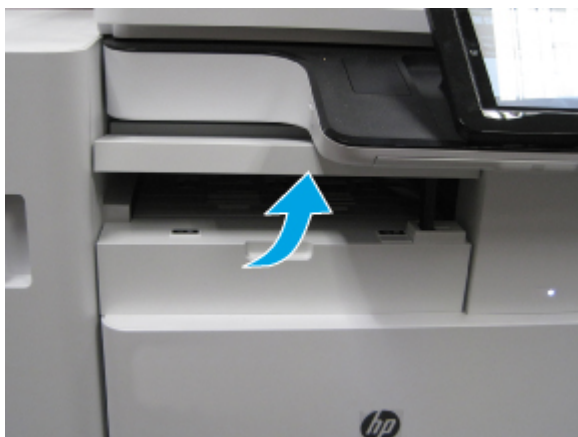
1. Open the IPTU access cover, remove the paper from the main body exit or the IPTU entrance, and then close the door.

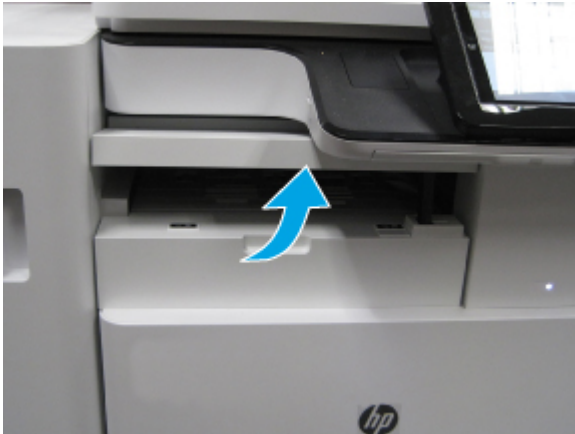
2. Open the IPTU access cover, remove the paper from the main body exit or the IPTU entrance, and then close the door.

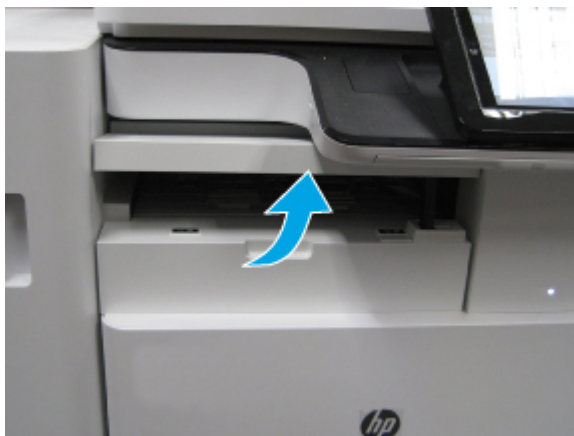
1. Open the IPTU access cover, remove the paper from the main body exit or the IPTU entrance, and then close the door.

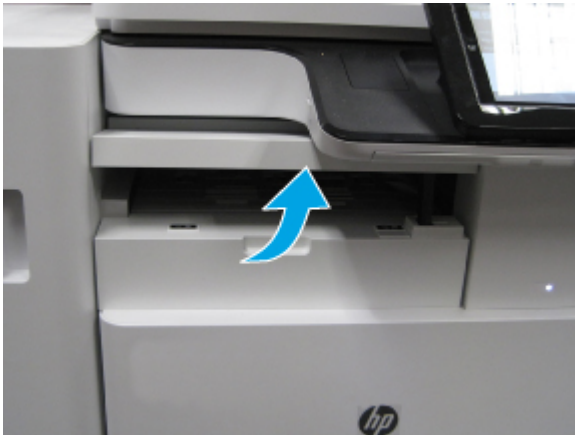
1. Open the IPTU access cover, remove the paper from the main body exit or the IPTU entrance, and then close the door.

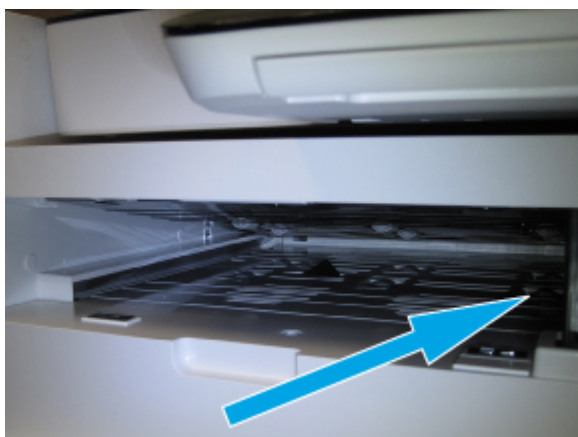
2. Turn the printer off, and then on.
3. Check the IPTU input sensor S1.

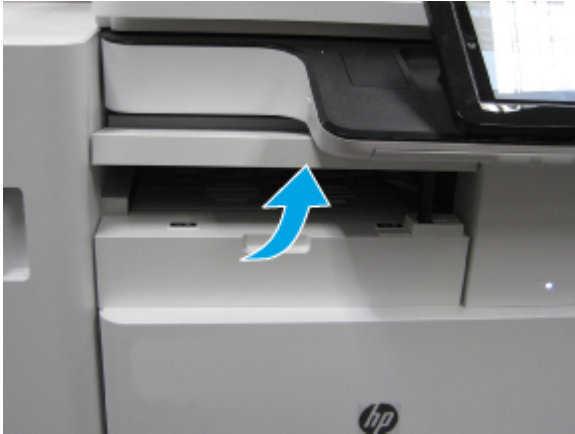
1. Open the IPTU access cover, remove the paper from the main body exit or the IPTU entrance, and then close the door.

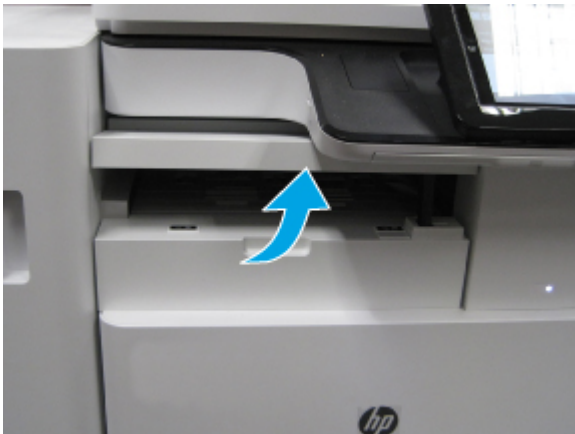
1. Open the IPTU access cover, remove the paper from the main body exit or the IPTU entrance, and then close the door.

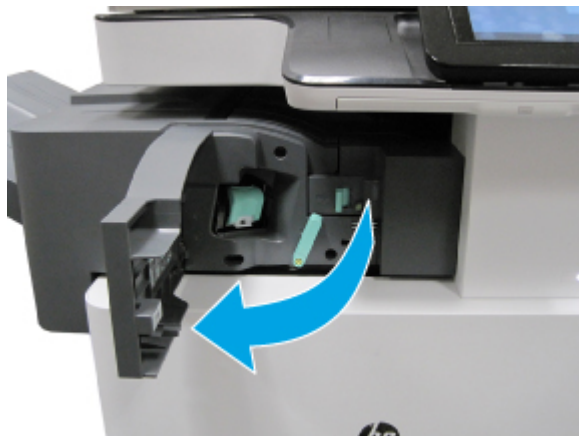
1. Open the finisher and check for any jammed paper or obstructions, and remove them.
  - a. Open the finisher door.

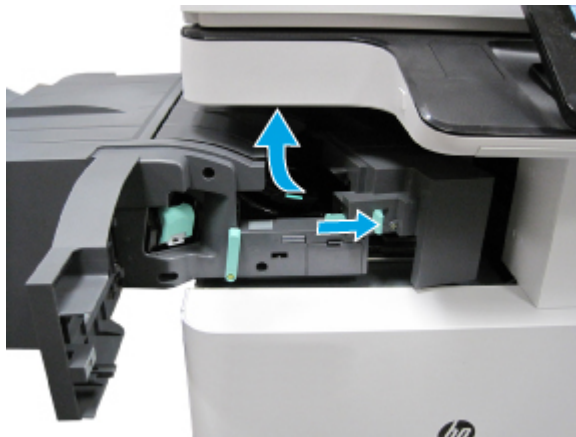
- c. Open the right and upper jam covers.

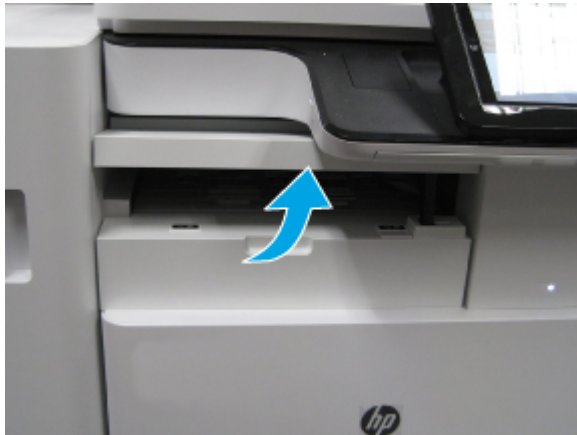
- a. Open the IPTU cover.

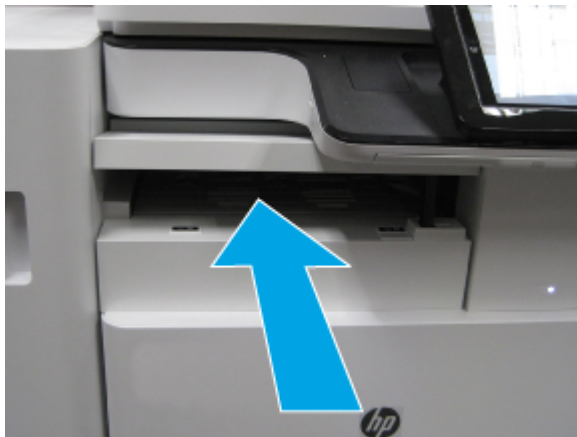
- b. Check for paper jams or obstructions.

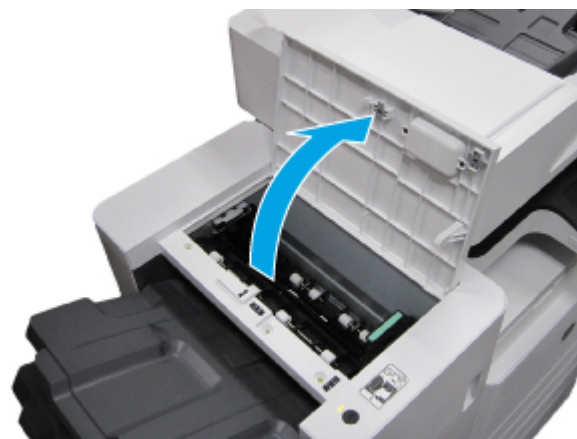
- a. Open the finisher top cover.

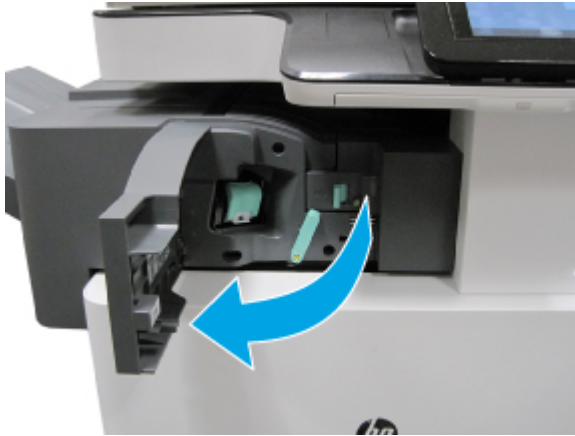
1. Open the finisher and check for any jammed paper or obstructions, and remove them.
  - a. Open the finisher door.

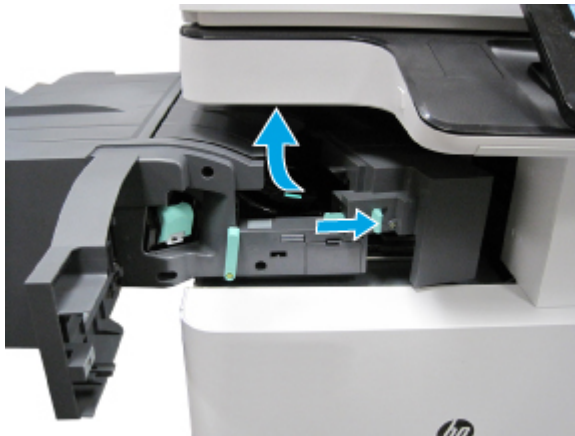
- c. Open the right and upper jam covers.

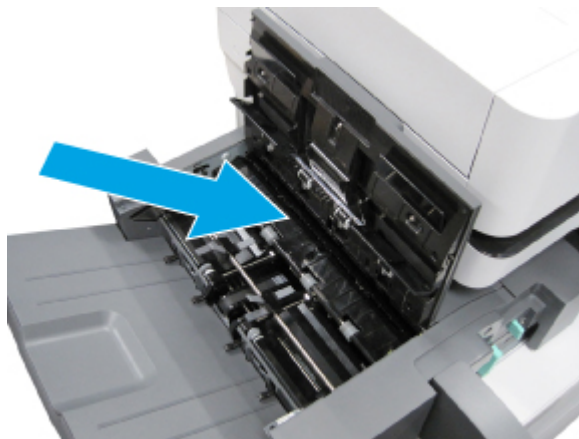
- g. Remove any jammed paper or obstructions.

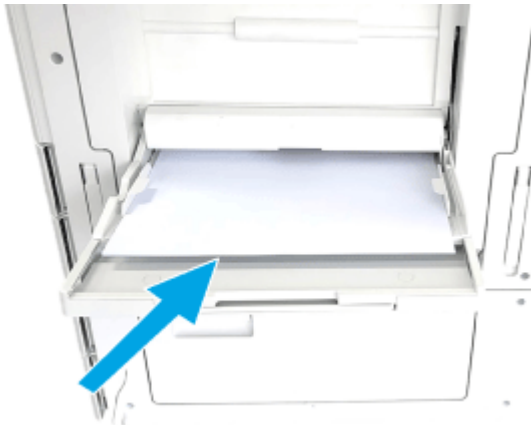
3. If the jam is occurring with paper that is not A4 or Letter, try printing out with A4 or letter paper using long edge feeding. If another error appears, follow the troubleshooting for that specific error.

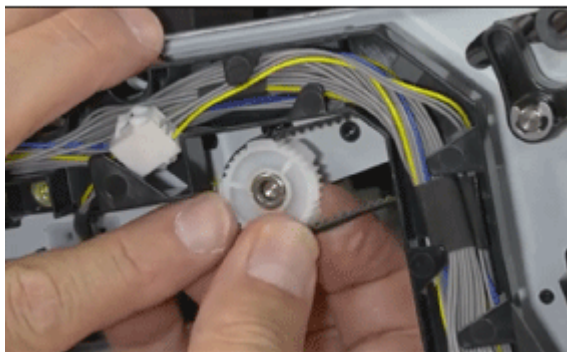
- c. Check the driving gear to ensure it is installed with the correct orientation and to make sure the one-way bearing is running in the correct direction.

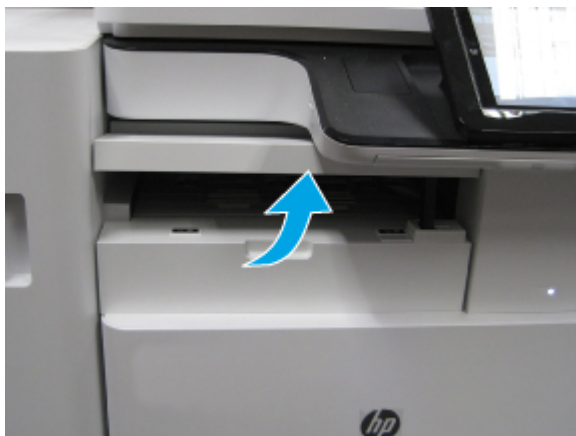
- 1. Check the IPTU for paper jams or obstructions.
  - a. Open the IPTU cover.

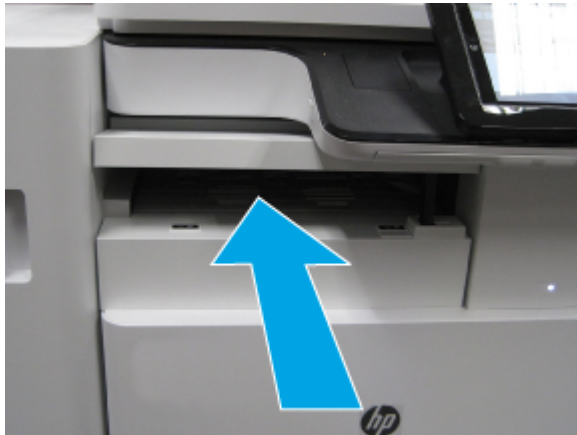
- b. Check for paper jams or obstructions.

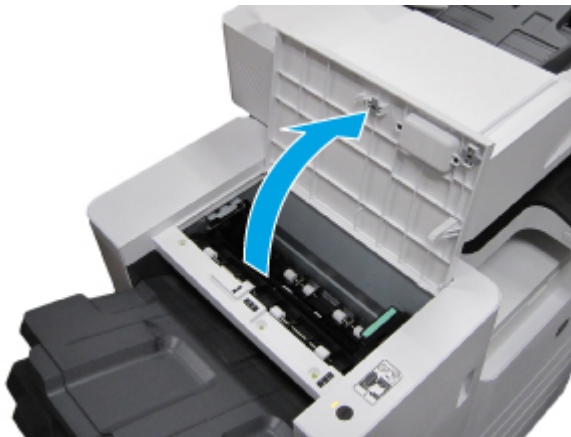
- a. Open the finisher top cover.

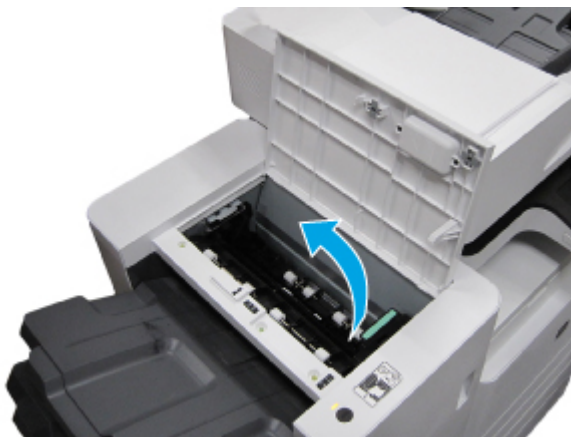
- b. Open the inner jam cover.

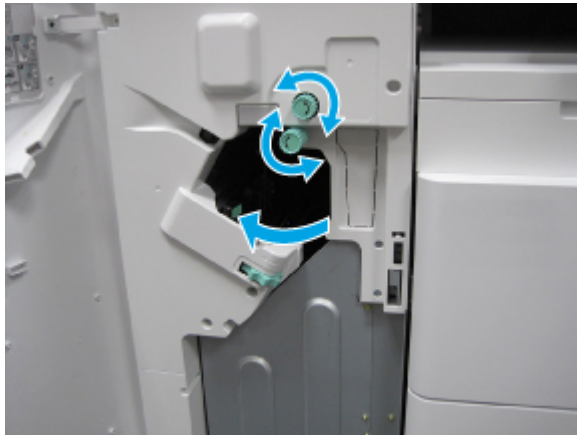
- d. Open the finisher front cover and inner jams access cover.

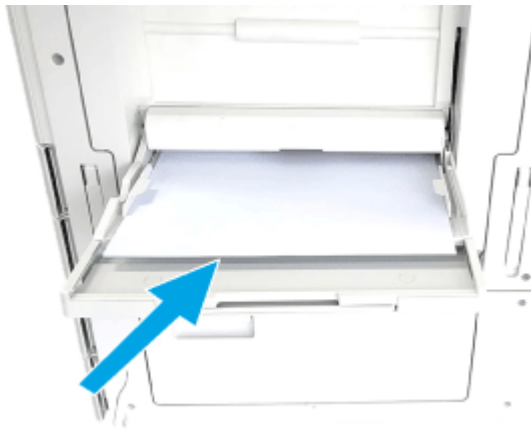
- e. Remove any jams or obstructions.
  - f. Close all finisher covers.
3. If the jam is occurring with paper that is not A4 or Letter, try printing out with A4 or letter paper using long edge feeding. If another error appears, follow the troubleshooting for that specific error.

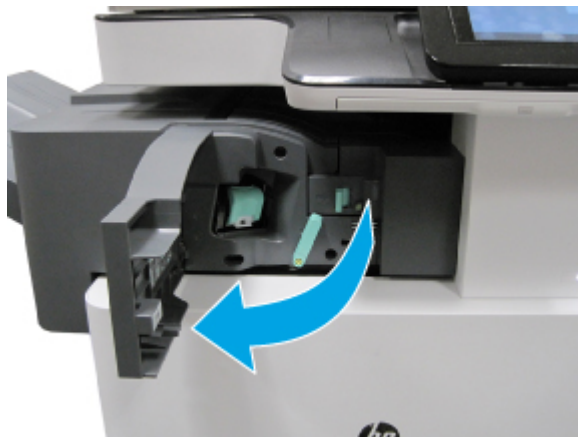
- Open the finisher and check for any jammed paper or obstructions, and remove them.
  - Open the finisher door.

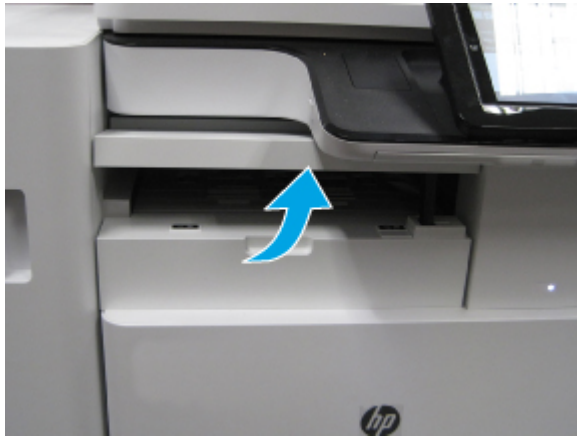
- a. Open the IPTU cover.

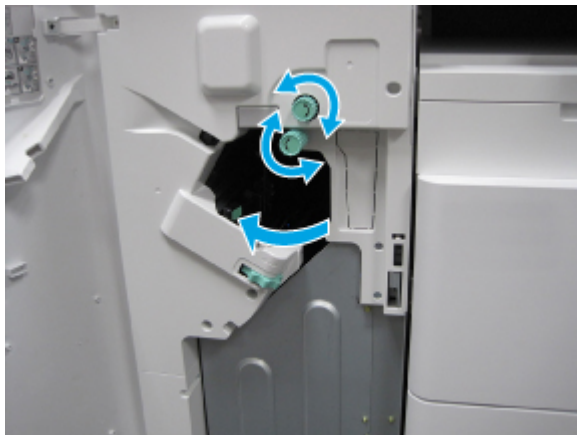
- d. Open the finisher front cover and inner jams access cover.

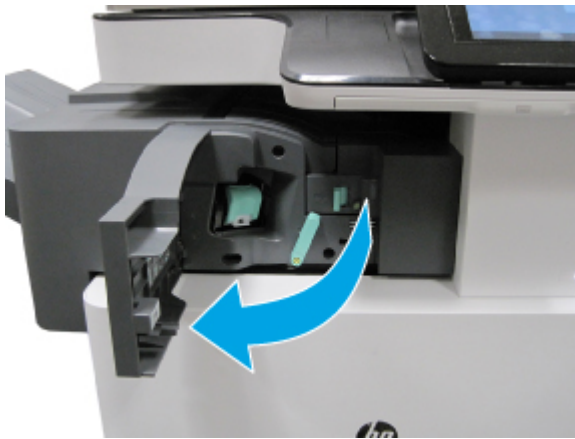
1. Open the finisher and check for any jammed paper or obstructions, and remove them.
  - a. Open the finisher door.

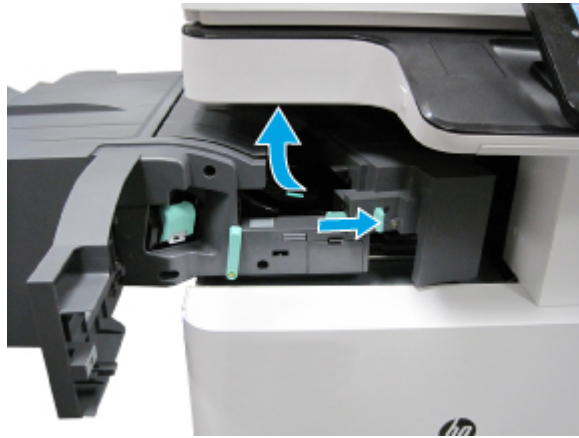
- c. Open the right and upper jam covers.

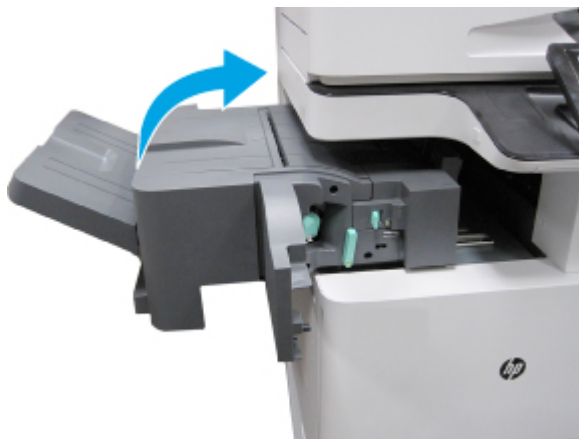
- e. Close the covers and slide the inner finisher into place.
- f. Open the finisher output cover.

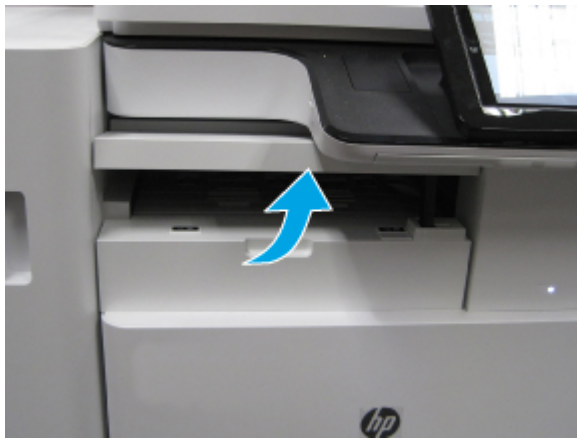
- a. Open the IPTU cover.

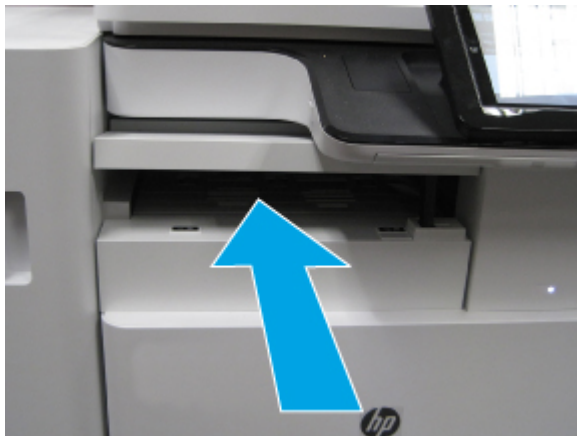
- b. Check for paper jams or obstructions.

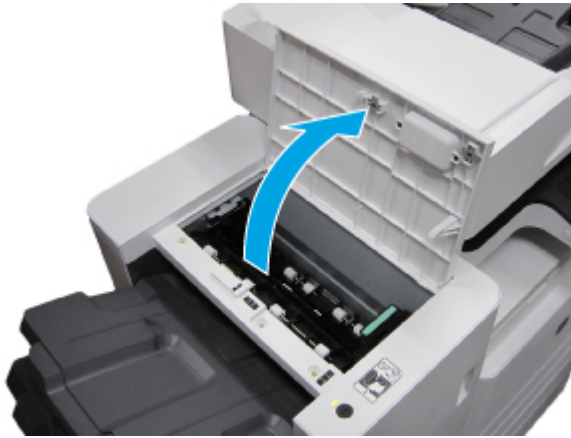
- a. Open the finisher top cover.

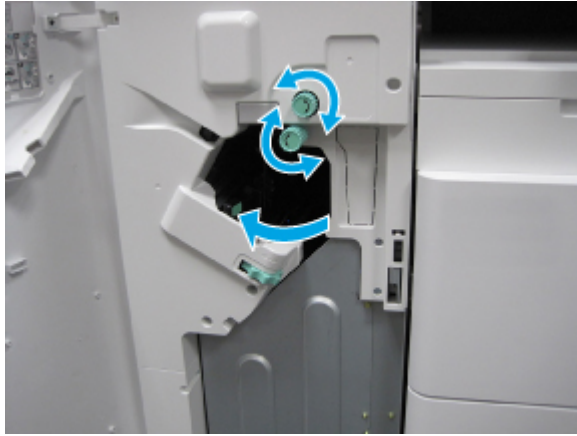
- d. Open the finisher front cover and inner jams access cover.

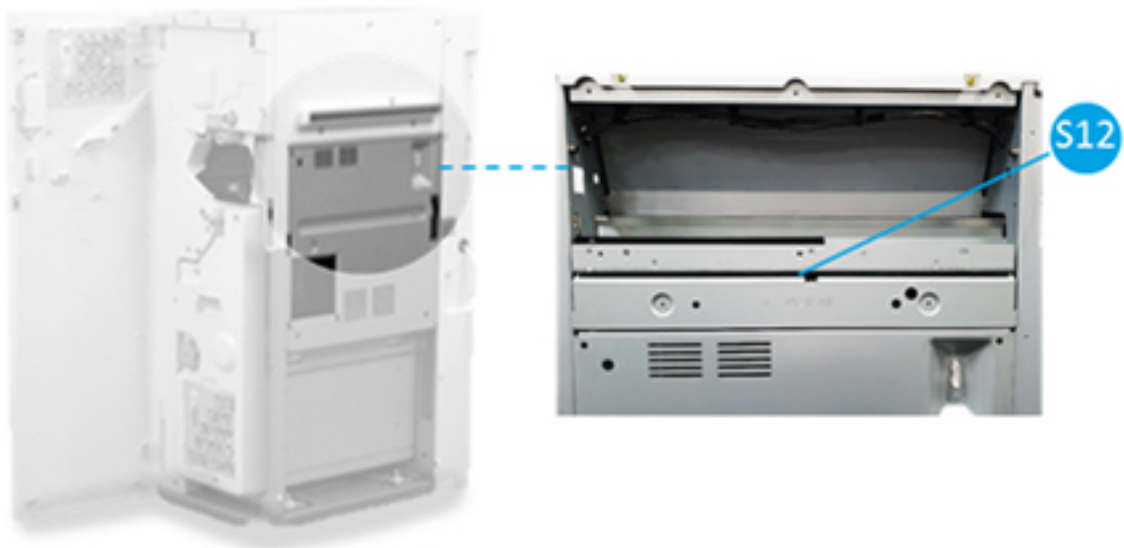
5. If the error persists, check the finisher entrance sensor (S12).

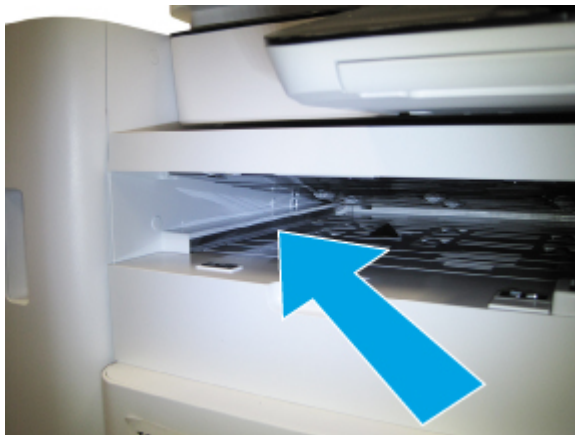
- Service Tools
  - Diagnostics
  - Engine Diagnostics
  - Engine Test Routines
- b. Run test 113-2080, 2 Bin Finisher Entrance sensor.
- c. Move a folded piece of paper or card stock in and out and back and forth in the following location and out to check the reading value changes.

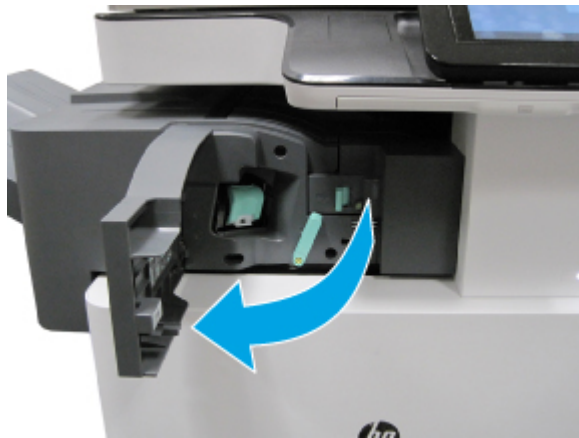
1. Open the finisher and check for any jammed paper or obstructions, and remove them.
  - a. Open the finisher door.

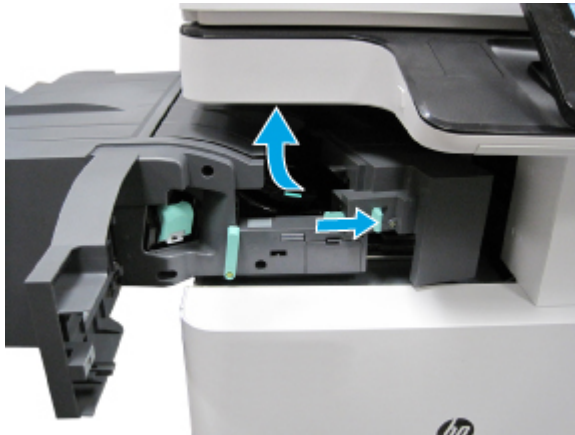
- c. Open the right and upper jam covers.

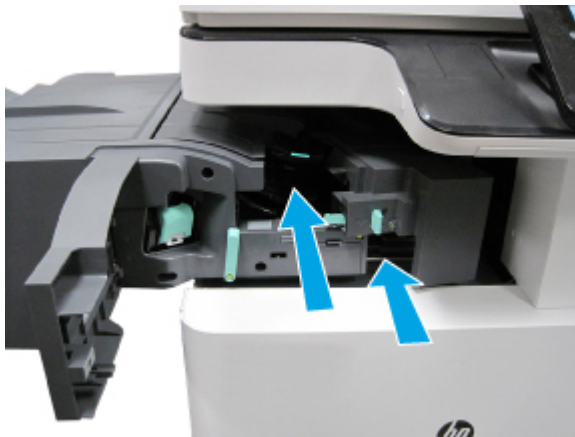
- d. Inspect the areas for paper jams or obstructions.

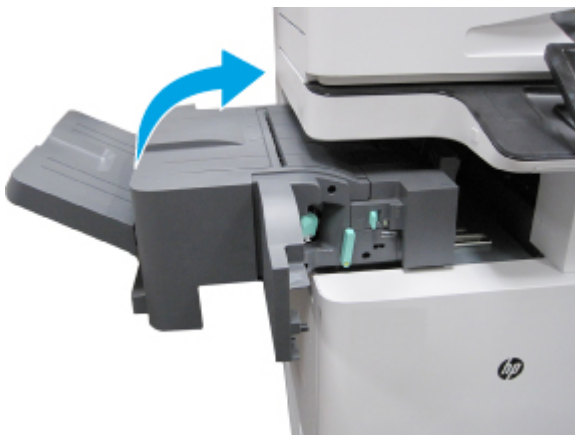
- e. Open the finisher output cover.

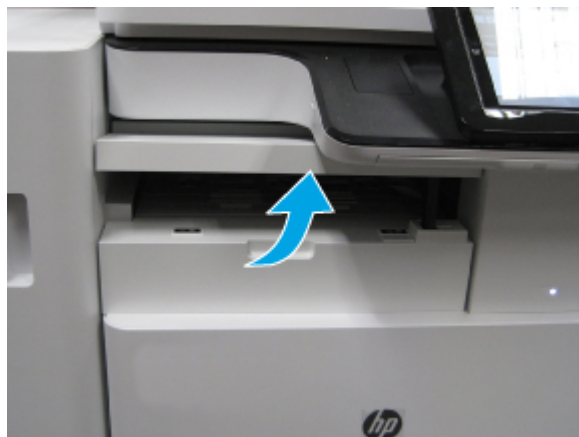
1. Check the IPTU for paper jams or obstructions.
  - a. Open the IPTU cover.

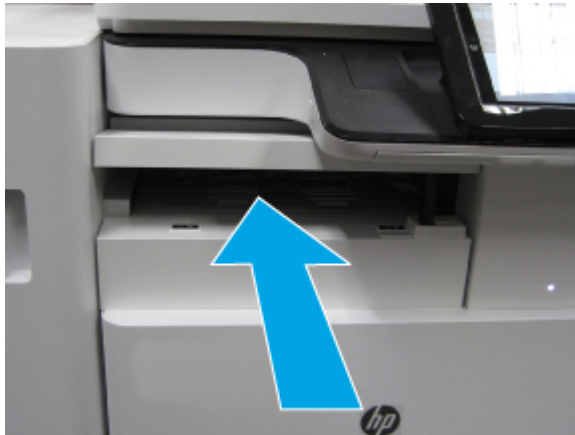
- b. Check for paper jams or obstructions.

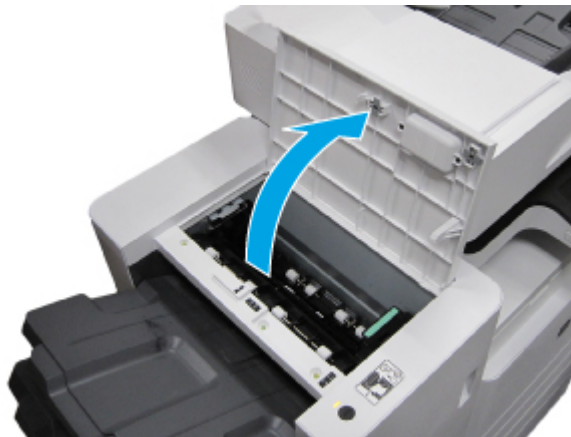
- a. Open the finisher top cover.

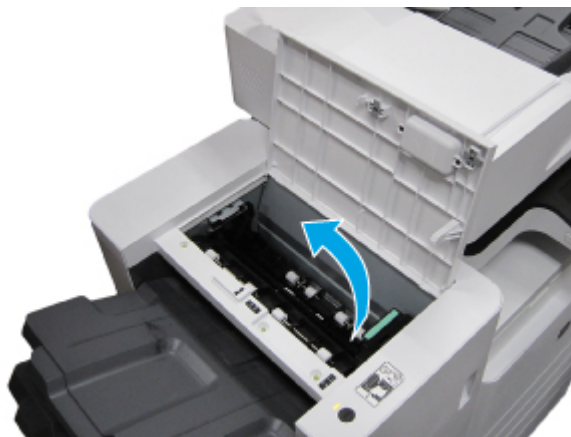
- b. Open the inner jam cover.

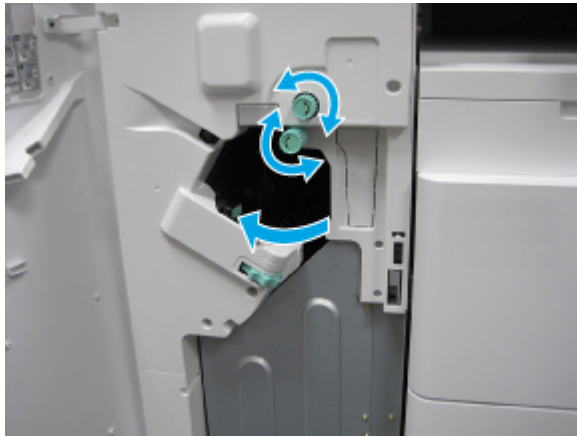
- d. Open the finisher front cover and inner jams access cover.

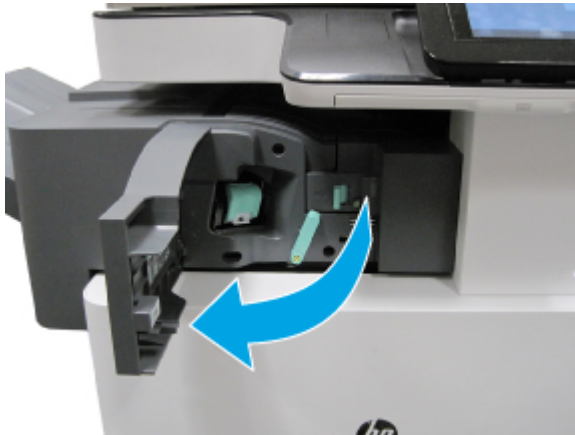
- a. Open the finisher door.

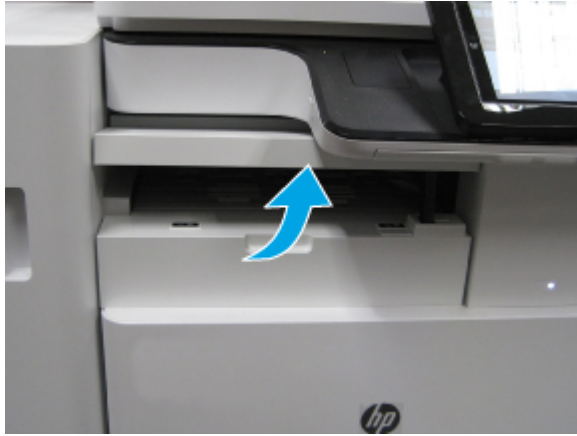
- a. Open the IPTU cover.

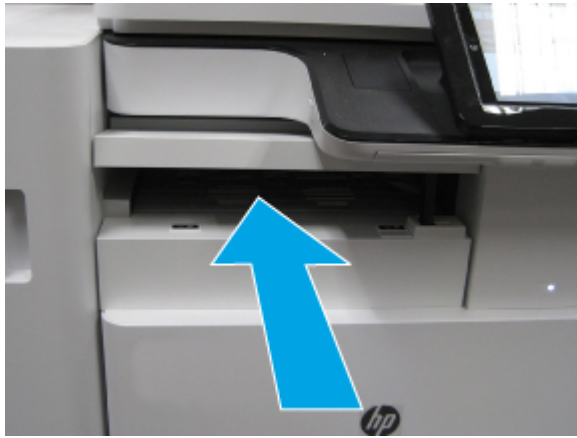
- b. Check for paper jams or obstructions.

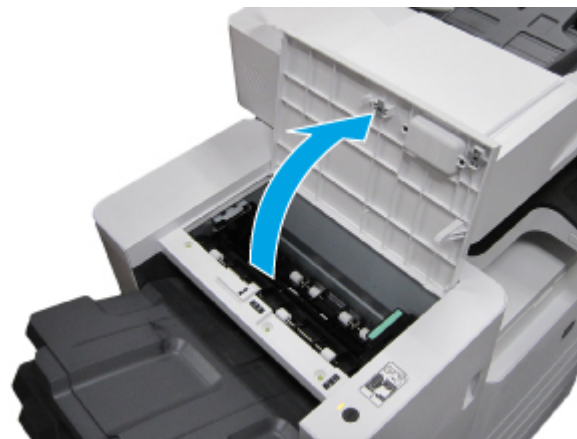
- a. Open the finisher top cover.

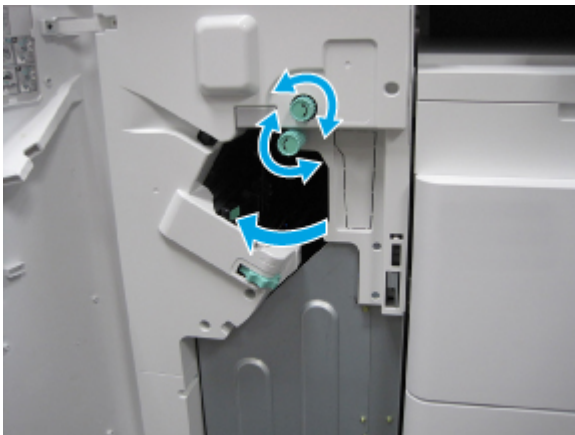
- d. Open the finisher front cover and inner jams access cover.

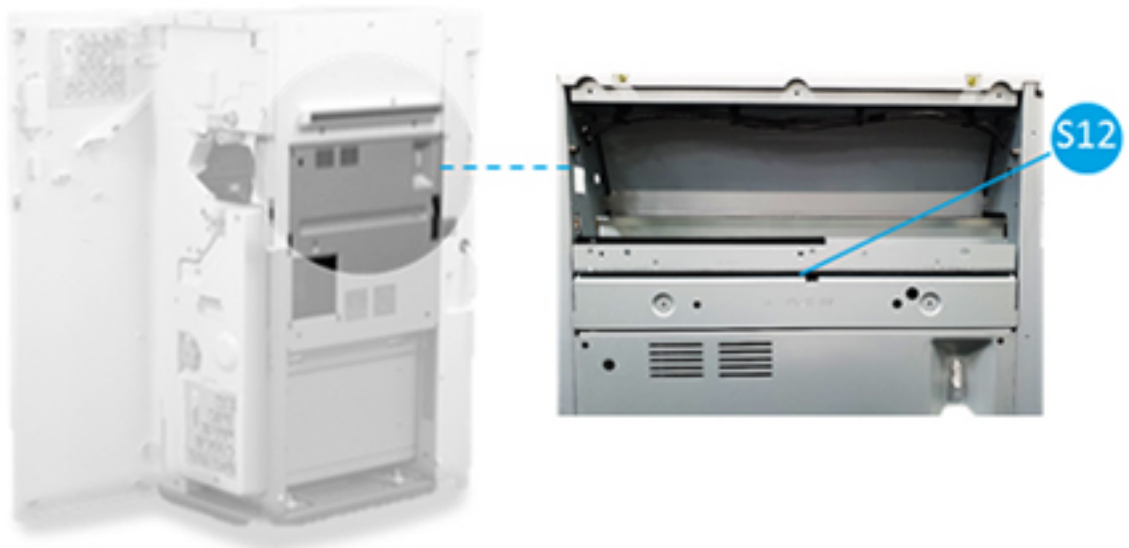
4. If the error persists, check the finisher entrance sensor (S12).

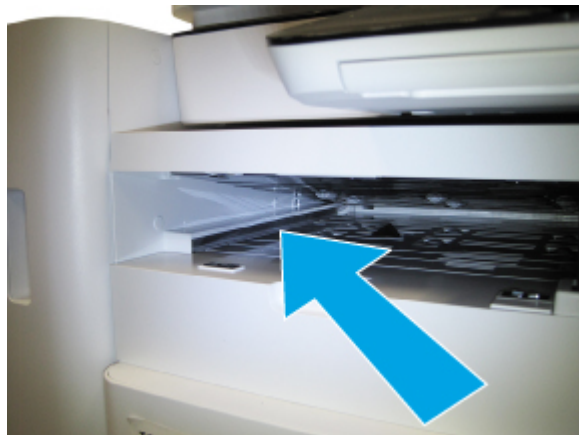
- Service Tools
  - Diagnostics
  - Engine Diagnostics
  - Engine Test Routines
- b. Run test 113-2080, 2 Bin Finisher Entrance sensor.
- c. Move a folded piece of paper or card stock in and out and back and forth in the following location and out to check the reading value changes.

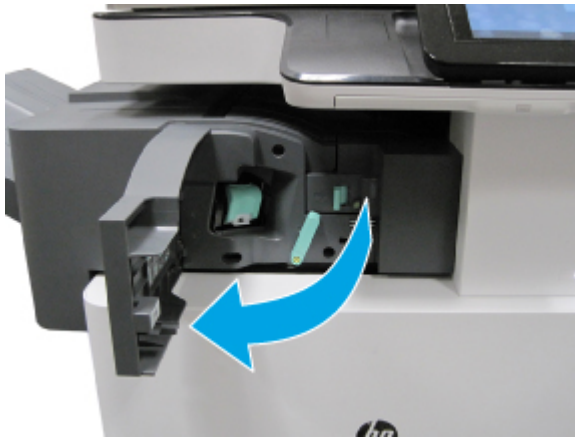
1. Open the finisher and check for any jammed paper or obstructions, and remove them.
  - a. Open the finisher door.

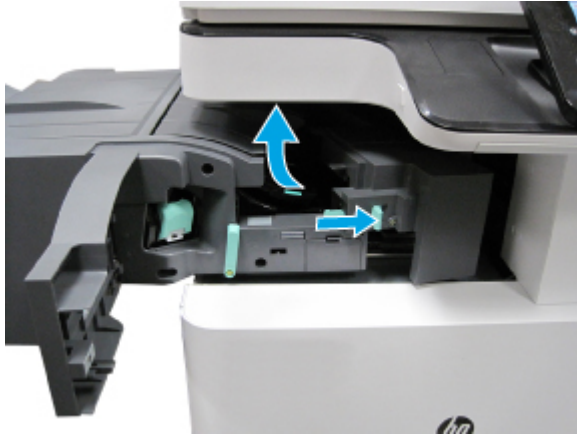
- c. Open the right and upper jam covers.

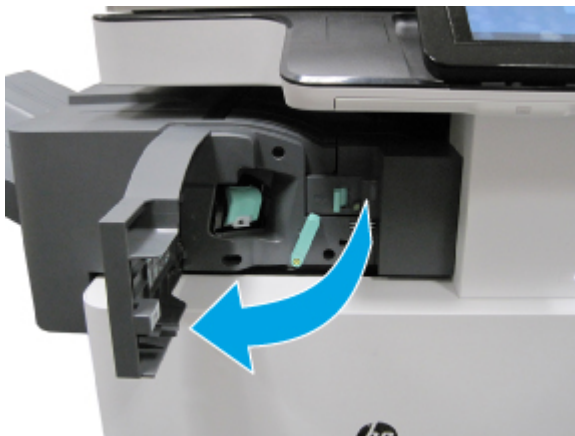
1. Open the finisher and check for any jammed paper or obstructions, and remove them.
  - a. Open the finisher door.

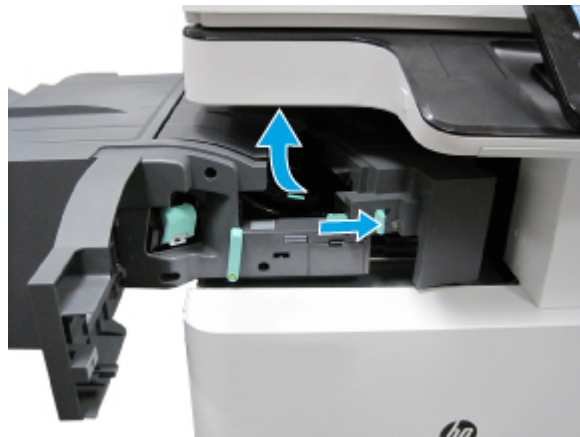
- c. Open the right and upper jam covers.

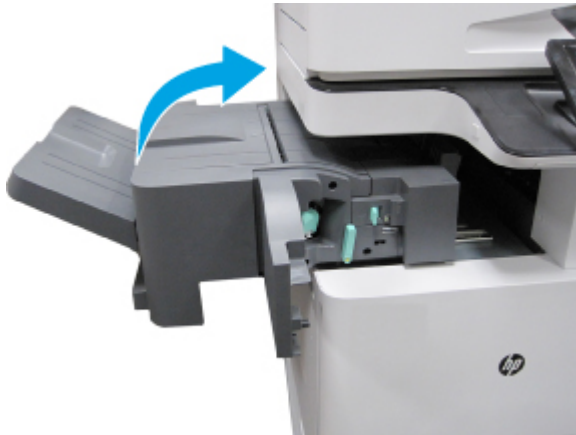
- f. Open the finisher output cover.

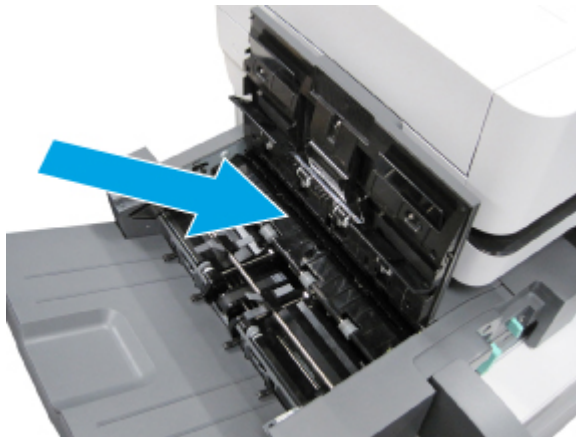
- g. Remove any jammed paper or obstructions.

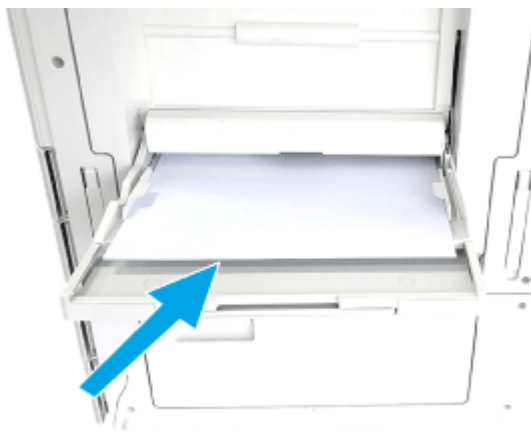
2. Turn the printer off, and then on.
3. If the jam is occurring with paper that is not A4 or Letter, try printing out with A4 or letter paper using long edge feeding. If another error appears, follow the troubleshooting for that specific error.

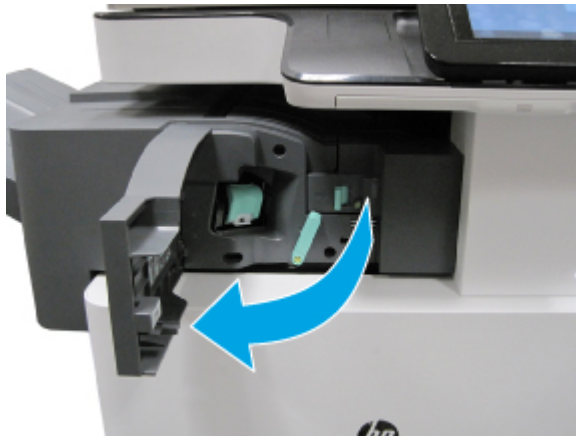
- 1. Open the finisher and check for any jammed paper or obstructions, and remove them.
  - a. Open the finisher door.

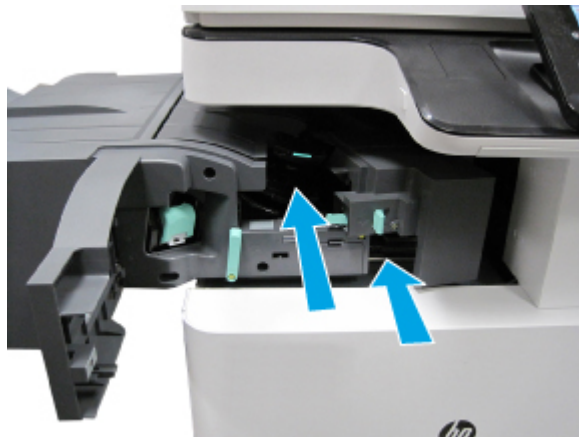
- d. Inspect the areas for paper jams or obstructions.
