# HP Color LaserJet Managed MFP E77822-E77830 series – Control Panel Message Document (CPMD)

This document provides error-code troubleshooting information

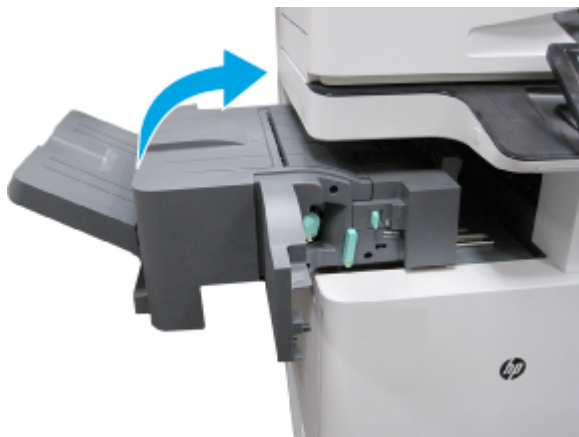
- e. Open the finisher output cover.

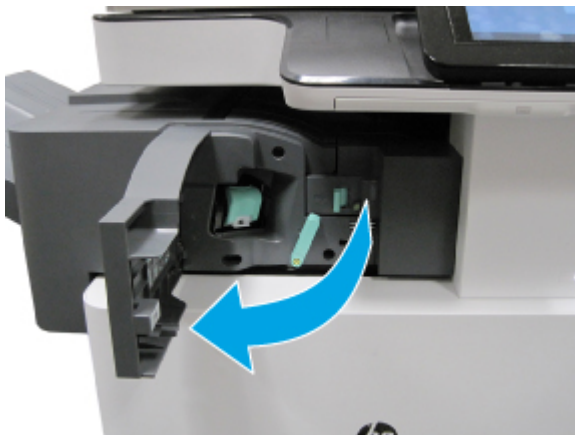
1. Open the finisher and check for any jammed paper or obstructions, and remove them.
  - a. Open the finisher door.

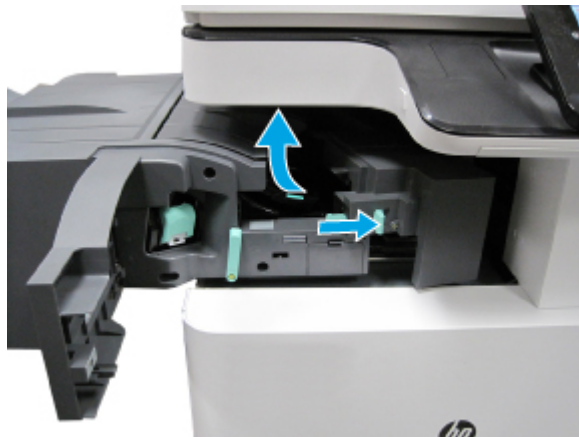
- c. Open the right and upper jam covers.

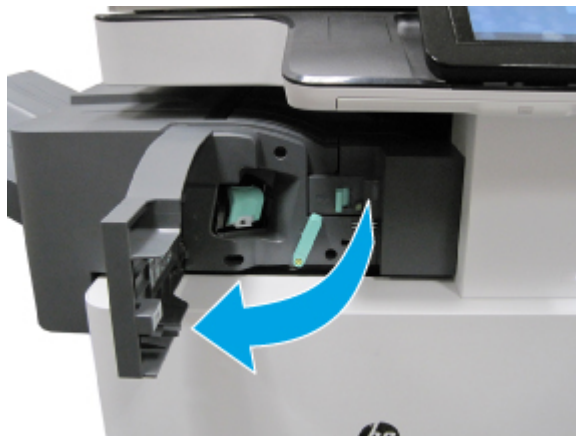
1. Open the finisher and check for any jammed paper or obstructions, and remove them.
  - a. Open the finisher door.

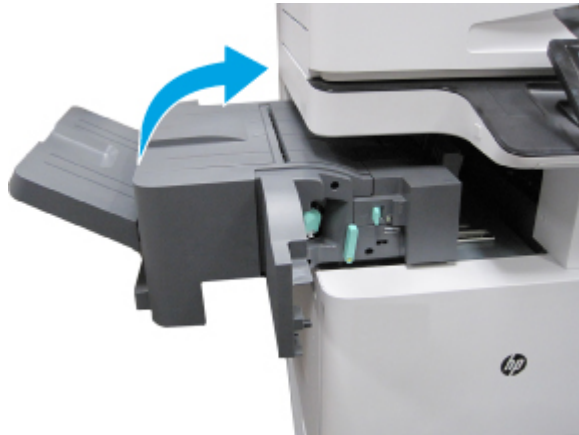
- e. Open the finisher output cover.

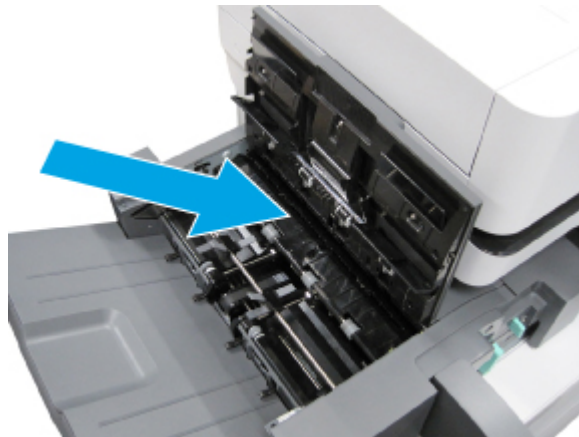
- f. Remove any jammed paper or obstructions.

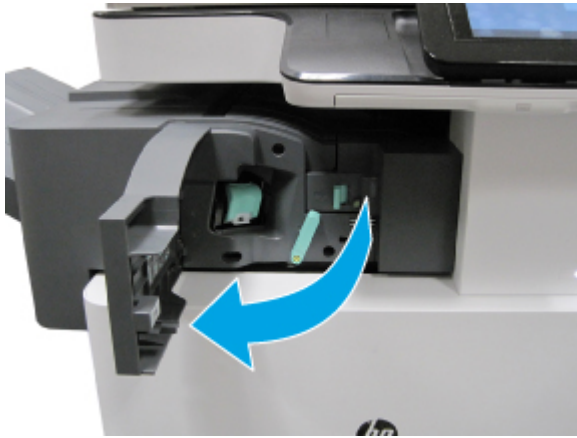
- a. Open the finisher door.

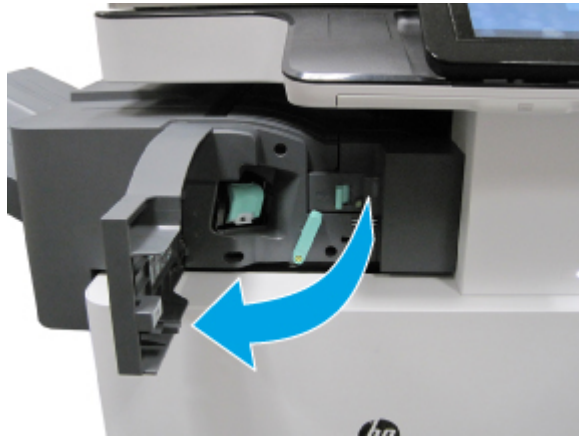
- a. Open the finisher door.

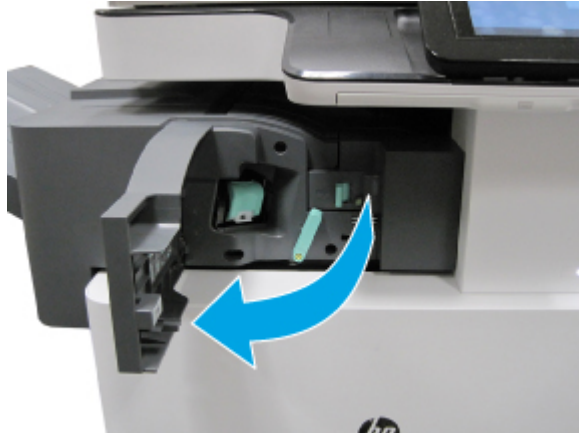
1. Open the finisher and check for any jammed paper or obstructions, and remove them.
  - a. Open the finisher door.

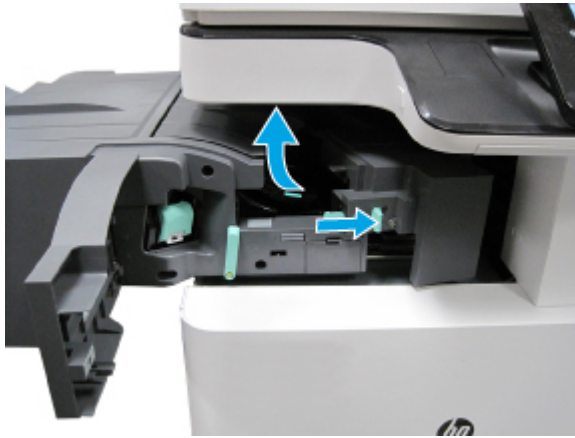
- c. Open the right and upper jam covers.

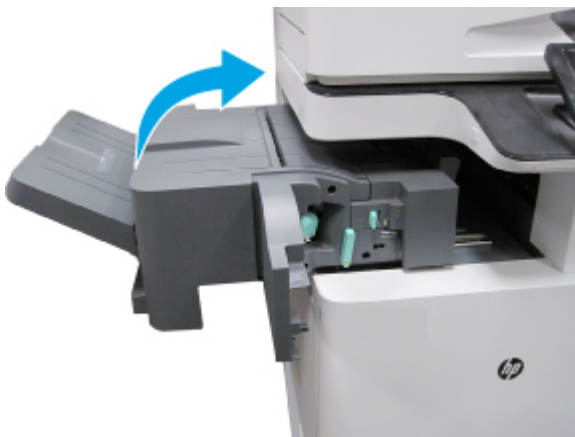
- e. Close the covers and slide the inner finisher into place.
- f. Open the finisher output cover.

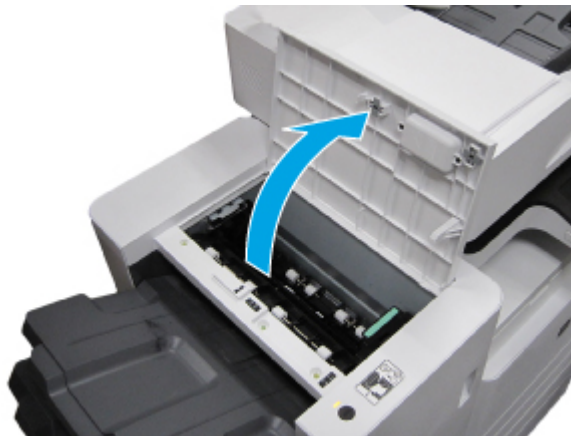
- 1. Check the finisher for paper jams or obstructions.
  - a. Open the finisher top cover.

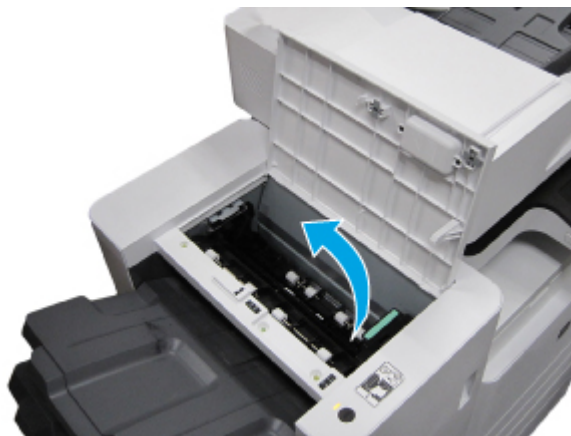
- b. Open the inner jam cover.

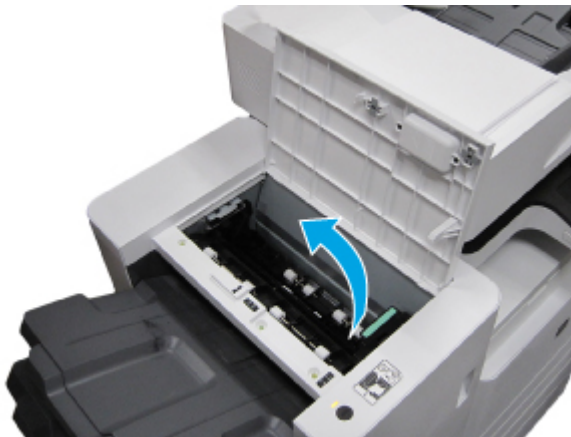
- b. Open the inner jam cover.

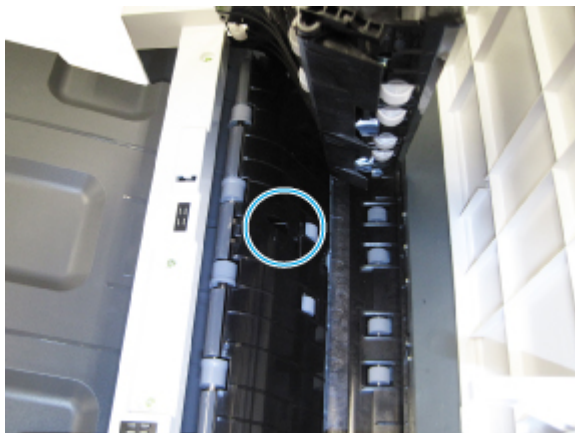
- Service Tools
  - Diagnostics
  - Engine Diagnostics
  - Engine Test Routines
- c. Run test 113-2091, 2 Bin Finisher Sub Exit sensor.
- d. Push the top exit sensor actuator to check the reading value changes.

- e. If the sensor still does not read correctly, disconnect and reconnect both ends of the wire harness from the exit sensor to the finisher PCA.
- f. If the sensor still fails, replace the sensor.

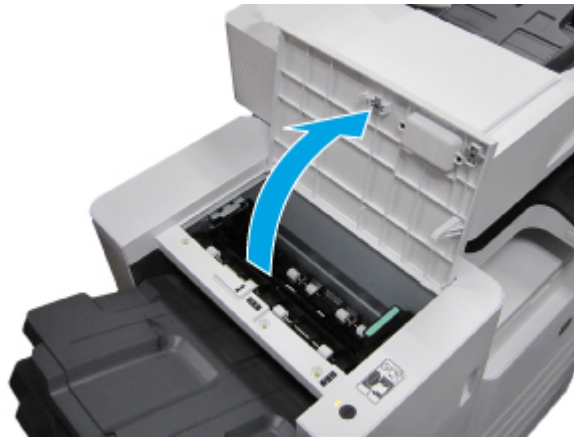
1. Check the finisher for paper jams or obstructions.
  - a. Open the finisher top cover.

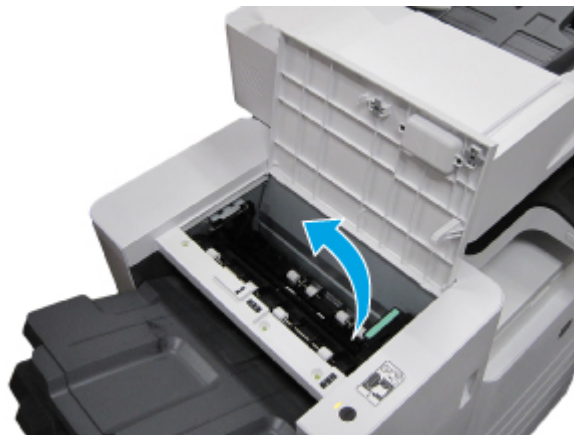
- b. Open the inner jam cover.

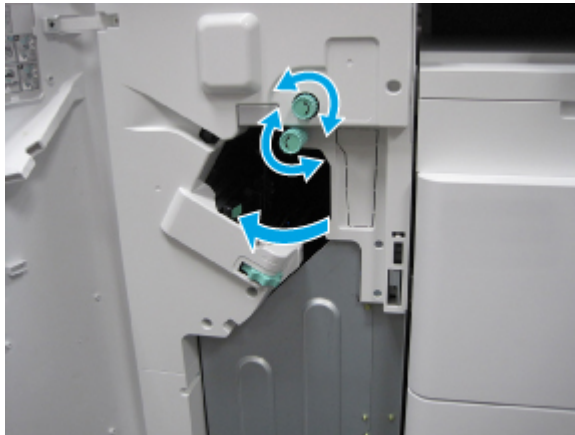
- d. Open the finisher front cover and inner jams access cover.

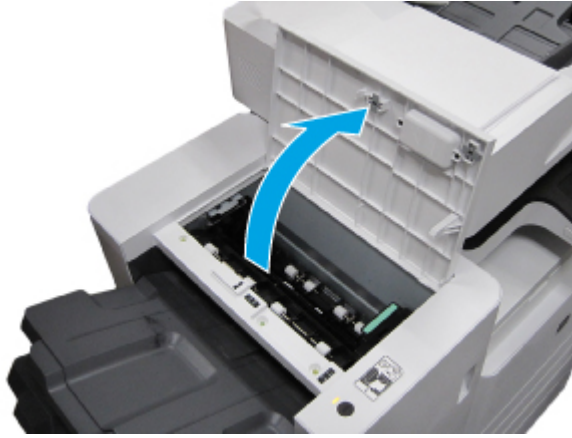
- a. Open the finisher top cover.

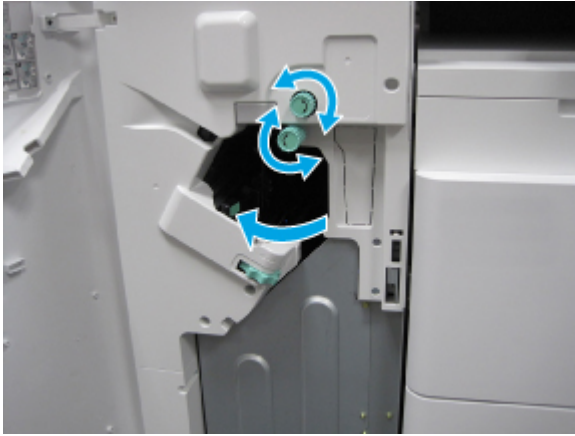
- d. Open the finisher front cover and inner jams access cover.

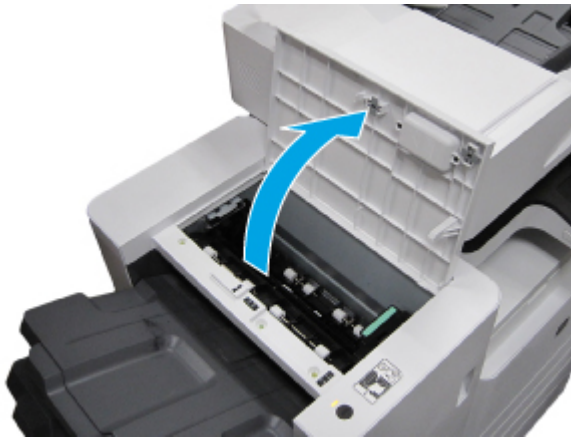
1. Check the finisher for paper jams or obstructions.
  - a. Open the finisher top cover.

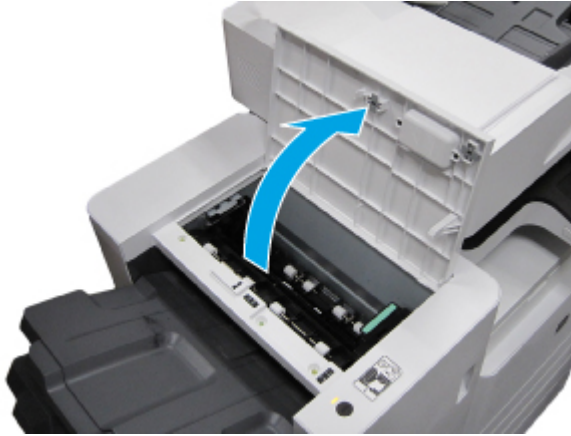
- a. Open the finisher top cover.

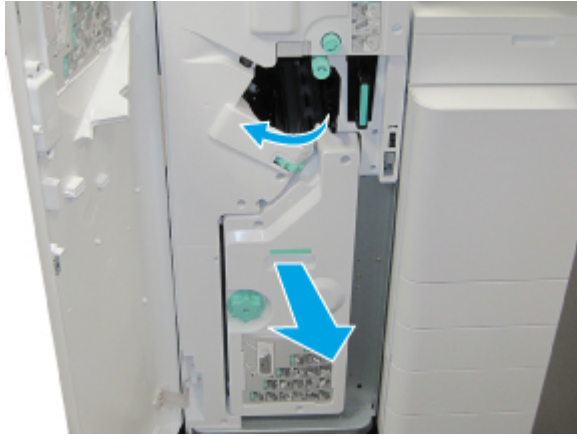
- a. Open the finisher front cover and the inner jams access cover, and then pull the booklet maker out.

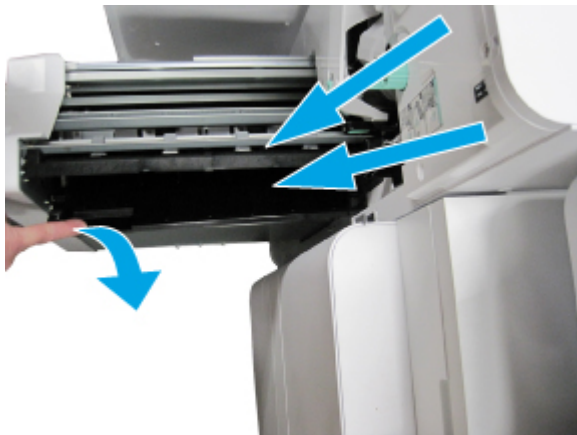
- c. Open the booklet entrance jam access door and check for paper or obstructions.

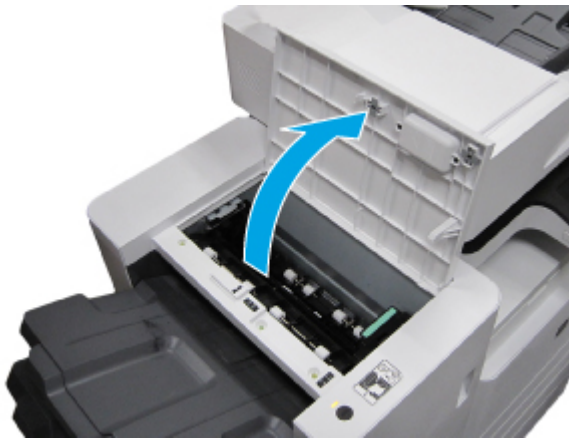
1. Check the finisher for paper jams or obstructions.
  - a. Open the finisher top cover.

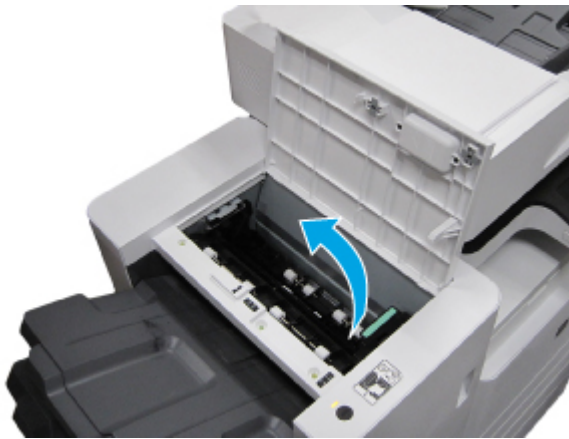
- b. Open the inner jam cover.

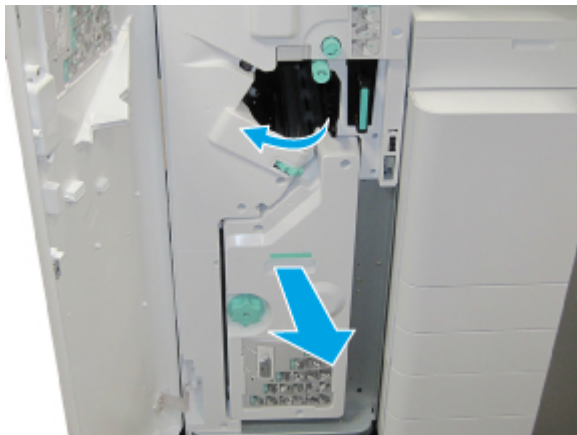
- a. Open the finisher front cover and the inner jams access cover, and then pull the booklet maker out.

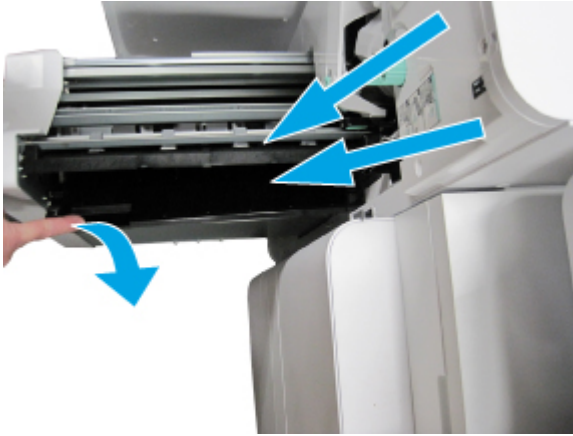
- c. Open the booklet entrance jam access door and check for paper or obstructions.

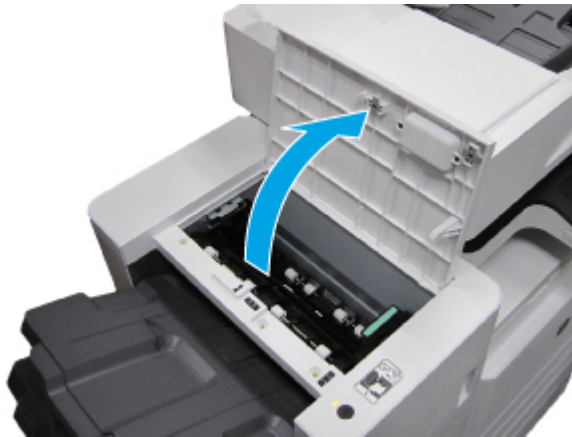
- 1. Check the finisher for paper jams or obstructions.
  - a. Open the finisher top cover.

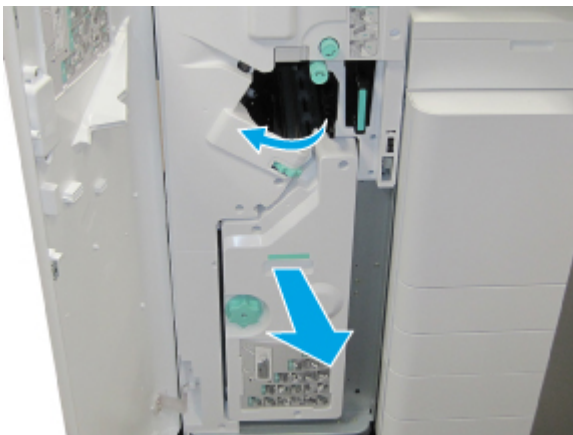
- a. Open the finisher front cover and the inner jams access cover, and then pull the booklet maker out.

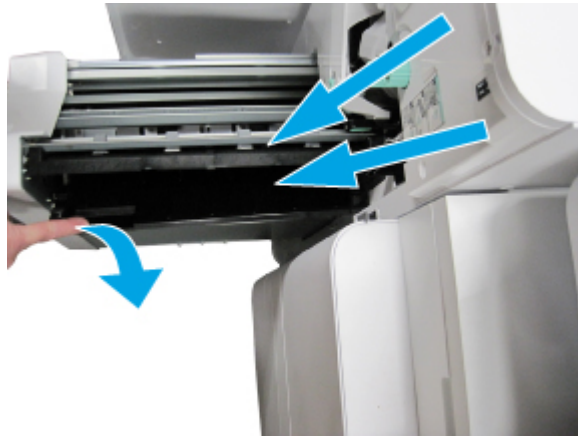
- c. Open the booklet entrance jam access door and check for paper or obstructions.

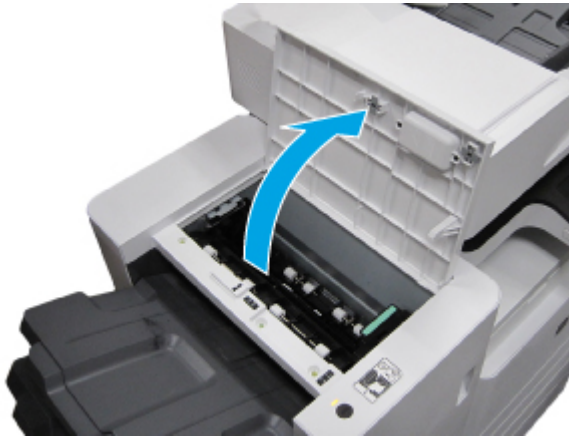
Open top cover

- a. Open the finisher top cover.

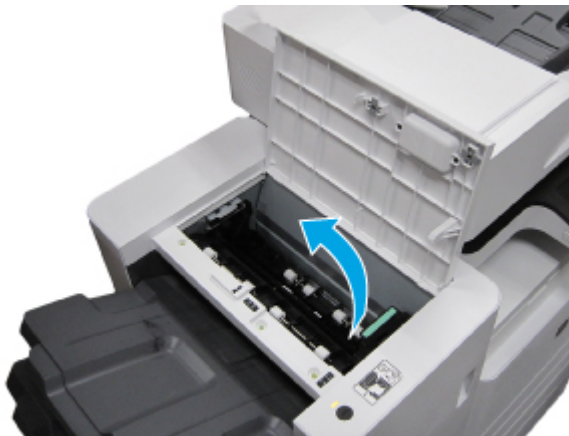
Open jam access

- b. Open the inner jam cover.

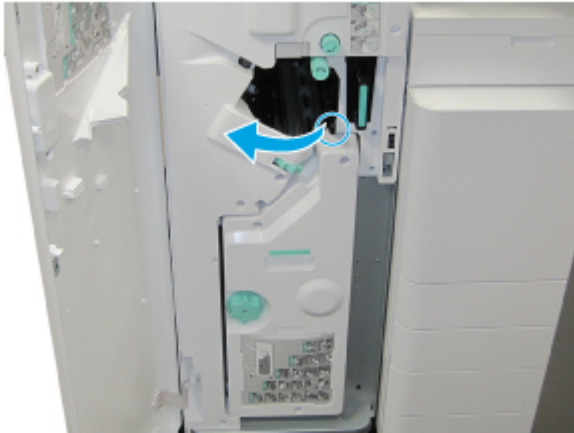
**Figure 37** Open jam access

- d. Open the finisher front cover, then open the jam clearance guide to the right of the stapler.

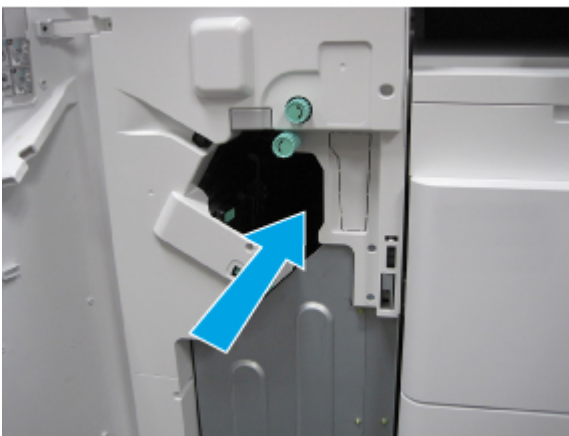
**Figure 38** Check for paper

- e. Remove any jams or obstructions.

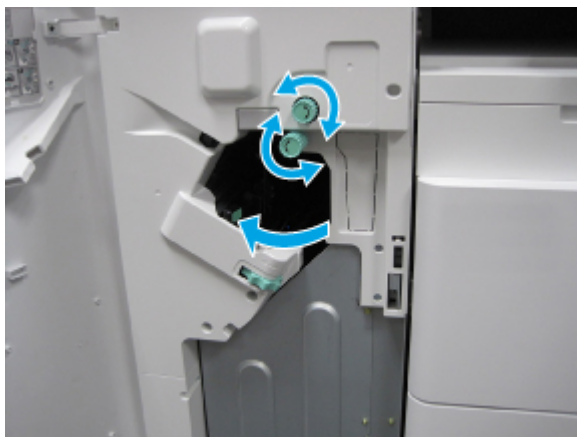
**NOTE:** Use the paper roller knobs to move paper for easier access.

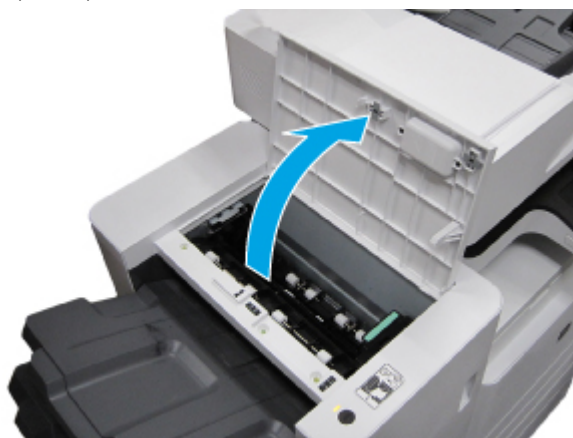
Open top cover

1. Check the finisher for paper jams or obstructions.
  - a. Open the finisher top cover.

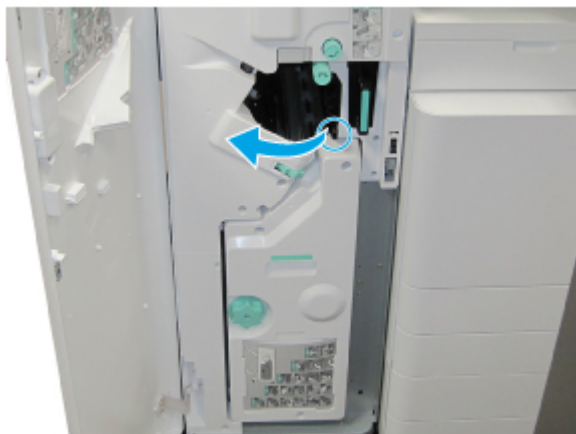
**Figure 39** Open jam access

- d. Open the finisher front cover, then open the jam clearance guide to the right of the stapler.

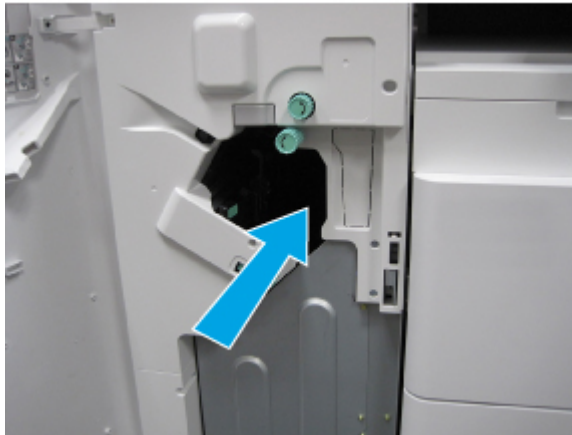
**Figure 40** Check for paper

- e. Remove any jams or obstructions.

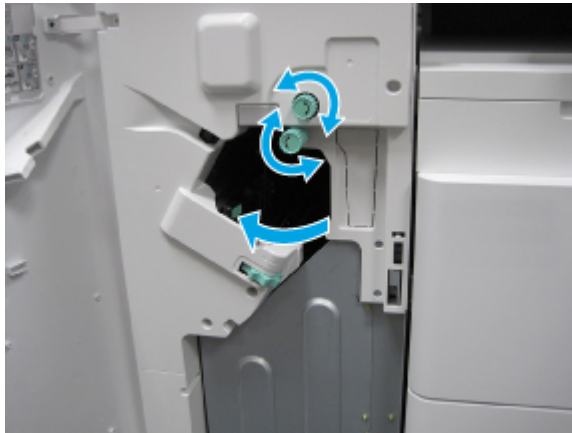
**NOTE:** Use the paper roller knobs to move paper for easier access.

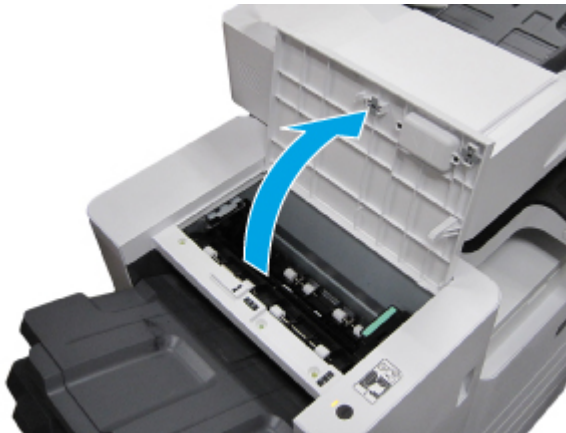
Open top cover

- f. Close all finisher covers.
2. If the error persists, check to ensure the finisher diverter is functioning correctly.
- a. Open the finisher top cover.

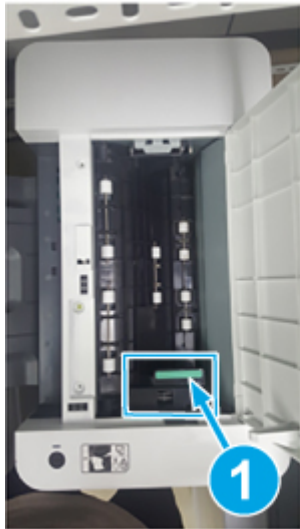
**Figure 41** Check diverter

- c. Locate the diverter and check it by pushing down and releasing it.

**Call-out 1:** Jam access handle

**Call-out 2:** Push down on diverter

Once released, the diverter should quickly pop back up.

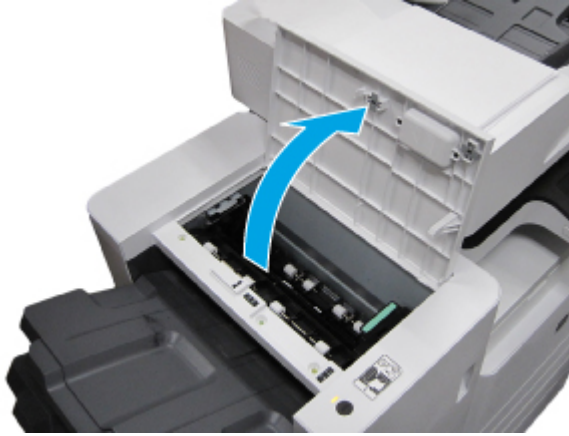
Open top cover

- a. Open the finisher top cover.

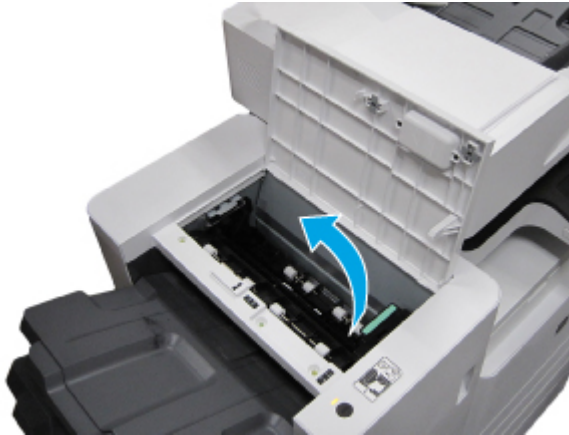
Open jam access

- b. Open the inner jam cover.

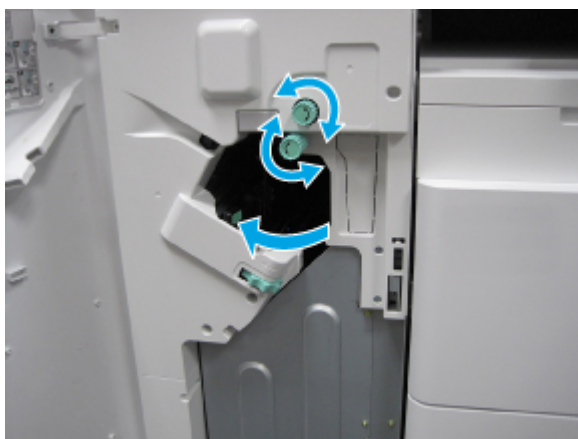
**NOTE:** Use the paper roller knobs to move paper for easier access.

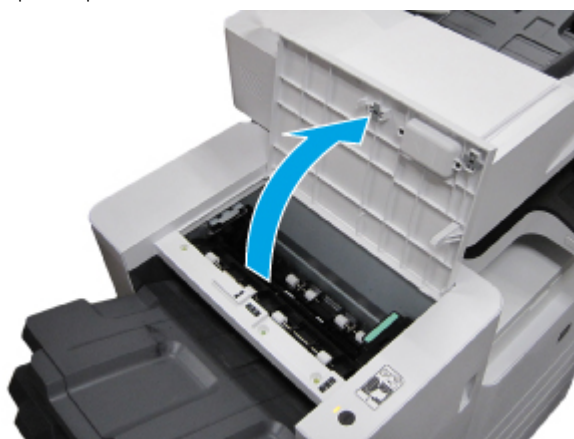
Open top cover

1. Check the finisher for paper jams or obstructions.
  - a. Open the finisher top cover.

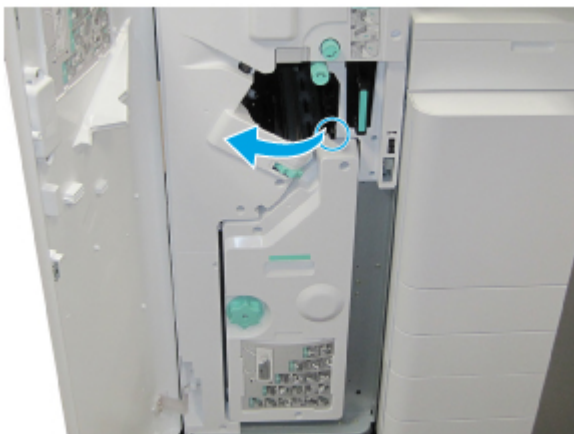
**Figure 44** Open jam access

- d. Open the finisher front cover, then open the jam clearance guide to the right of the stapler.

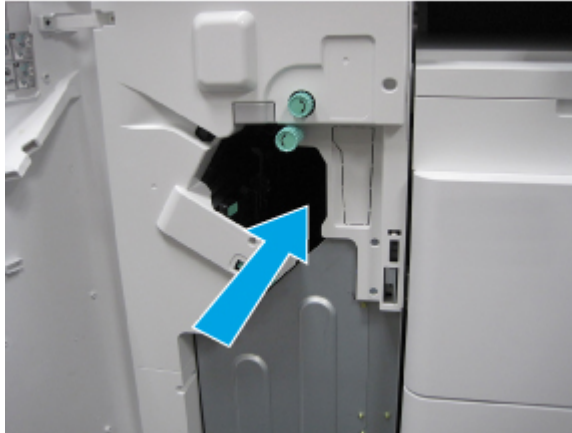
**Figure 45** Check for paper

- e. Remove any jams or obstructions.

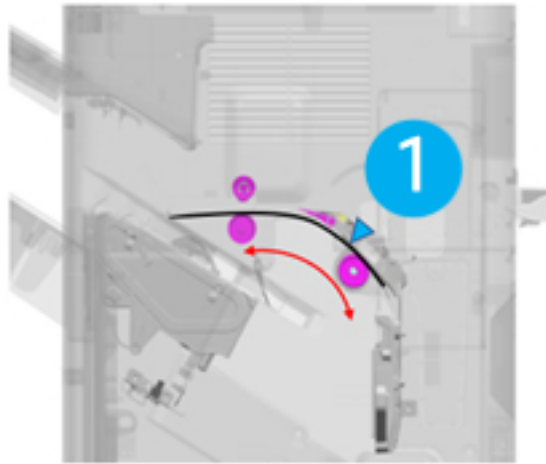
- b. Run test 113-2100, 2BinFinisher Buffer exit Sensor.

- c. Put paper in and out to check the value change.

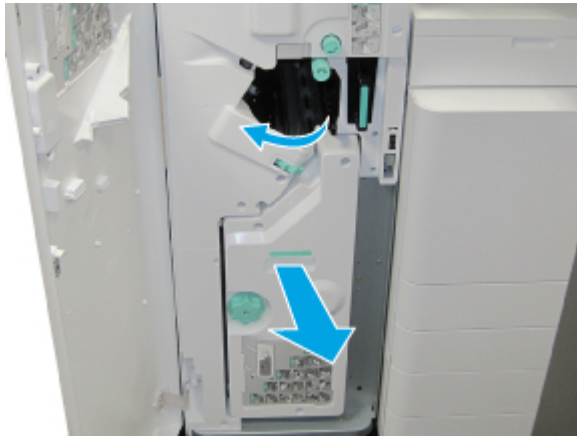
1. Check the booklet maker for jams or obstructions.
  - a. Open the finisher front cover and the inner jams access cover, and then pull the booklet maker out.

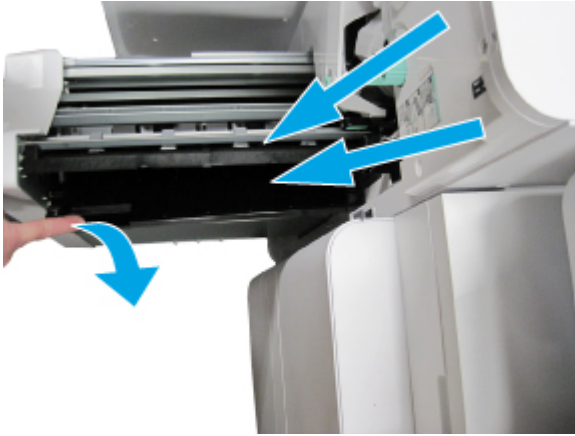
- c. Open the booklet entrance jam access door and check for paper or obstructions.

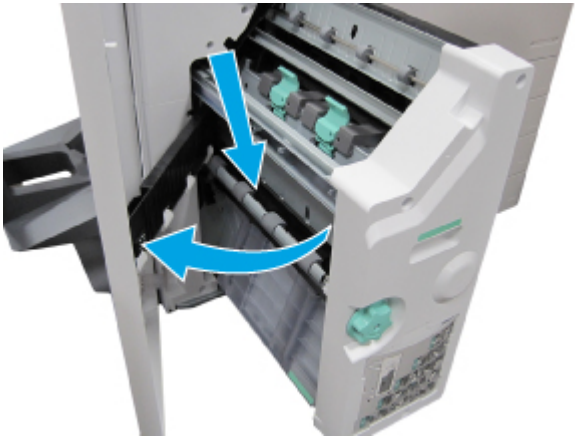
- d. Open the upper jam access door and clear any jams.

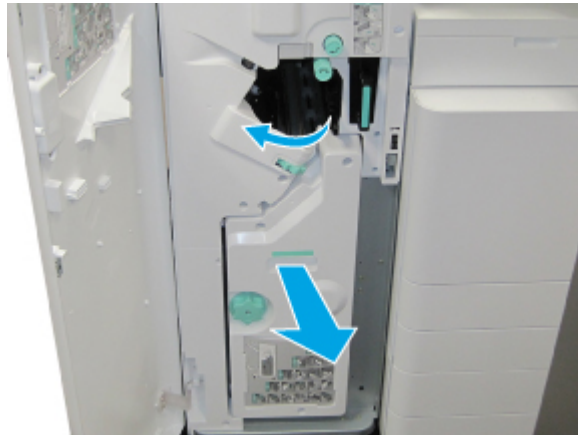
1. Check the booklet maker for jams or obstructions.
  - a. Open the finisher front cover and the inner jams access cover, and then pull the booklet maker out.

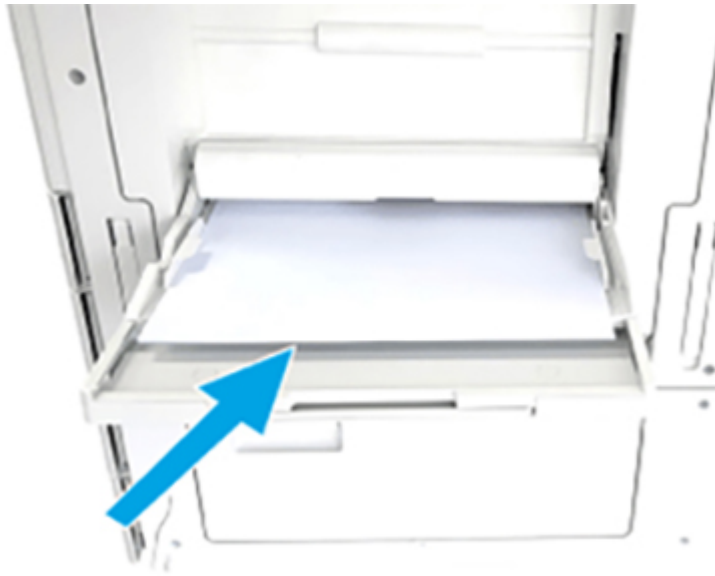
3. If the paper being used is not A4 or letter, test with A4 or letter fed short edge first as indicated below. If a new error occurs, follow that error guide.

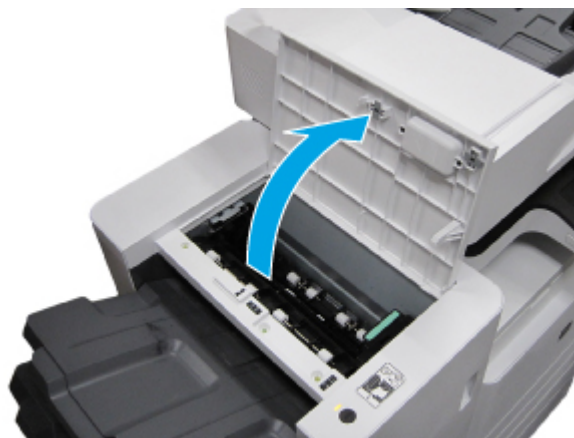
1. Check the finisher for paper jams or obstructions.
  - a. Open the finisher top cover.

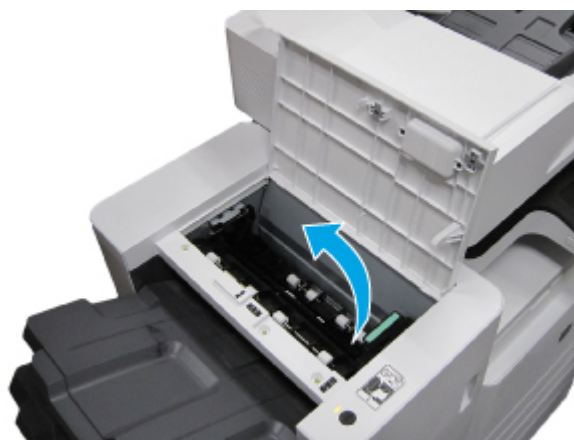
- b. Open the inner jam cover.

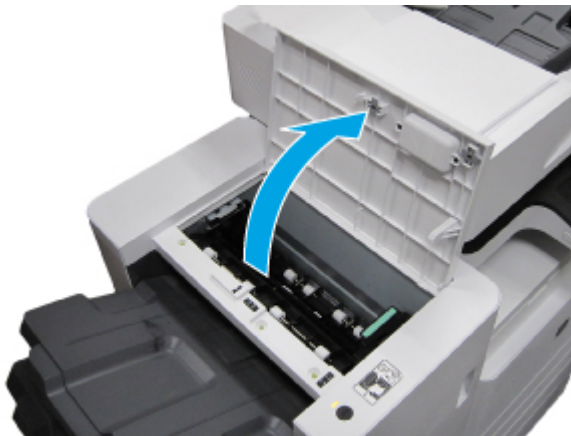
1. Check the finisher for paper jams or obstructions.
  - a. Open the finisher top cover.

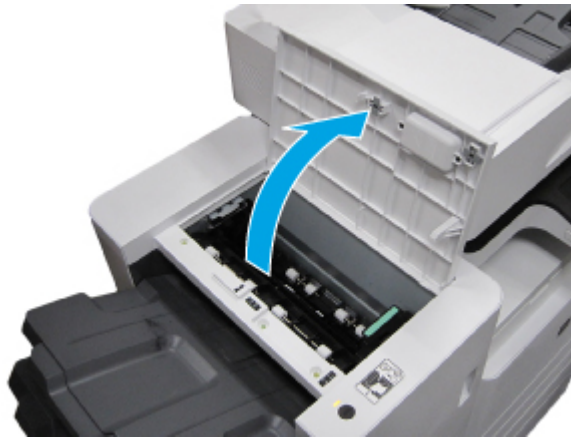
Open top cover

- a. Open the finisher top cover.

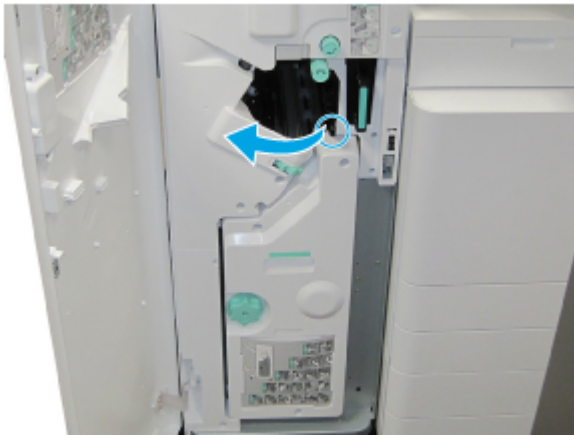
**Figure 46** Open jam access

- d. Open the finisher front cover, then open the jam clearance guide to the right of the stapler.

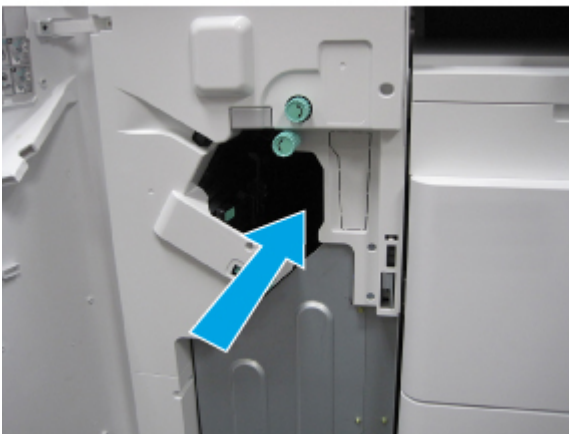
**Figure 47** Check for paper

- e. Remove any jams or obstructions.

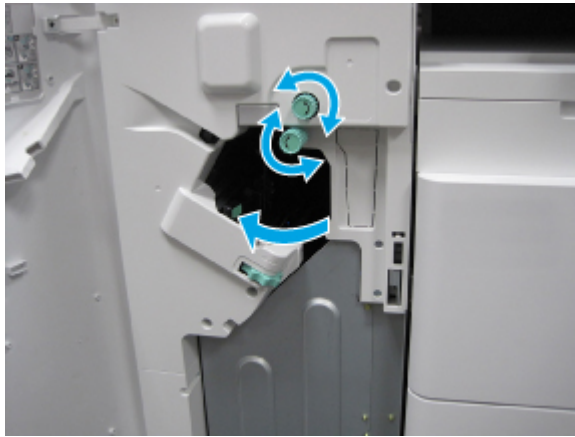
**NOTE:** Use the paper roller knobs to move paper for easier access.

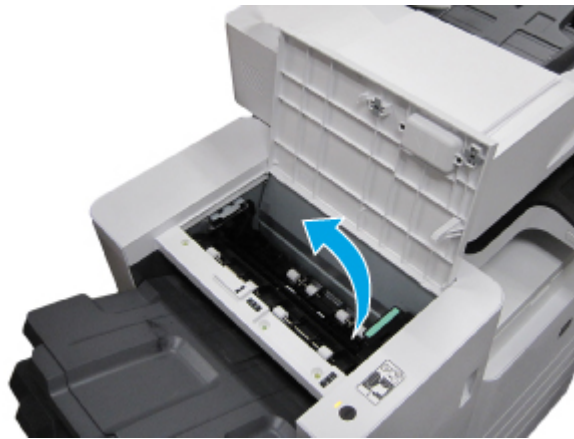
Open jam access

- b. Open the inner jam cover.

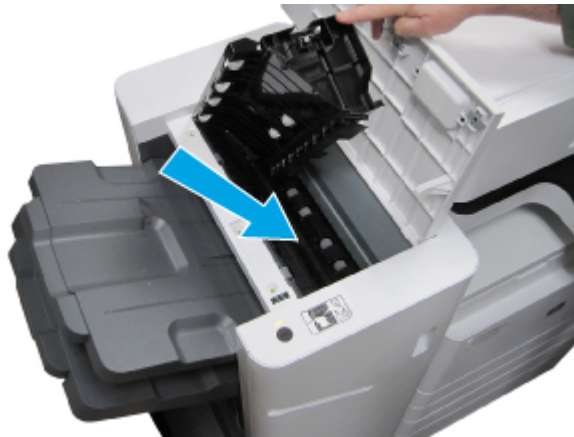
Check for paper jam

- c. Check for jams in the indicated area.

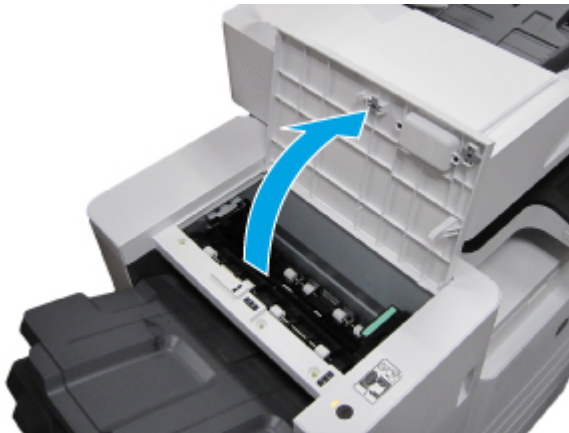
Open top cover

- f. Close all finisher covers.
2. If the error persists, check to ensure the finisher diverter is functioning correctly.
- a. Open the finisher top cover.

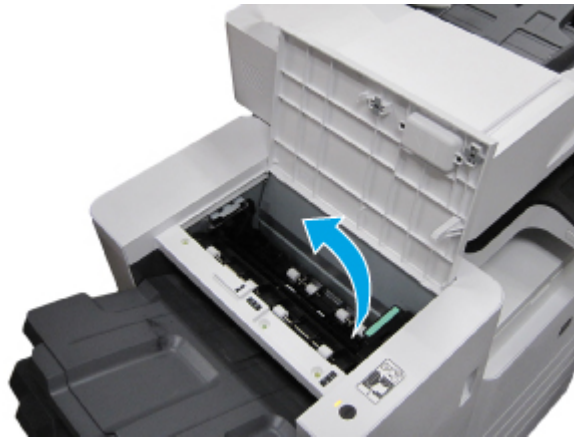
Open jam access

- b. Open the inner jam cover.

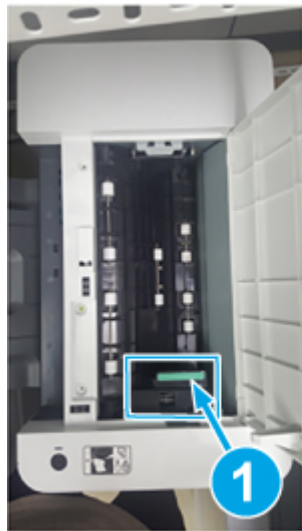
**Figure 50** Check diverter

- c. Locate the diverter and check it by pushing down and releasing it.

**Call-out 1:** Jam access handle

**Call-out 2:** Push down on diverter

Once released, the diverter should quickly pop back up.

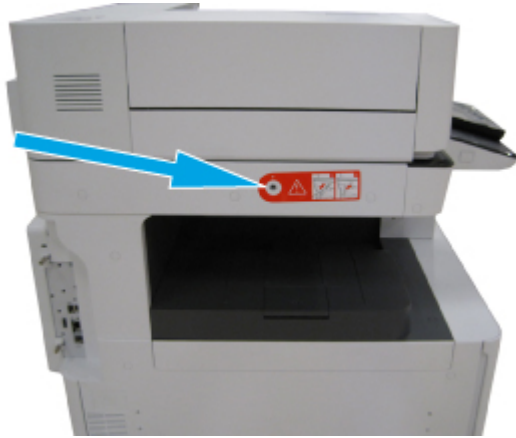
2. Make sure the scanner lock screw is removed.

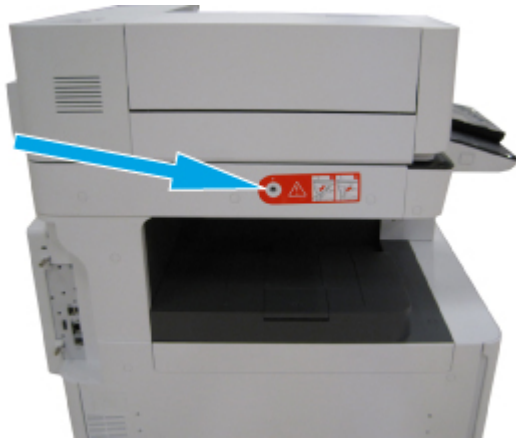
1. Turn the printer off.
2. Make sure the scanner lock screw is removed.

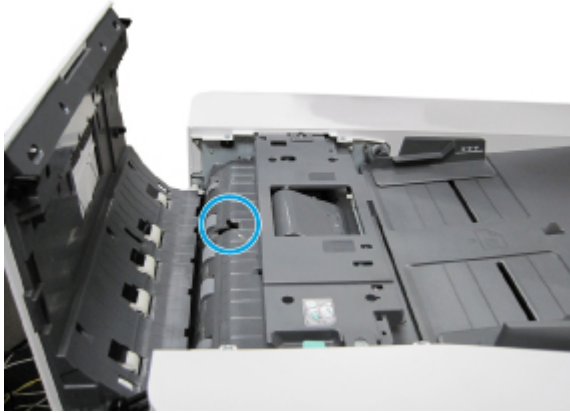
3. If this error occurs continually, check the registration sensor and registration actuator.

- a. Push and release the registration actuator.
- b. Check if the registration actuator returns the original position.
- c. Use the sensor test to check the correct operation of the sensor.

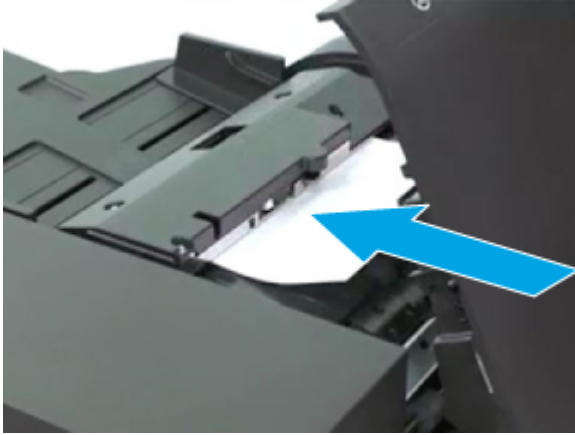
1. Open the document feeder and remove any jammed paper, then close the cover and check whether it operates again.
2. Test the document feed sensor.

- Service Tools
  - Diagnostics
  - Scanner Diagnostics
  - Scanner/Document Feeder Test Routines
- b. Run test 05–0060, Document Simplex Registration Sensor.
  - c. If the sensor does not function correctly replace the sensor.  
Part number: 0604-001502

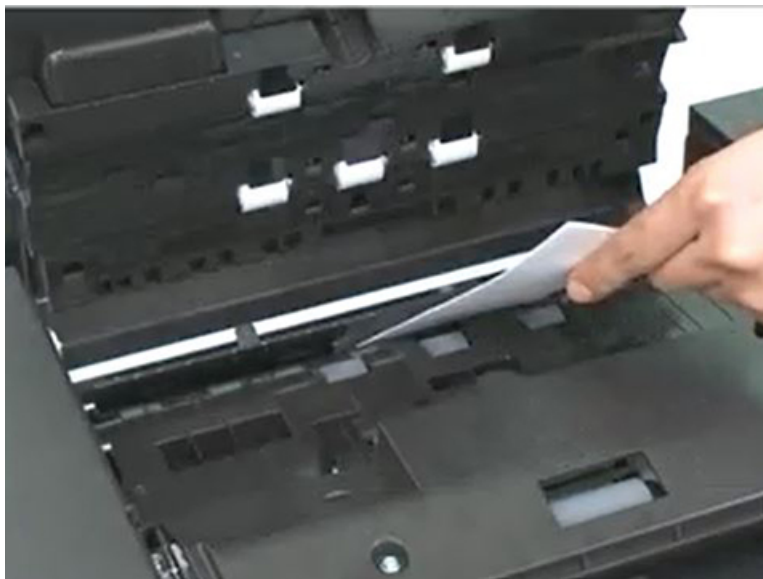
4. If this error occurs continually, check the duplex registration sensor.

- a. Run test 05–0061, Document Duplex Registration Sensor.
- b. If the sensor is defective, replace the document feeder contact image sensor.

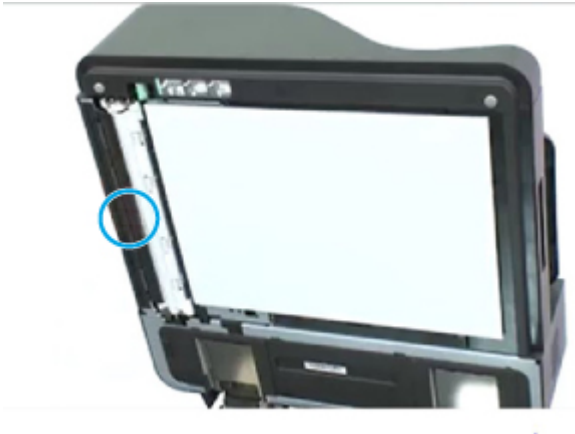
5. If this error occurs continually, check the document feeder scan in sensor.

- a. Run test 05-0070, Document Scan Read Sensor 1.
- b. If the sensor is defective, replace the scan in lower assembly.

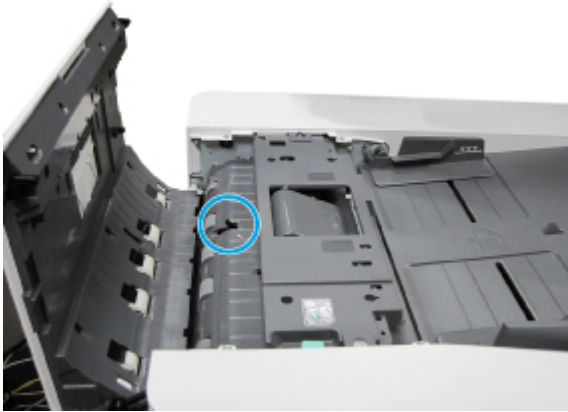
- E78223-E78230 dn models only
1. Open and then close the top door of the automatic document feeder and check whether the problem occurs again.
  2. Open the document feeder cover. If there is jammed paper, remove it.
  3. If this error occurs continually, check the registration sensor and registration actuator.

- a. Push and release the registration actuator, check that the actuator returns to its original position.
- b. Check if the registration actuator returns to the original position.
- c. Use the sensor test to check the correct operation of the sensor.

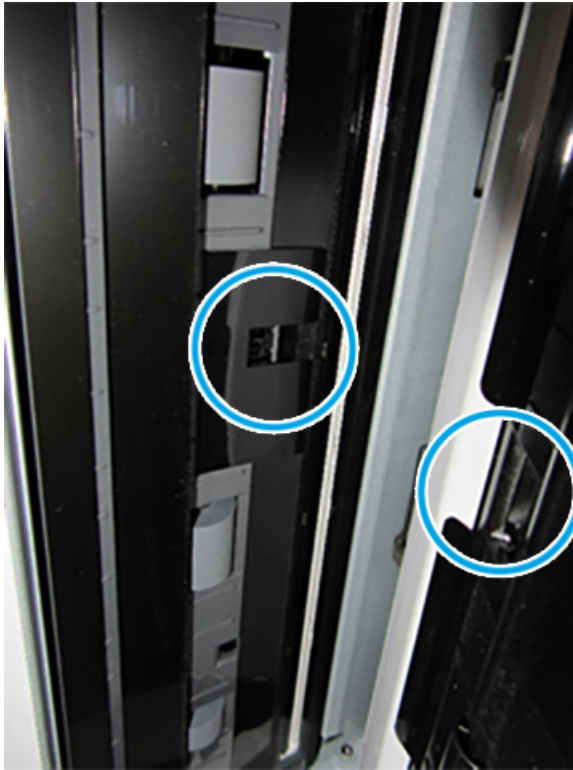
**Figure 53** Sensor location

4. Check the scan sensor and scan actuator. If their operation is abnormal, replace the defective part.

- a. Run test 05-0070, Document Scan Read Sensor 1.
  - b. If the sensor does not function correctly, replace the automatic document feeder assembly.  
Part number: Non- Flow ADF assembly - JC97-04954A
5. Check the reflect film. If it is contaminated, clean it.

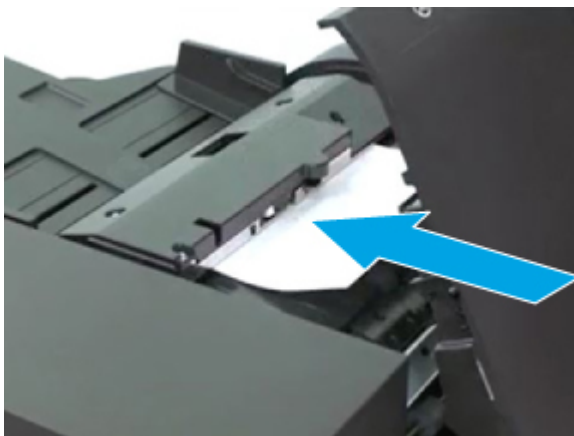
1. Open the document feeder and remove any jammed paper, then close the cover and check whether it operates again.
2. Test the document feed sensor.

- Service Tools
  - Diagnostics
  - Scanner Diagnostics
  - Scanner/Document Feeder Test Routines
- b. Run test 05–0050, Document Feed Sensor.
  - c. If the sensor does not function correctly replace the sensor.  
Part number: 0604-001502
3. Test the simplex registration sensor.

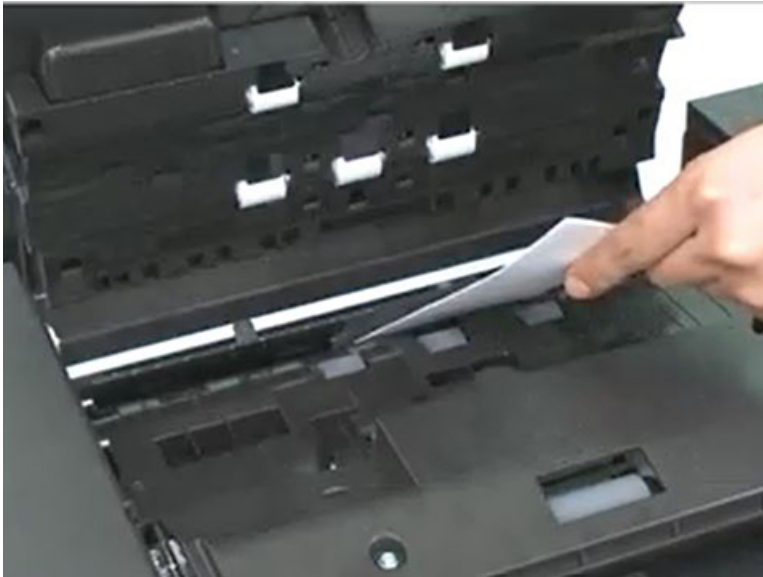
4. If this error occurs continually, check the duplex registration sensor.

- a. Run test 05–0061, Document Duplex Registration Sensor.
- b. If the sensor is defective, replace the document feeder contact image sensor.

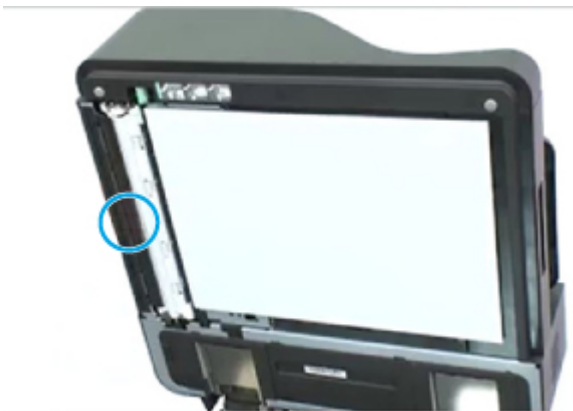
5. If this error occurs continually, check the document feeder scan in sensor.

- a. Run test 05–0070, Document Scan Read Sensor 1.
- b. If the sensor is defective, replace the scan in lower assembly.

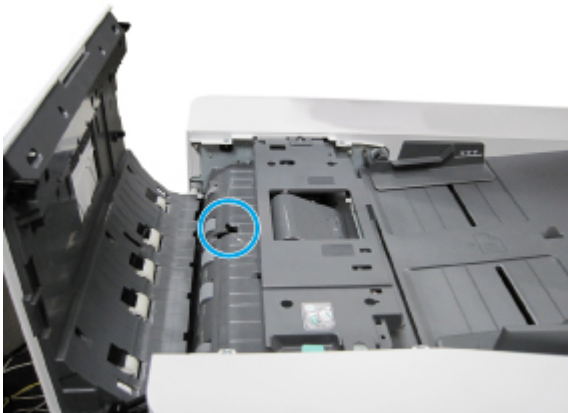
- E72525-E72535 dn models only
  - E77822-E77830 dn models only
  - E82540-E82560 du models only
  - E87640-E87660 du models only
  - E78223-E78230 dn models only
  - E78223-E78230 dn models only
1. Open and then close the top door of the scanner and check whether the problem occurs again.
  2. Open the document feeder cover. If there is jammed paper, remove it.
  3. If this error occurs continually, check the registration sensor and registration actuator.

- a. Push and release the registration actuator.
- b. Check if the registration actuator returns the original position.
- c. Use the sensor test to check the correct operation of the sensor.
  - i. Open the following menus:
