# HP Color LaserJet Managed MFP E77822-E77830 series – Control Panel Message Document (CPMD)

This document provides error-code troubleshooting information

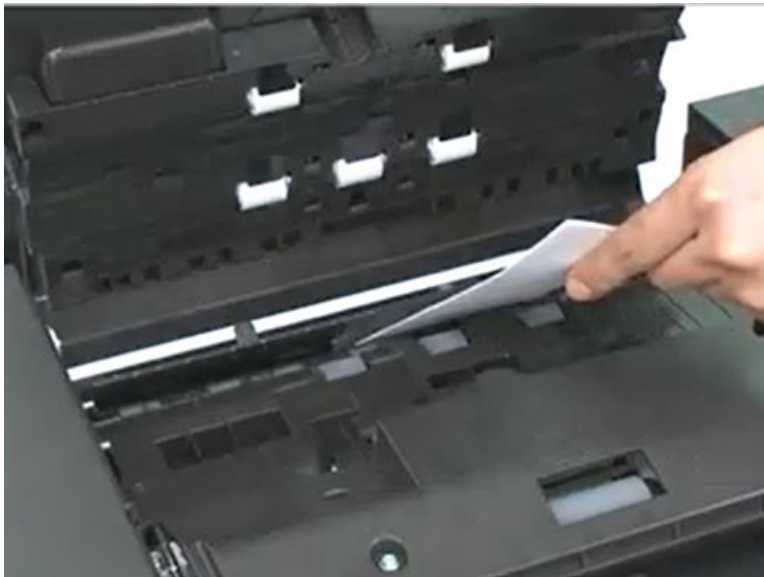
3. If this error occurs continually, check the duplex registration sensor.

a. Run test 05–0061, Document Duplex Registration Sensor.

b. If the sensor is defective, replace the document feeder contact image sensor.

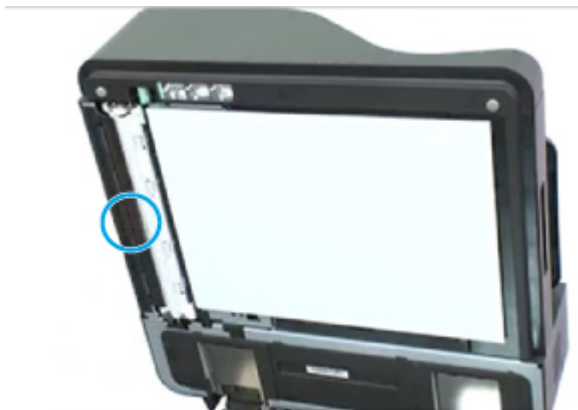
4. If this error occurs continually, check the document feeder scan in sensor.

- a. Run test 05-0070, Document Scan Read Sensor 1.
- b. If the sensor is defective, replace the scan in lower assembly.

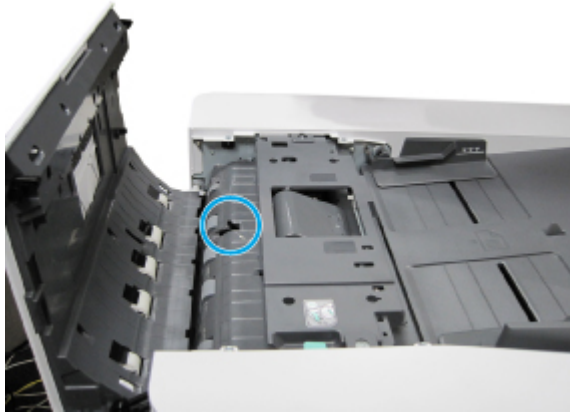
- E82540-E82560 du models only
  - E87640-E87660 du models only
  - E78223-E78230 dn models only
  - E78223-E78230 dn models only
1. Open the document feeder cover. If there is jammed paper, remove it.
  2. If this error occurs continually, check the registration sensor and the registration actuator.

- a. Push and release the registration actuator.
- b. Check if the registration actuator returns the original position.
- c. Use the sensor test to check the correct operation of the sensor.

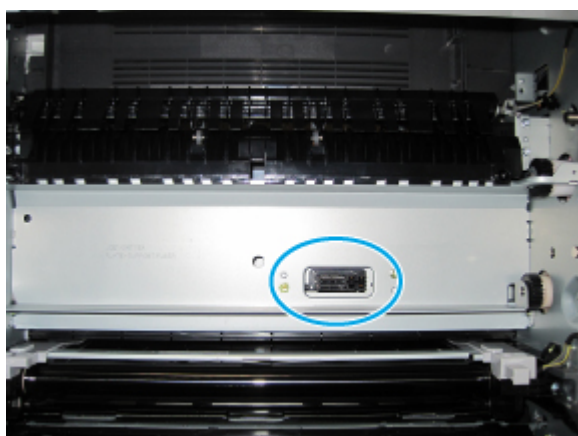
5. Check the connector inside the printer that connects to the fuser. If the connector is damaged, replace the fuser connector assembly.

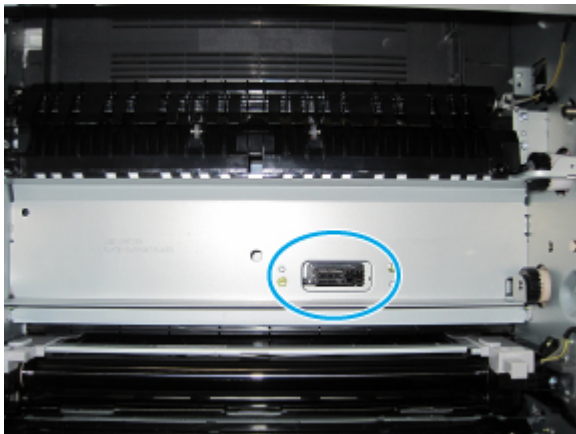
7. Check the connector inside the printer that connects to the fuser. If the connector is damaged, replace the fuser connector assembly.

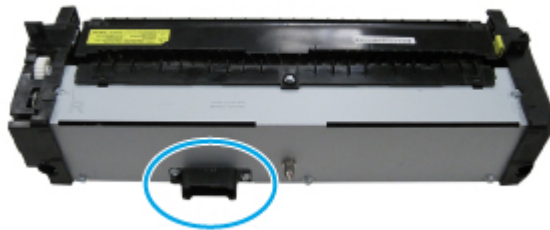
1. Turn the printer off, and then on.
2. Check the fuser.
  - a. Turn the printer off.
  - b. Open the right side cover.
  - c. Remove the fuser.
  - d. Check the connector between the fuser and the engine for damage. Replace the fuser as needed.

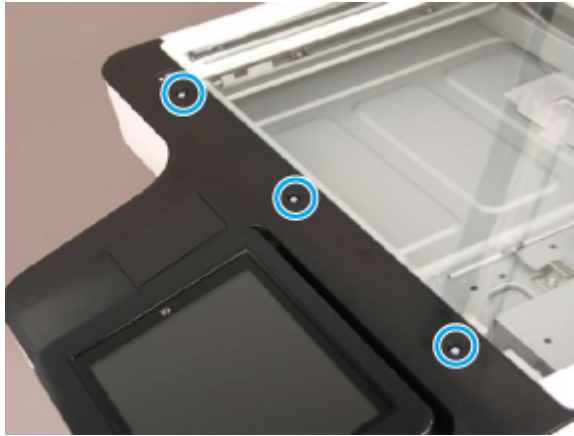
- b. Remove the control panel bezel.
  - i. Open the document feeder, and then remove three screws.

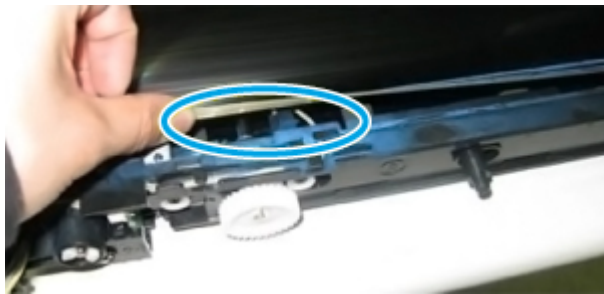
**Figure 68** ITB sensor

ITB Sensor Part number: 0604-001393

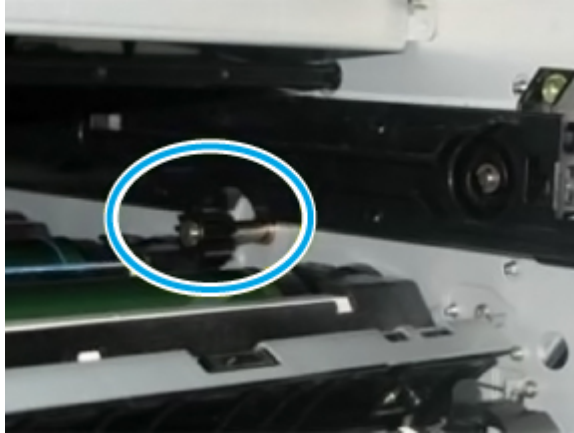
Figure 69 ITB engagement gear

6. If the motor is operational, run the ITB engagement test with the ITB removed and watch for the engage gear to rotate. If the gear is not operating correctly, replace the main sub drive unit.

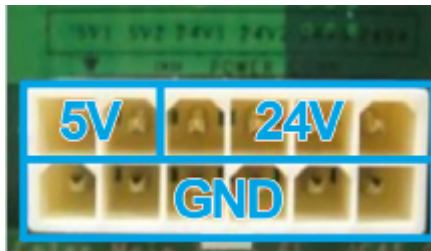
Figure 73 Main board PCA

- g. If the 24V is not being supplied, check the 24V on connector 17 to chassis ground on the main board PCA from the LVPS type 5.

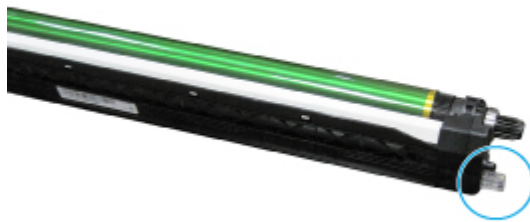
- c. Remove the failing imaging drum unit and check the CRUM connector for damage. Replace the imaging drum unit as needed.

- d. Check the metal drum unit contact and printer contact for dirt, dust or debris. Clean contacts as needed.
  - e. Reinstall the imaging drum unit.
  - f. Reinstall the toner collection unit and close the front and right covers.
3. Turn the printer on and test the printer.
  4. If the error persists, replace the failing imaging drum unit.  
Part number: W9215-67901  
For instructions: Removal and replacement: Imaging unit See the Repair Service Manual for this product.
  5. If the error persists, replace the high voltage power supply (HVPS).  
Part number: JC44-00212B  
For instructions: Removal and replacement: High-voltage power supply See the Repair Service Manual for this product.
  6. If the error persists after all troubleshooting is performed, elevate the issue using the Standard Support Process.

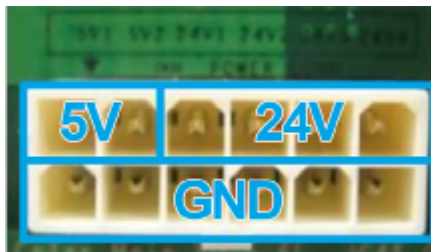
Figure 82 Main board PCA

- f. If the 24V is not being supplied, check the 24V on connector 17 to chassis ground on the main board PCA from the LVPS type 5.

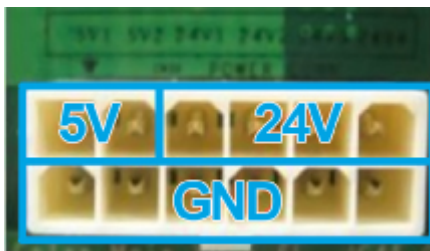
**Figure 86** Connector 17 on the main board PCA

1. Turn the printer off, and then on.
2. Check the 24V to chassis ground on the main board PCA from the LVPS type 5.

3. If the 24V is abnormal, disconnect the cable and test the voltage on the cable connector from the LVPS. (24V  $\pm$  5%).
4. If the voltage from the LVPS type 5 board is abnormal, replace it.  
Part number: (110V) JC44-00249A  
Part number: (220V) JC44-00250A  
For instructions: Removal and replacement: LVPS board See the Repair Service Manual for this product.
5. If the voltage is good from the LVPS but not normal when plugged into the connectors, replace the main board PCA.  
Part number: 8GR94-60003  
For instructions: Removal and replacement: Main board See the Repair Service Manual for this product.

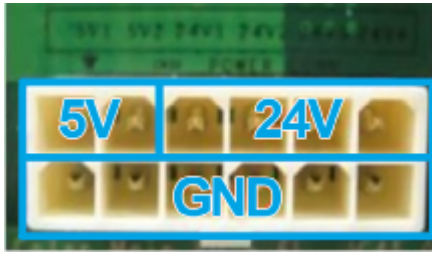
Figure 87 Connector 17 on the main board PCA

2. Check the 5V to chassis ground on the main board PCA from the LVPS type 5.

3. If the 24V is abnormal, disconnect the cable and test the voltage on the cable connector from the LVPS. (5V  $\pm$  5%).
4. If the voltage from the LVPS type 5 board is abnormal, replace it.  
Part number: (110V) JC44-00249A  
Part number: (220V) JC44-00250A  
For instructions: Removal and replacement: LVPS board See the Repair Service Manual for this product.
5. If the voltage is good from the LVPS but not normal when plugged into the connectors, replace the main board PCA.  
Part number: 8GR94-60003  
For instructions: Removal and replacement: Main board See the Repair Service Manual for this product.

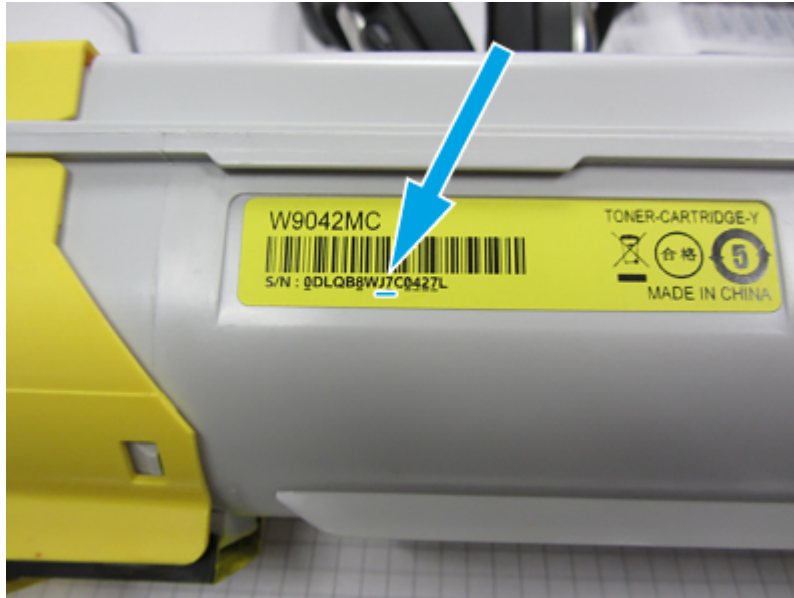
Figure 89 Serial number label

- c. Remove the failing color toner cartridge.
  - d. Check the date-code of toner cartridge. The eighth digit is the year, the ninth digit is the month. Toner cartridges built before September 2017 may induce one of these errors

**NOTE:** Any cartridges before the date-code of “JA” would be considered suspect to possibly cause this issue.

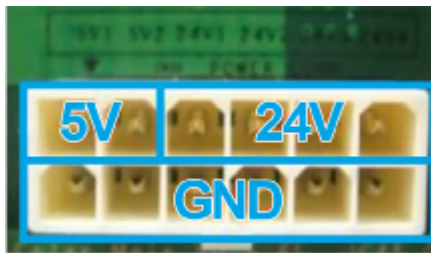
Figure 90 Main board PCA

- f. If the 24V is not being supplied, check the 24V on connector 17 to chassis ground on the main board PCA from the LVPS type 5.

- g. If the 24V is abnormal, disconnect the cable and test the voltage on the cable connector from the LVPS. ( $24V \pm 5\%$ ).
- h. If the voltage from the LVPS type 5 board is abnormal, replace it.  
Part number: (110V) JC44-00249A  
Part number: (220V) JC44-00250A  
For instructions: Removal and replacement: LVPS board See the Repair Service Manual for this product.
- i. If the voltage is good from the LVPS but not normal when plugged into the connectors, replace the main board PCA.  
Part number: 8GR94-60003  
For instructions: Removal and replacement: Main board See the Repair Service Manual for this product.
- j. If the voltage from the main board PCA is good, replace the failing color motor.  
Part number: JC93-00446B  
For instructions: Removal and replacement: Toner supply drive assembly See the Repair Service Manual for this product.

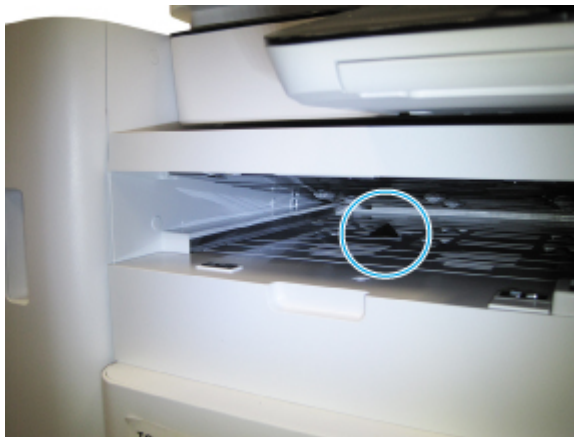
**Figure 91** Sensor location

1. Open bridge and check for sensor. If sensor is in bridge as photo shows then go to next step. If sensor is not seen, then remove the bridge turn it over and check to see if flag is installed or dislodged. There is a spring that will also be with the sensor flag.

Reinstall the sensor and spring in the bridge. Test the system to see if error is resolved.

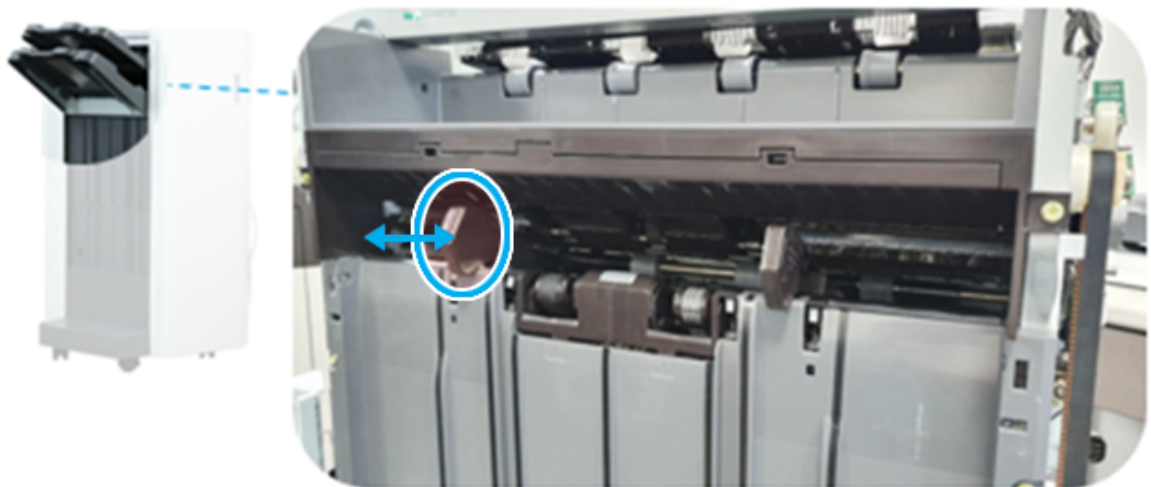
1. Turn the printer off, and then on.
2. Upgrade the firmware to 24.4.2 or greater and if issue persists.
3. If the error persists, move the rear tamper from the home position to the end.

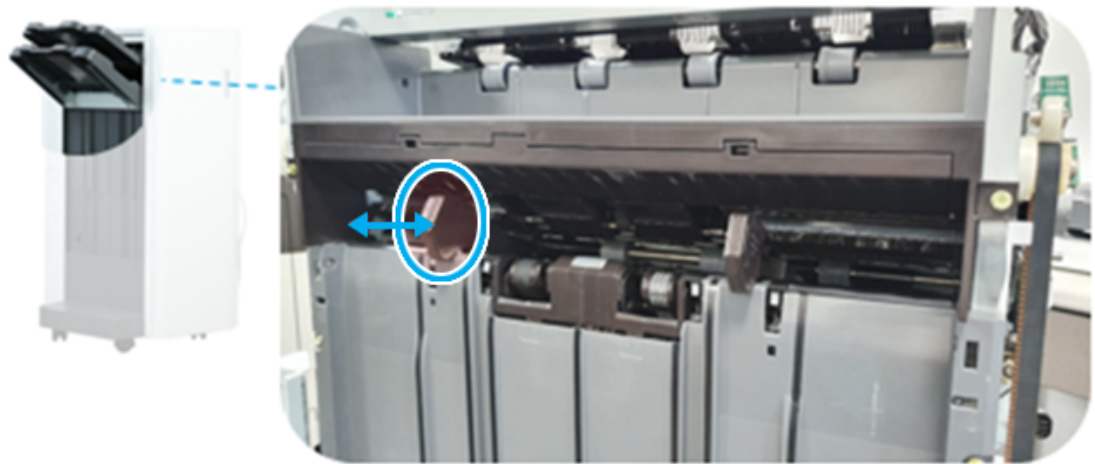
5. If the error persists, check the rear tamper home sensor (S9).

- a. Using code 113-2130, run the diagnostic test for the sensor:
- b. Move the tamper from the home position to the other position to check the reading value change.

- c. If the test fails, disconnect and reconnect both ends of the wire harness from the sensor to the finisher PCA.
- d. Test the sensor, if the error persists, replace the rear tamper sensor.

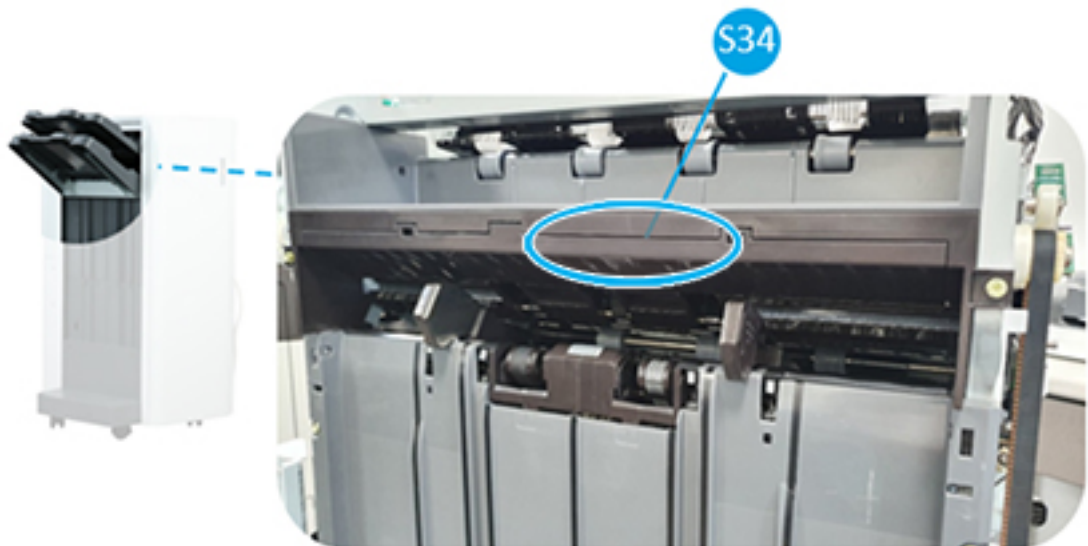
- 7. If the error persists, check the Main output tray top of stack switch (S34).

- a. Run the diagnostic test for the stack top sensor using code 113-2190.

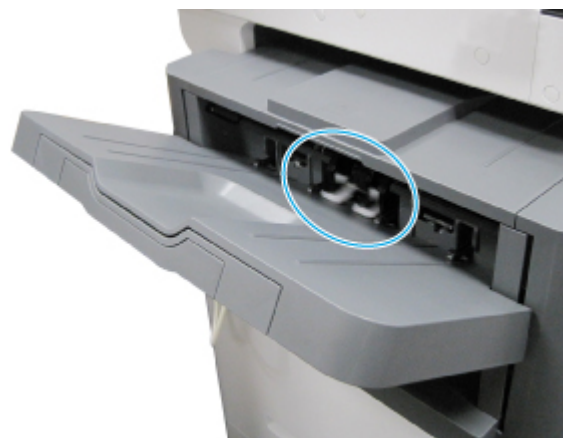
- b. Run test 113–0510 Finisher Paddle Motor.
- c. Ensure the motor functions correctly by viewing the finisher paddles.

- d. If the motor does not function correctly, disconnect and reconnect the wire harness from the motor to the finisher PCA.
- e. Make sure that there is no damage or obstructions that would cause the failure.

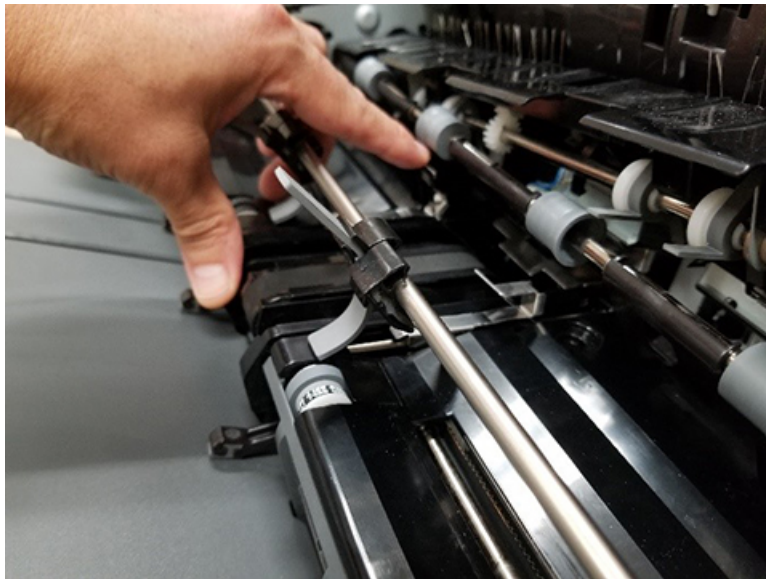
**Figure 96** Reform metal ejector

- c. Push down on the deformed Metal Ejector to reshape it to a square shape. The target is to have 90° corners as shown in following image.

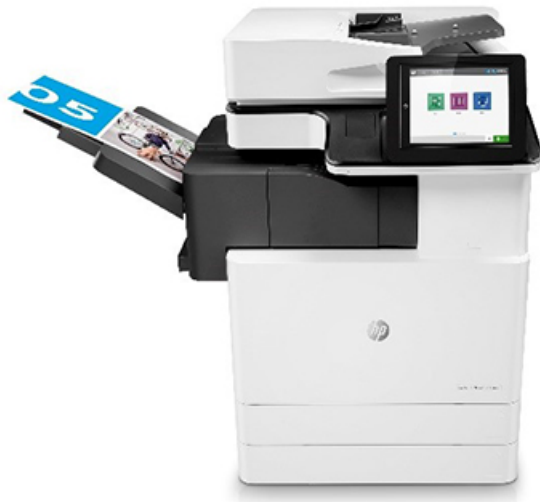
1. Verify that the inner finisher is installed using the following image.

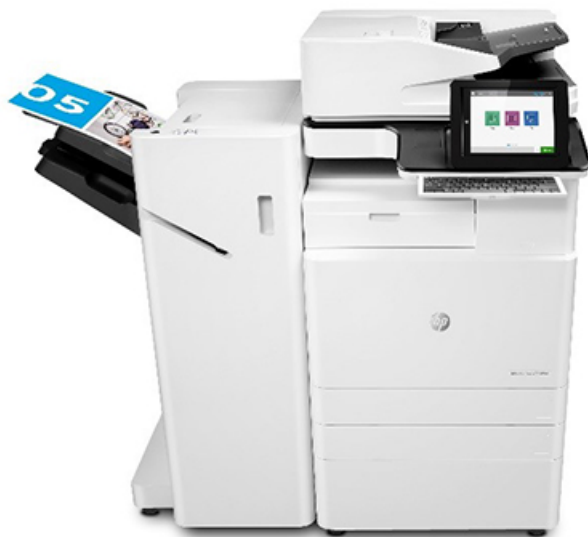
1. Verify that a stapler/stacker or booklet maker finisher is installed using the following image.

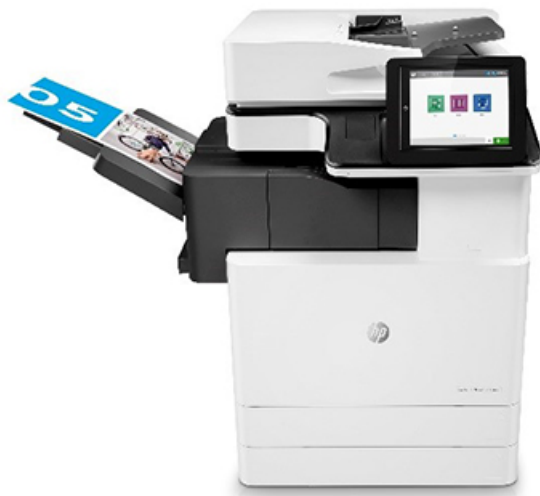
1. Verify that the inner finisher is installed using the following image.

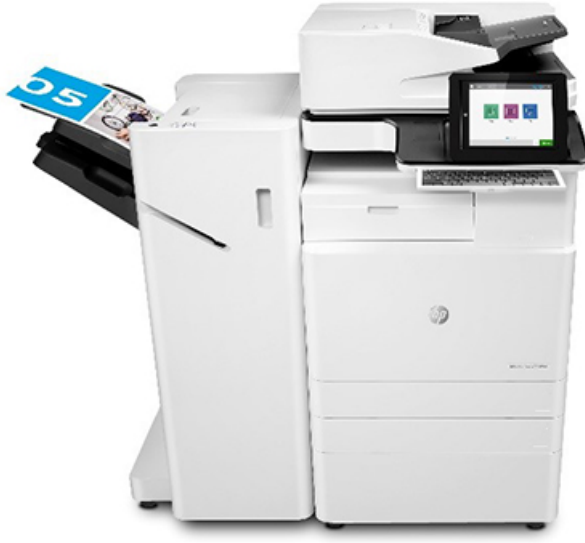
1. Verify that a stapler/stacker or booklet maker finisher is installed using the following image.

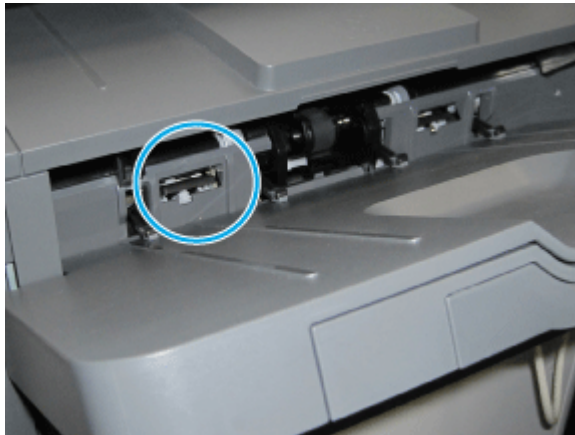
- b. Push the paper support ( Call-out 1) to ensure the reading changes.

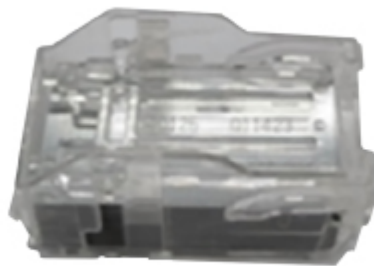
4. If the staple cartridge is empty, replace the staple cartridge.

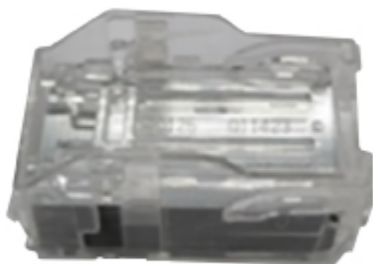
4. If the staple cartridge is empty, replace the staple cartridge.

5. Replace the stapler cartridge and close the finisher door.
6. If the staple cartridge unit is damaged, replace the staple cartridge unit.  
Part number: JC81-09882A
7. Turn the printer off, and then on.
8. If the error persists, disconnect and reconnect the both ends of the wire harness to the stapler sub unit and the finisher PCA.
9. Retest the finisher, If the error persists, replace the finisher sub-staple unit.  
Part number: JC90-01412A

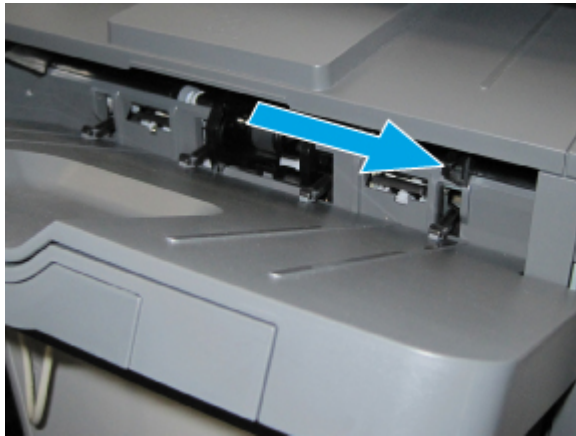
- 5. If the motor test functions correctly, check the tamper home sensor (S5).
  - a. Run test 113-0390, Finisher Right Tamper Sensor: **Support Tools > Service > Service Tools > Diagnostics > Engine Diagnostics > Engine Test Routines.**
  - b. Touch Start and then Get Status.
  - c. During the sensor test, move the front tamper back and forth to change the sensor value.

- d. If it does not function correctly, disconnect and reconnect both ends of the wire harness to the sensor from the finisher PCA.
- e. Retest the sensor, if it does not function correctly replace the sensor.

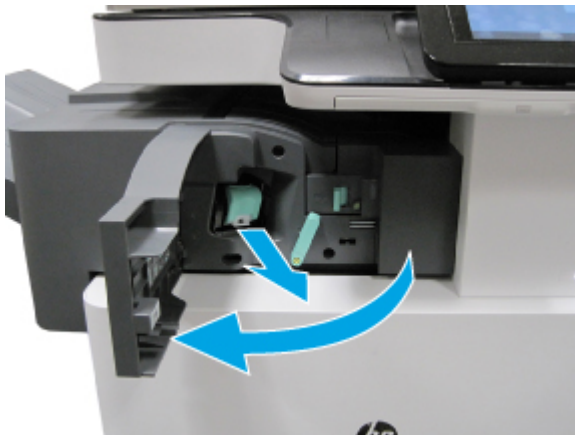
1. Check the staple cartridge.
  - a. Open the finisher door and remove the stapler cartridge.

- b. Check the staple cartridge for any jammed staples and remove them.
  - c. Install the staple cartridge.
  - d. Close the finisher cover.
2. Open the finisher and check for any jammed paper or obstructions, and remove them.

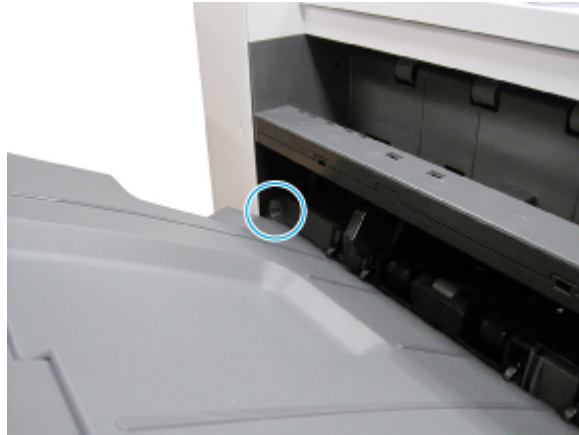
5. Check the main tray beam sensor.
  - a. Run test 113–2140, 2 Bin Finisher Main Beam Sensor.
  - b. Cover the beam sensor to ensure the reading changes from “Low” to “High”.

- c. If the reading does not change, disconnect and reconnect the wire harness from the sensor to the finisher PCA.
  - d. Retest the sensor. If the test fails, elevate the issue using the Standard Support Process.

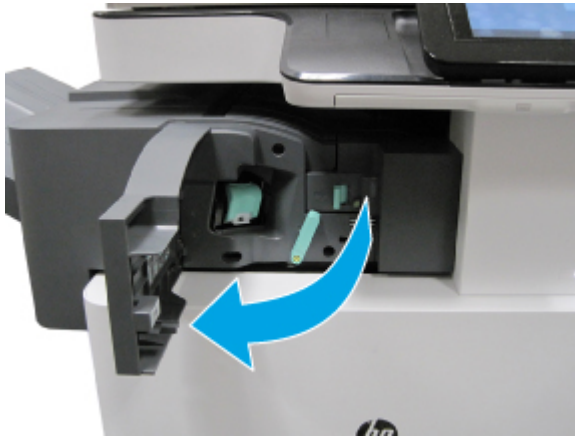
1. Open the finisher and check for any jammed paper or obstructions, and remove them.
  - a. Open the finisher door.

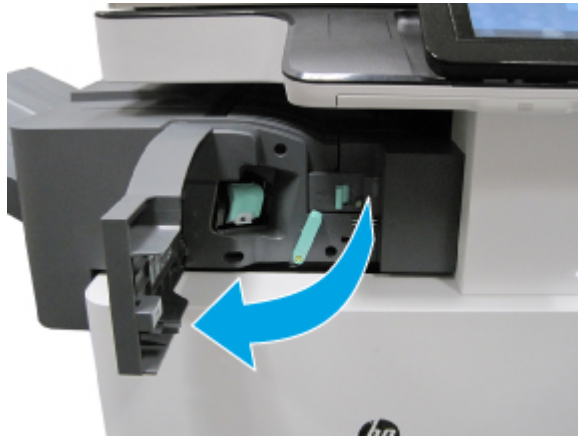
2. If the error was not caused by the unit shipped without the lock in place, continue troubleshooting with the following steps.
3. Verify there are no jammed staples in the staple cartridge. Lift the front metal and make sure the staples are correctly formed. Clear any damaged staples, and remove the current sheet of staples from the cartridge if needed.
4. Open the finisher and check for any jammed paper or obstructions, and remove them.
  - a. Open the finisher door.

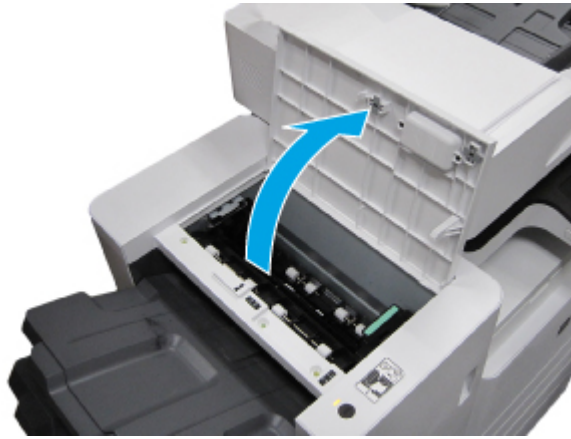
- a. Open the finisher top cover.

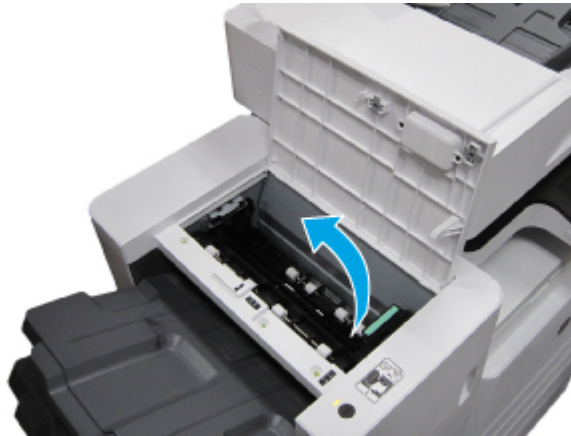
- b. Open the inner jam cover.

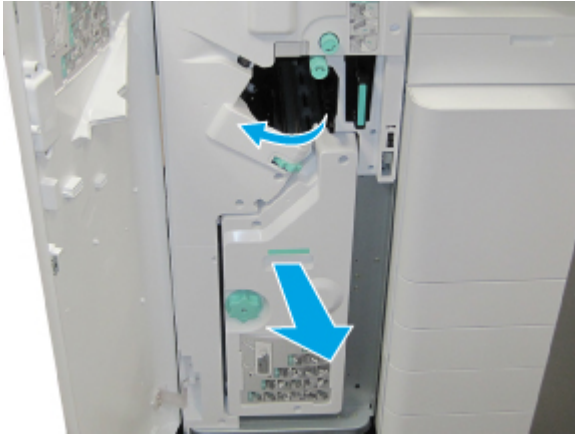
- a. Open the finisher front cover and the inner jams access cover, and then pull the booklet maker out.

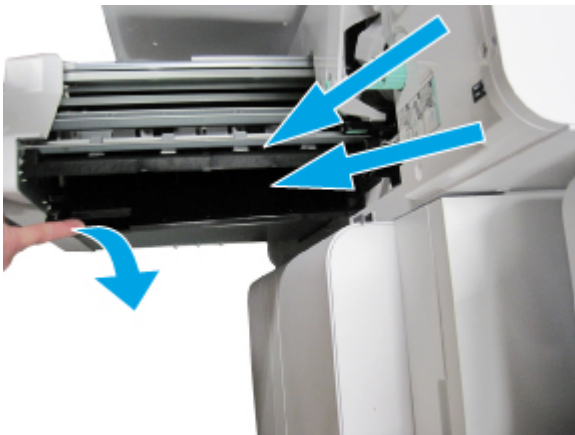
- c. Open the booklet entrance jam access door and check for paper or obstructions.

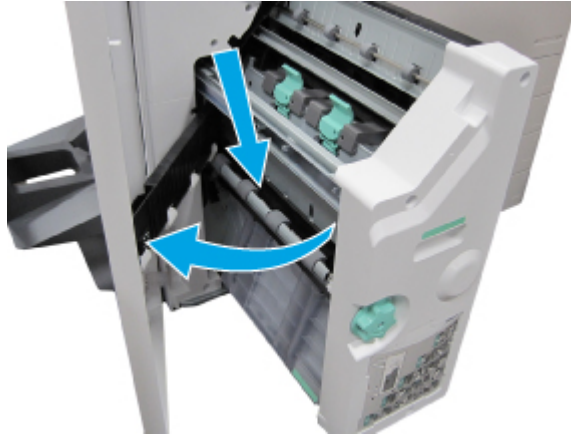
- d. Open the upper jam access door and clear any jams.

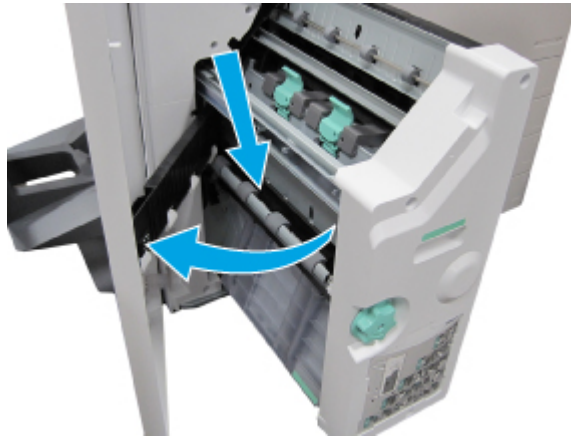
- d. Open the upper jam access door and clear any jams.

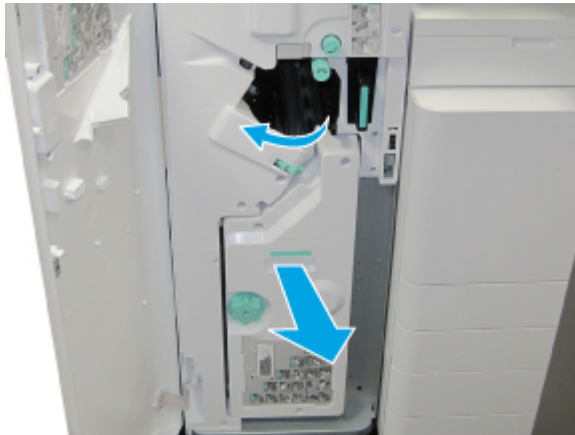
1. Check the booklet maker for jams or obstructions.
  - a. Open the finisher front cover and the inner jams access cover, and then pull the booklet maker out.

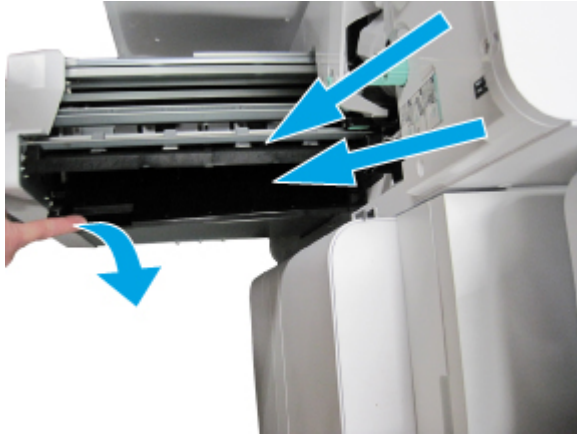
- c. Open the booklet entrance jam access door and check for paper or obstructions.

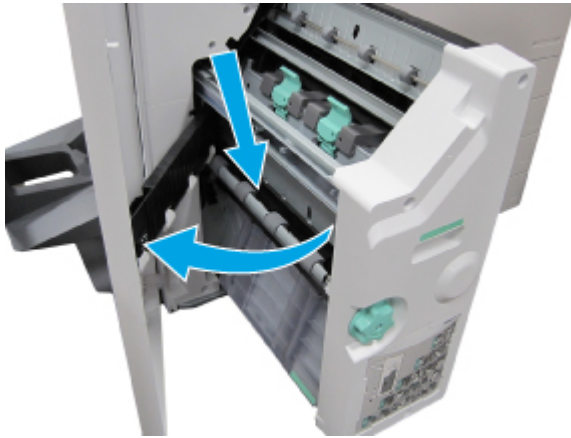
- d. Open the upper jam access door and clear any jams.

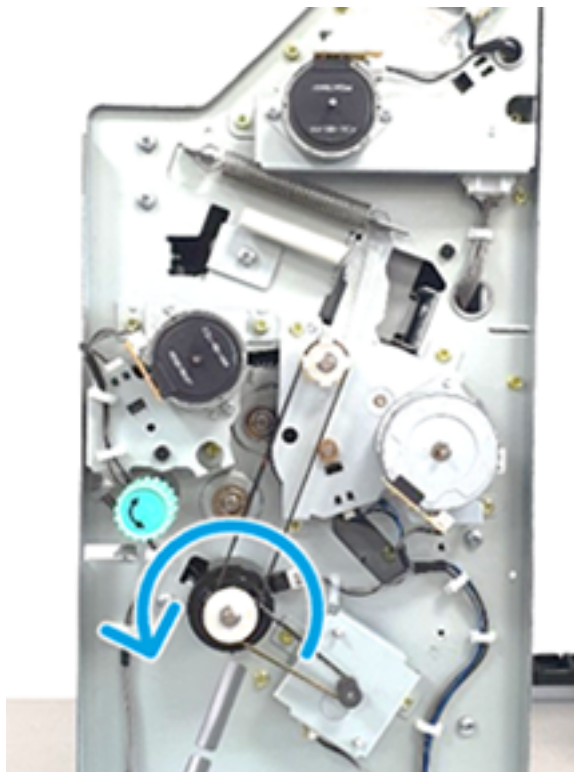
- a. Using code 113-3090 Booklet Paddle home Sensor, run the diagnostic test for the sensor.
- b. Rotate the booklet paddle encoder to check the reading value change.

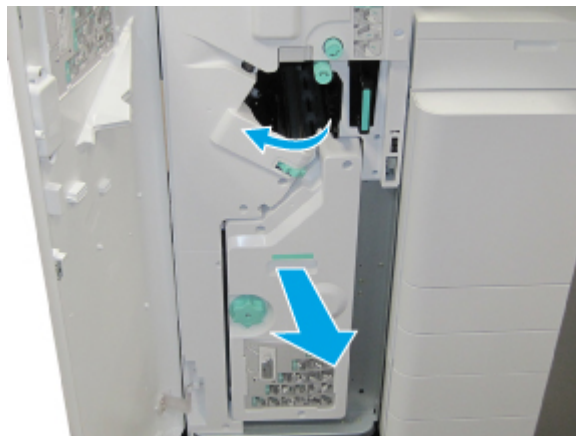
1. Open and then close the door of the finisher.
2. Check the finisher for any jammed paper or obstacles, and remove them.
  - a. Open the finisher front cover and the inner jams access cover, and then pull the booklet maker out.

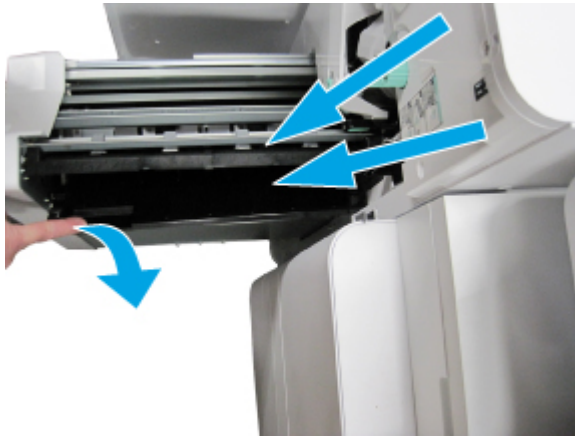
- c. Open the booklet entrance jam access door and check for paper or obstructions.

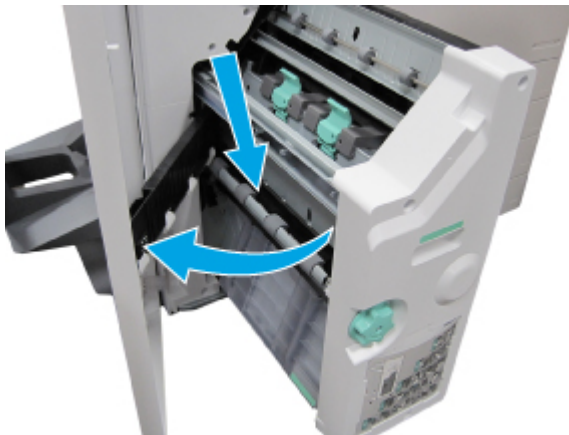
- d. Open the upper jam access door and clear any jams.

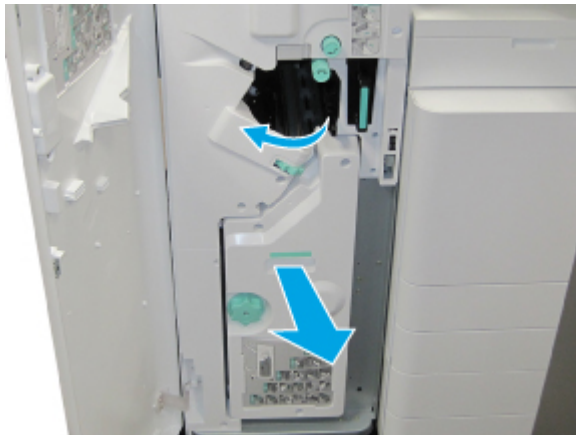
1. Open and then close the door of the finisher.
2. Check the finisher for any jammed paper or obstacles, and remove them.
  - a. Open the finisher front cover and the inner jams access cover, and then pull the booklet maker out.

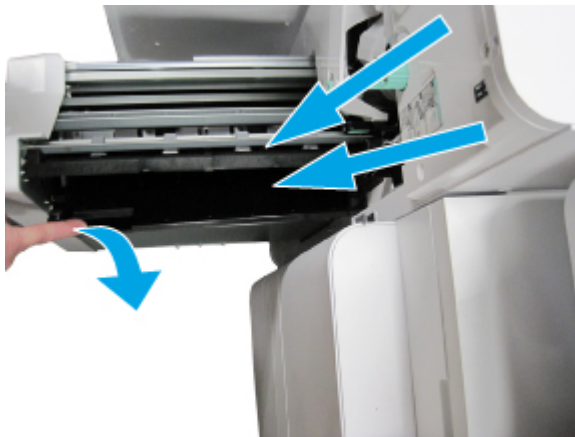
- c. Open the booklet entrance jam access door and check for paper or obstructions.

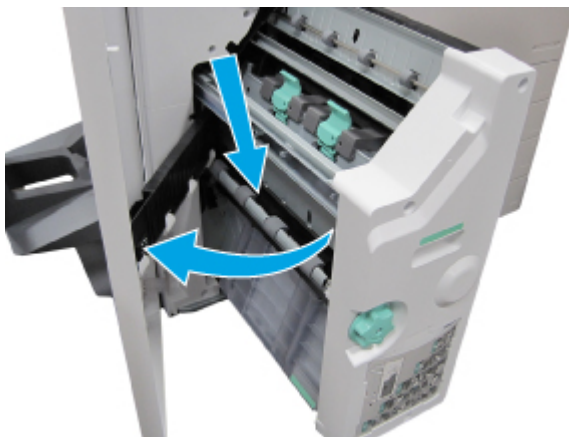
- d. Open the upper jam access door and clear any jams.

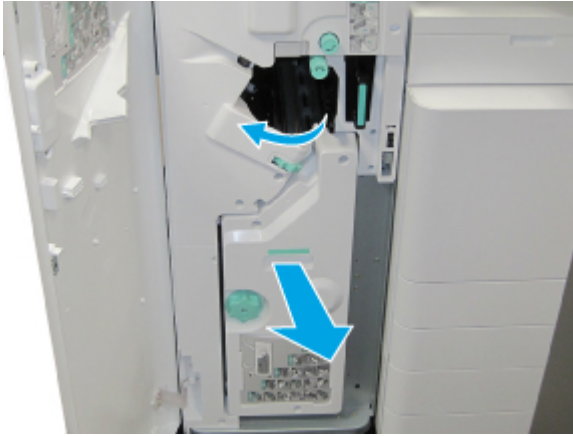
- a. Open the finisher front cover and the inner jams access cover, and then pull the booklet maker out.

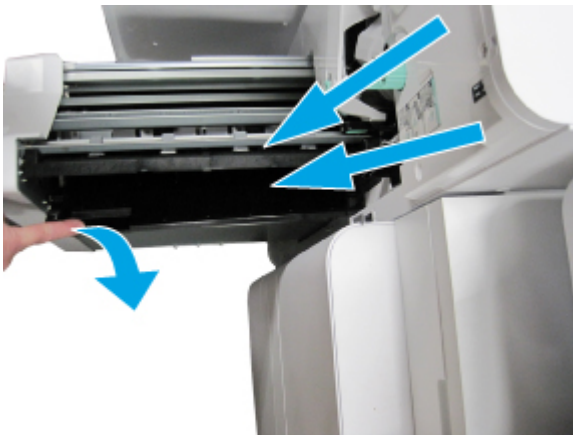
- c. Open the booklet entrance jam access door and check for paper or obstructions.

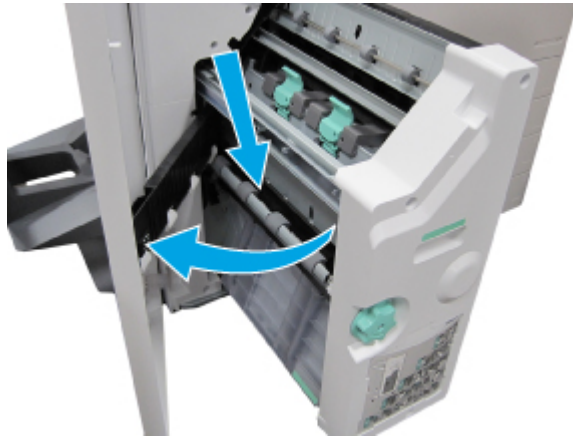
- d. Open the upper jam access door and clear any jams.

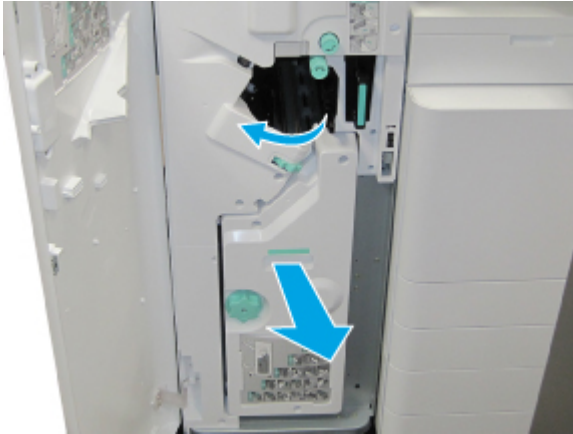
1. Open and then close the door of the finisher.
2. Check the finisher for any jammed paper or obstacles, and remove them.
  - a. Open the finisher front cover and the inner jams access cover, and then pull the booklet maker out.

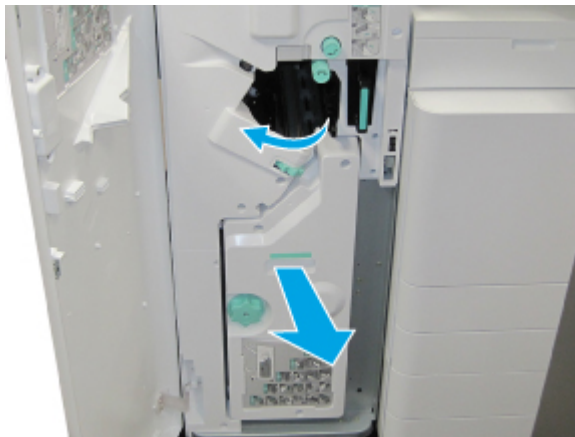
1. Open and then close the door of the finisher.
2. Check the finisher for any jammed paper or obstacles, and remove them.
3. Check the booklet maker for jams or obstructions.
  - a. Open the finisher front cover and the inner jams access cover, and then pull the booklet maker out.
